July 30, 2018

SUBJECT: Safety Recall 16S26 – Supplement #5
 Certain 2005-2006 Ford GT, 2005-2011 Mustang, 2006-2011 Fusion and Milan,
 2006 Zephyr, 2007-2011 MKZ, 2007-2010 Edge and MKX, and 2007-2011 Ranger
 Vehicles
 Passenger Airbag Inflator Replacement

CERTAIN 2005-2006 FORD GT AND 2010-2011 MUSTANG VEHICLES — PASSENGER AIRBAG INFLATOR REPLACEMENT

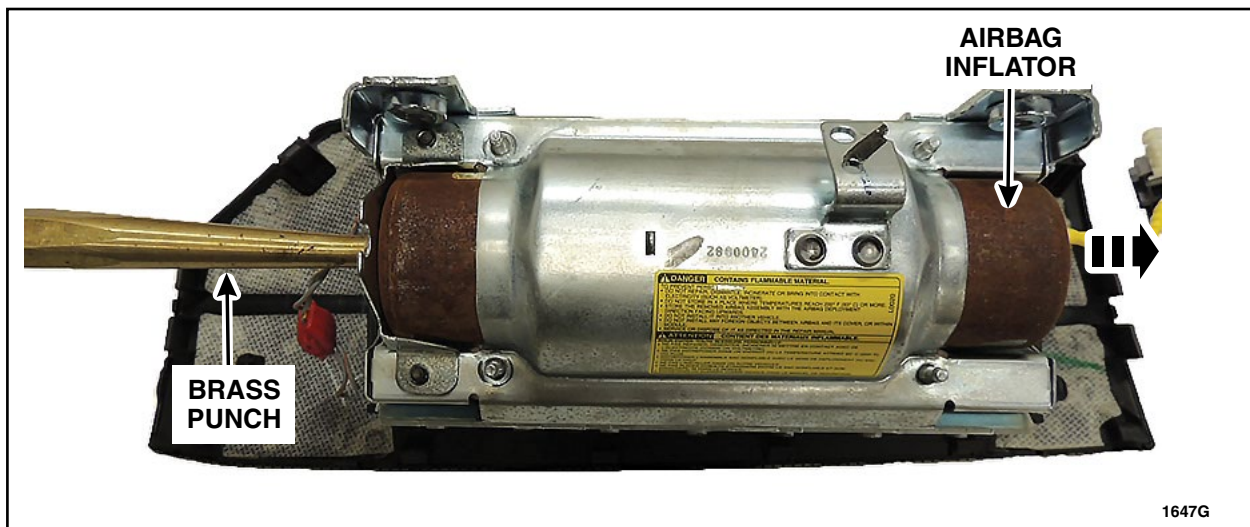
FIGURE 6

8. With an assistant holding the passenger airbag assembly, remove the inflator from the assembly by pushing outward on the inflator. Set the airbag inflator aside for return shipping. See Figure 6.
- If required, use of a brass punch is permitted (only at the location shown) to free the inflator from its mounted position.

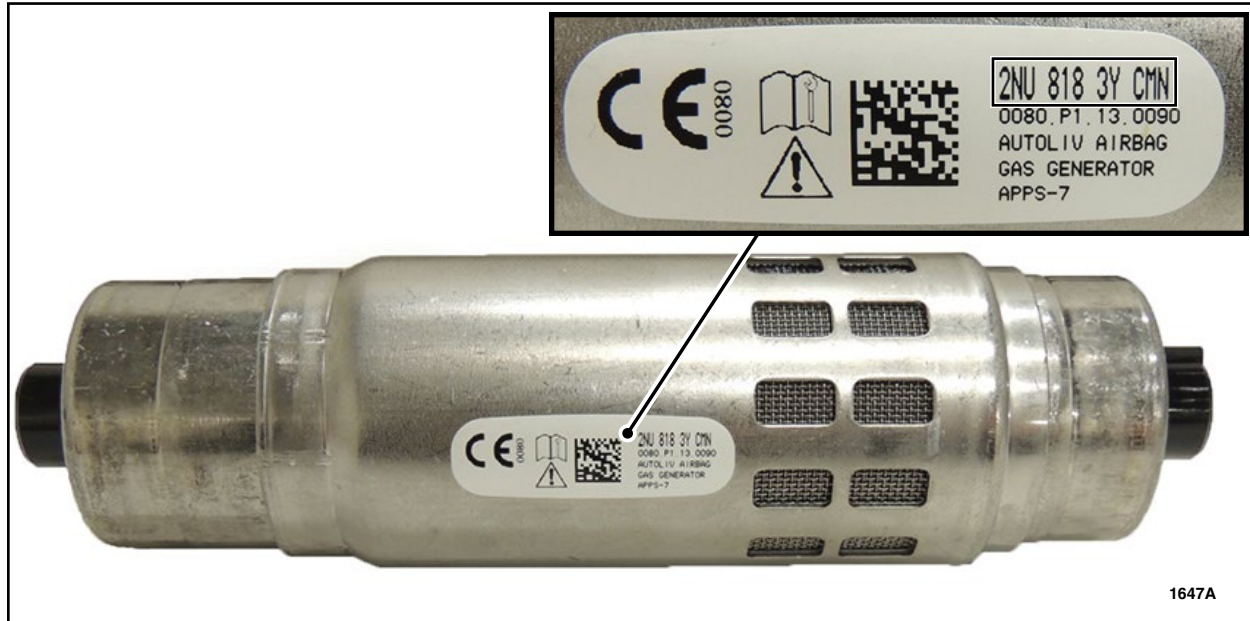
FIGURE 7

9. Record the 11 character serial number of the *new* airbag inflator on the repair order. See Figure 7.

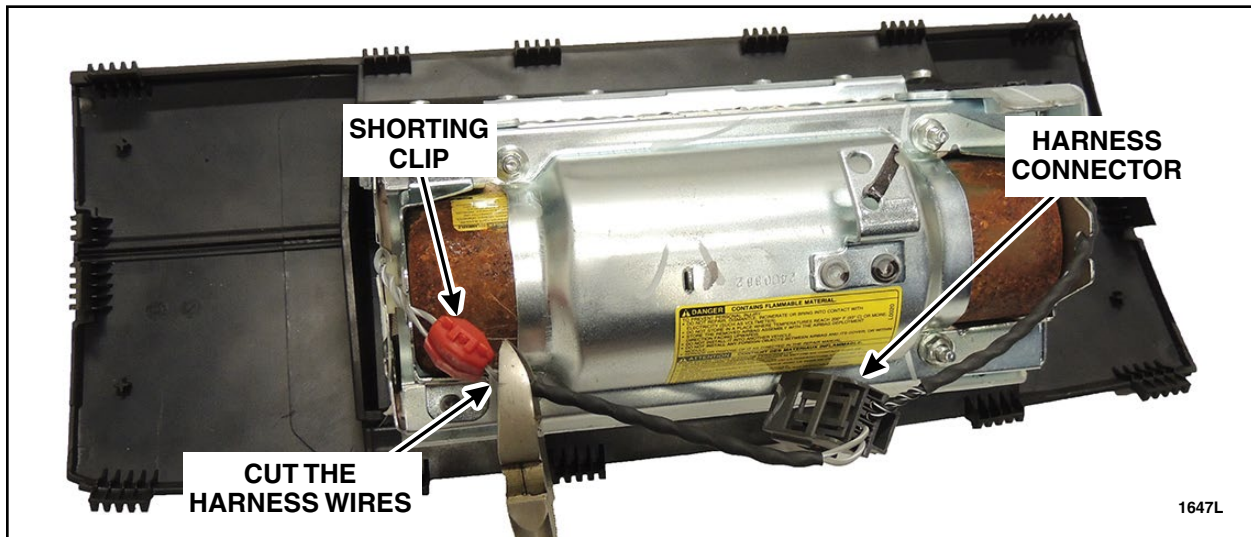
FIGURE 4

6. Cut the harness wires between the shorting clip and the harness connector. See Figure 4.
