| WORK INSTRUCTION | | | | | | |
|---|---|---|---|---|---|---|
| M0999507 | N/A | Service Instruction<br>Inspect and Repair J-brackets | 05 | Released | 10/21/2015 | Chris Perkins |

This procedure describes a 2 part process. Both inspection and repair, if necessary, are covered by this document.

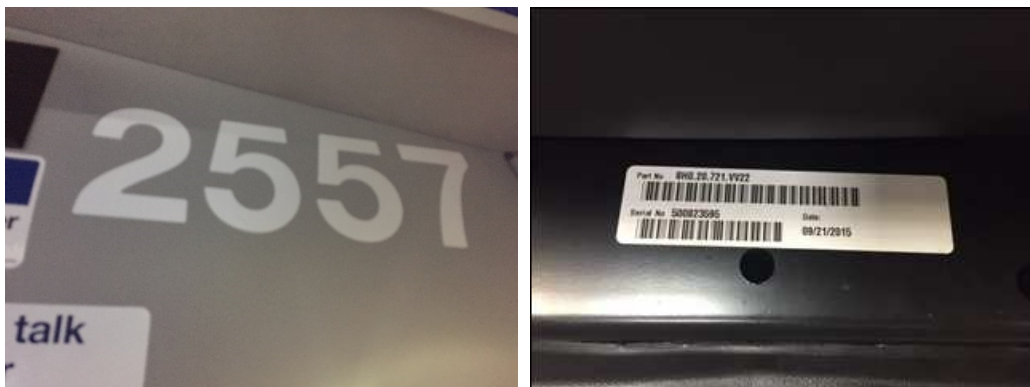
1. Position the seat to “full forward” and “full up” to obtain the serial number on the seat. The serial number decal is located on the back of the seat on the top of the suspension between the seat tracks, shown above. Record the bus number and serial number of the seat.

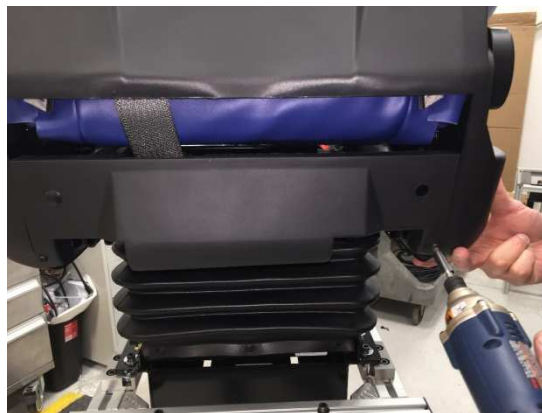
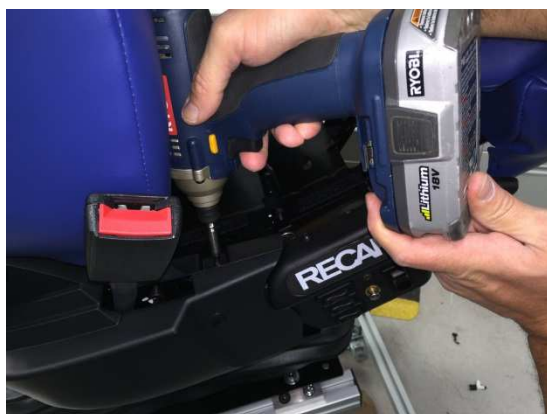
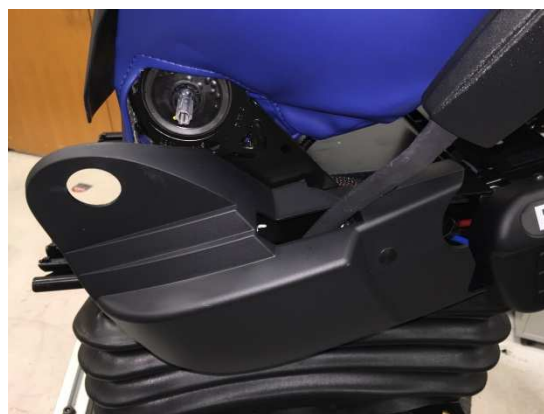
- If J-bracket(s) need to be replaced, remove the 2 hole plugs and 4 screws in the rear trim panel and the mounting screw from the rear corner panel(s). Remove the recliner handwheel.

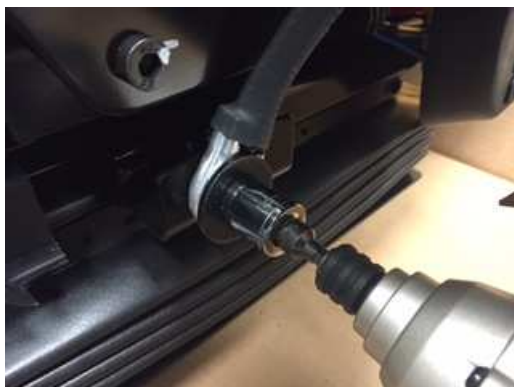
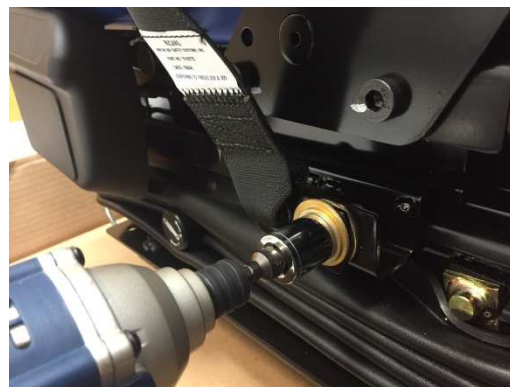
- Remove the belt buckle (or belt retractor/3pt anchor) from the bad J-bracket with a 5/8 socket. Set the removed components aside.

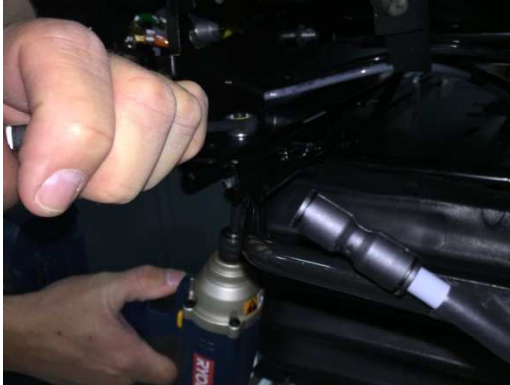
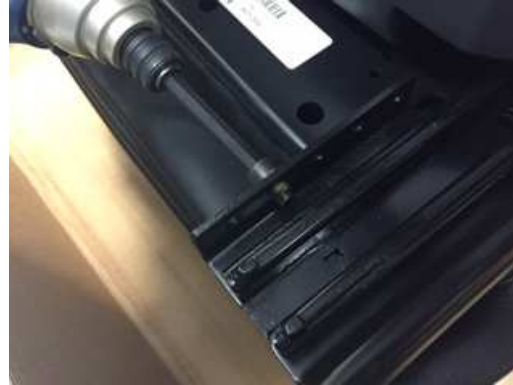
- Position the seat back to "full forward". Unfasten the front track bolt from the cushion frame using a 6mm hex bit and a 13mm wrench. Check the rear of seat for a track stop bolt. If present, remove it with the 6mm hex bit.

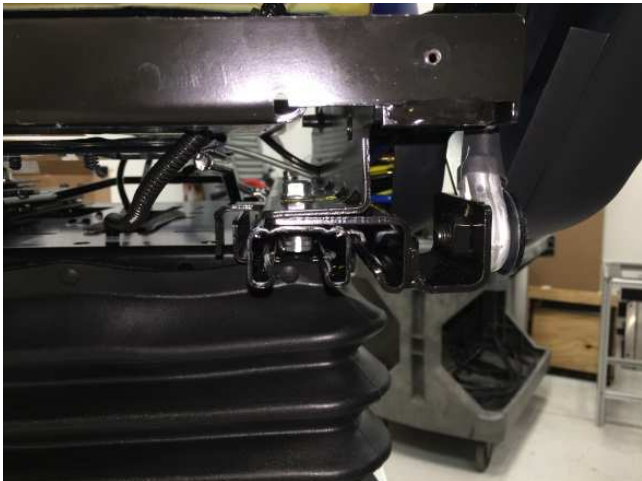
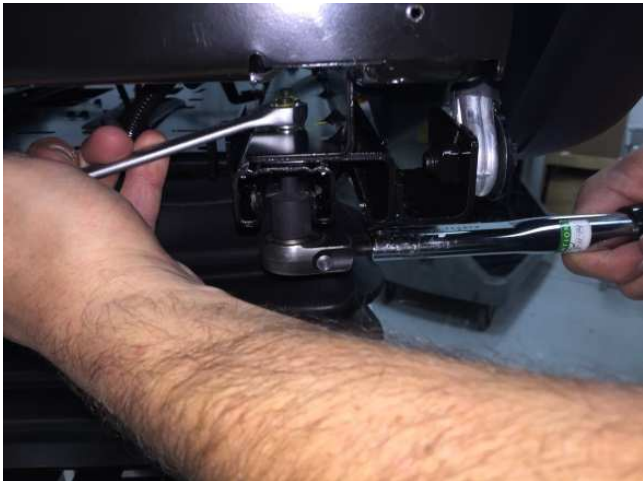
| STEP | PICTURES / DESCRIPTIONS | Special Criteria |
|---|---|---|
| 5. | <p>Position the seat to “full rear”. Unfasten the rear track bolts from the cushion frame using an 6mm hex bit and a 13mm wrench. Place a 2 inch block between the cushion frame and suspension to create just enough clearance to remove the J-bracket by sliding it rearward along the path of the track.</p> <div style="display: flex; justify-content: space-around;"> </div> | |

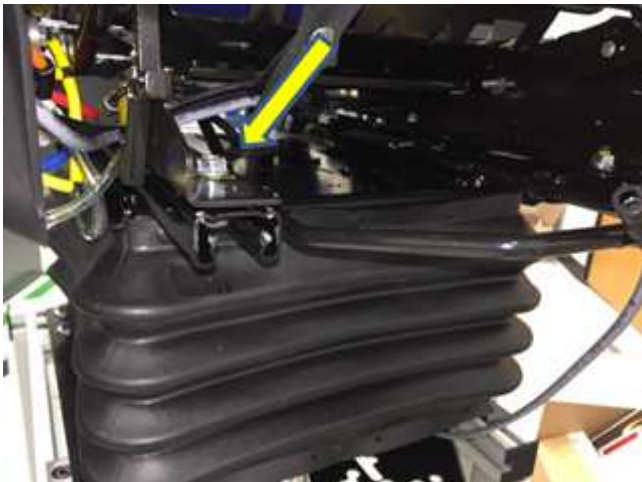
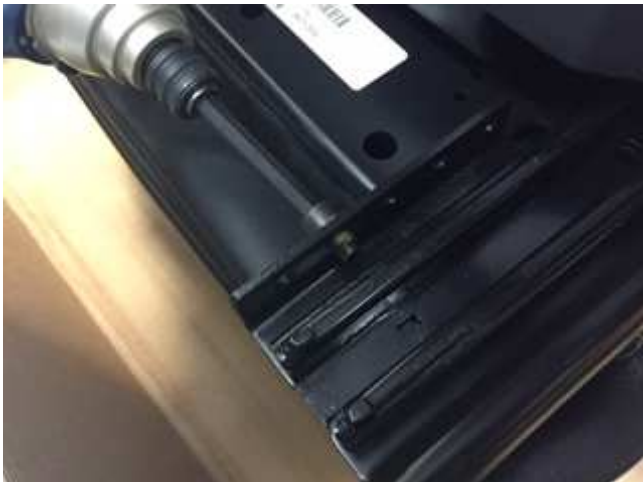
| STEP | PICTURES / DESCRIPTIONS | Special Criteria |
|---|---|---|
| 6. | <p>Position the replacement part utilizing the same path and aligning all the mounting holes. Obtain replacement M8 bolts. Place rear fasteners thru the mounting holes from below and start the flange nuts by hand. Torque to 22 Nm.</p> <div style="display: flex; justify-content: space-around;"> </div> | |

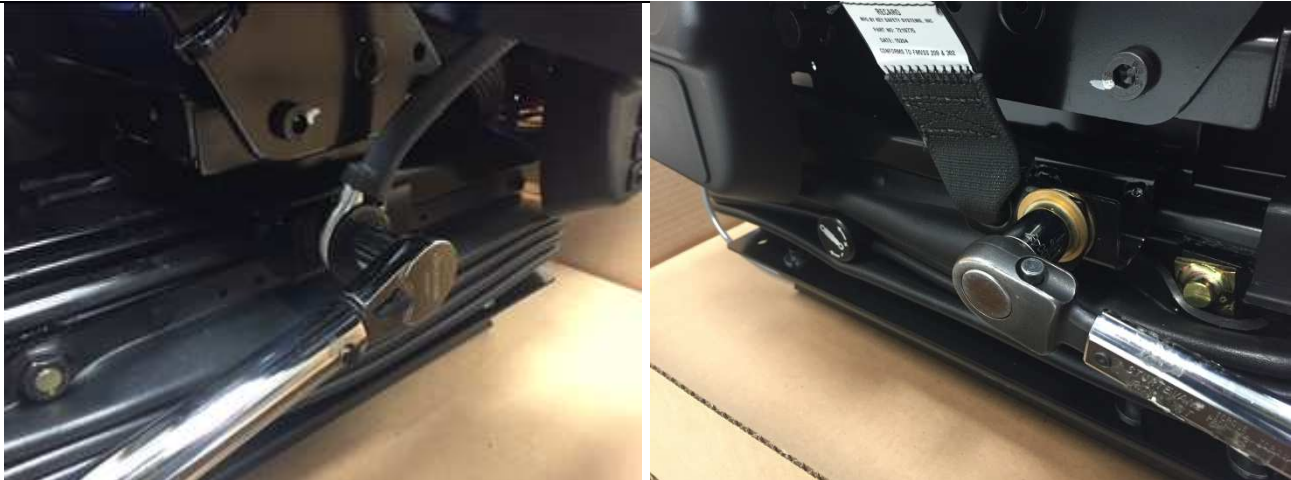
| STEP | PICTURES / DESCRIPTIONS | Special Criteria |
|---|---|---|
| 9. | Route the buckle through the rear trim panel. Hand start the seat belt buckle bolt into the replacement J-Bracket part now in the seat. Torque to 50 Nm. | |

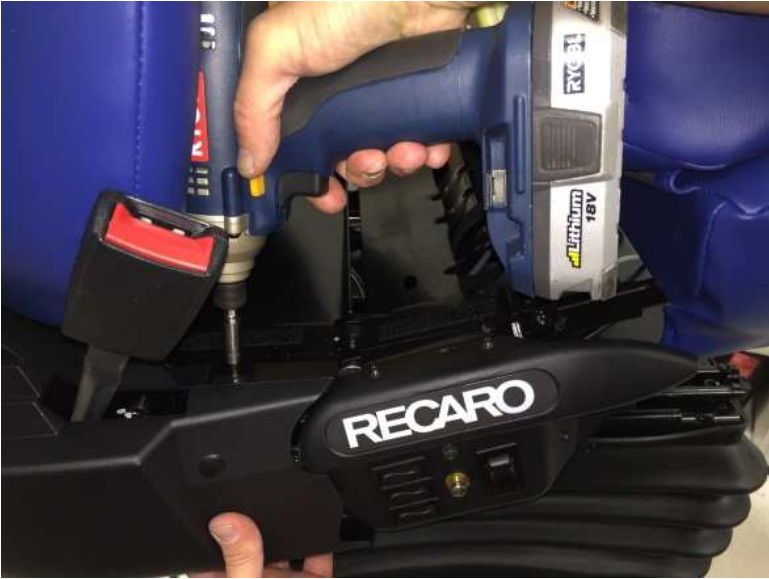
| STEP | PICTURES / DESCRIPTIONS | Special Criteria |
|---|---|---|
| 11. | Replace the corner panel(s) in original position and secure with the mounting screw(s) previously removed. | |

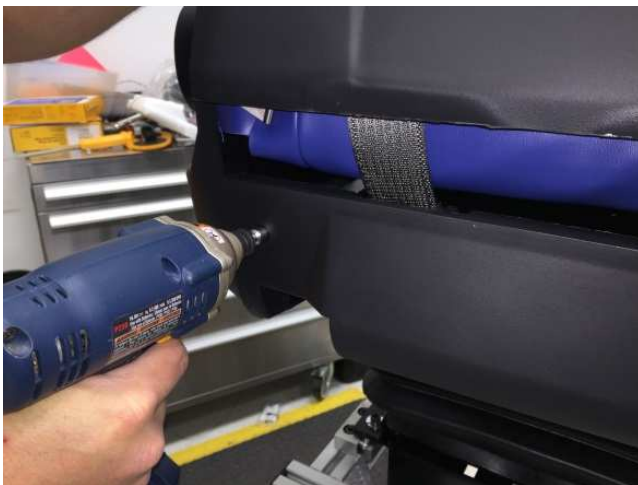
- Position the rear trim panel into its original position and secure with the mounting screws previously removed. Install the hole plugs into the rear trim panel that were previously removed.
