Operation #	SAP Line #	Operation Description	Level	Date	Author	
M0999507	N/A	Service Instruction Inspect and Repair J-brackets	05	Released	10/21/2015	Chris Perkins
	Page 1 / 8			Revised	10/30/2015	Chris Perkins

This procedure describes a 2 part process. Both inspection and repair, if necessary, are covered by this document.

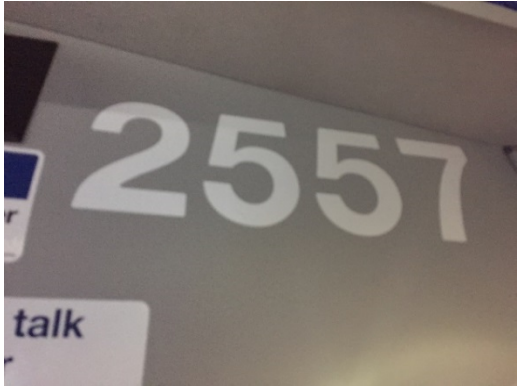
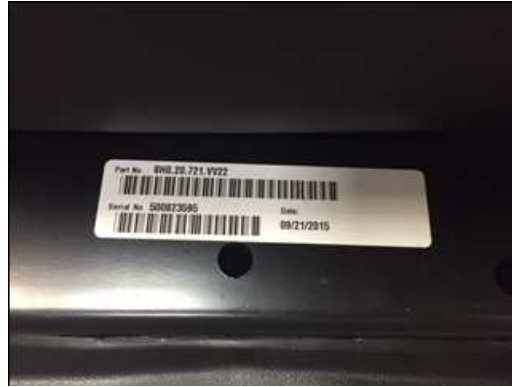
1. Position the seat to “full forward” and “full up” to obtain the serial number on the seat. The serial number decal is located on the back of the seat on the top of the suspension between the seat tracks, shown above. Record the bus number and serial number of the seat.

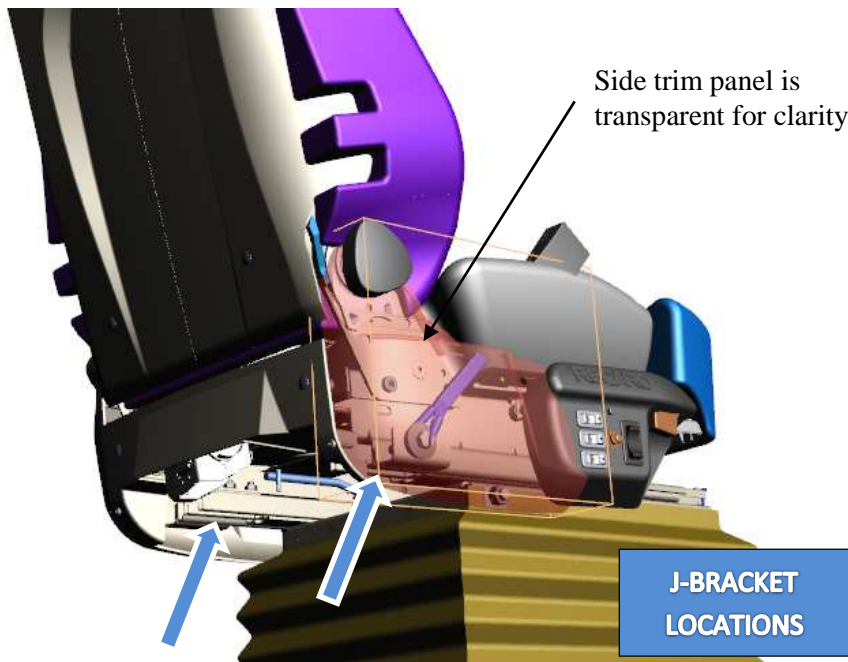
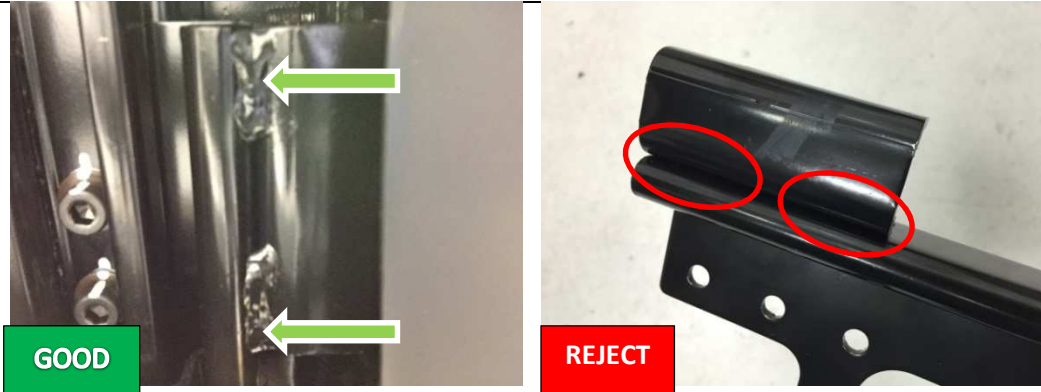
- Position the seat to best expose the underside of the J-brackets, “full up” and “full rear” would typically be best best location. Examine both J-brackets for presence of underside welds. Document condition of J-brackets.

If any of the welds are missing from the bottom of either J-Bracket, continue to section 2. If both welds are present and the parts are good, no further work is required.

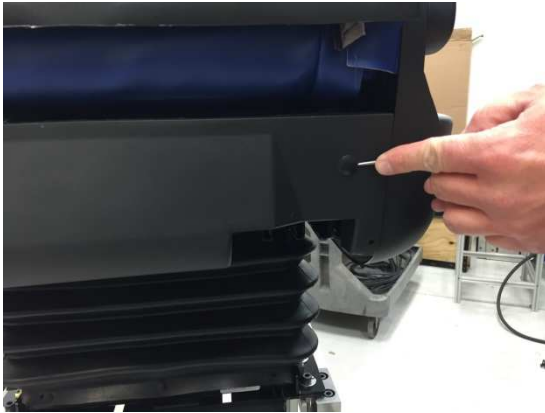
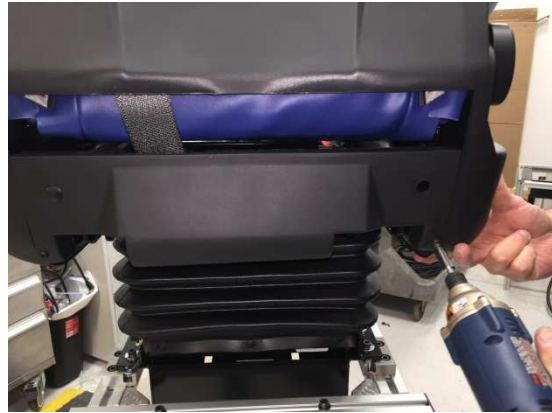
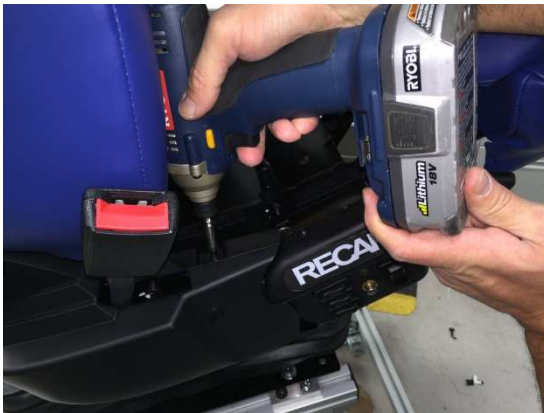
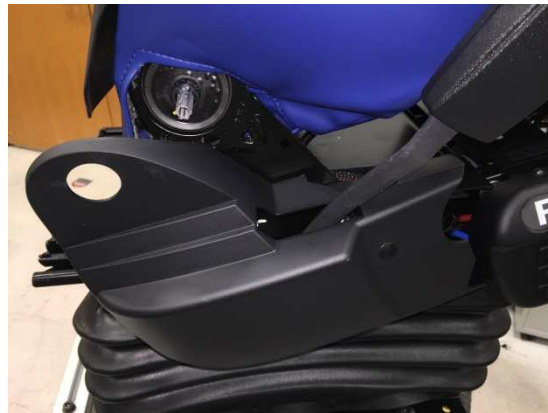
- If J-bracket(s) need to be replaced, remove the 2 hole plugs and 4 screws in the rear trim panel and the mounting screw from the rear corner panel(s). Remove the recliner handwheel.

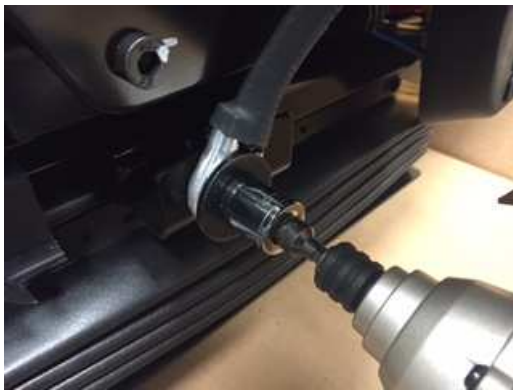
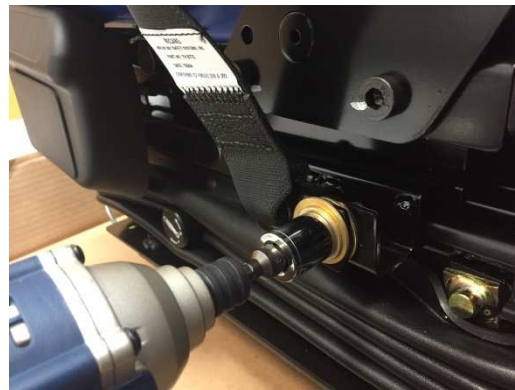
3. Remove the belt buckle (or belt retractor/3pt anchor) from the bad J-bracket with a 5/8 socket. Set the removed components aside.

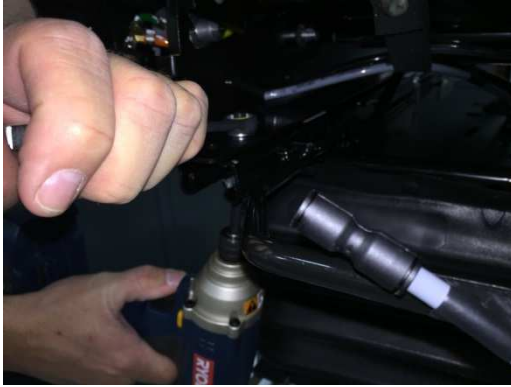
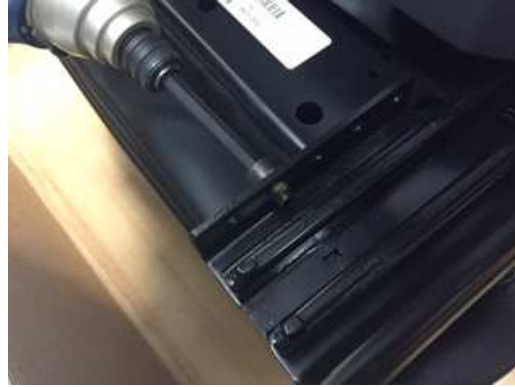
4. Position the seat back to “full forward”. Unfasten the front track bolt from the cushion frame using a 6mm hex bit and a 13mm wrench. Check the rear of seat for a track stop bolt. If present, remove it with the 6mm hex bit.

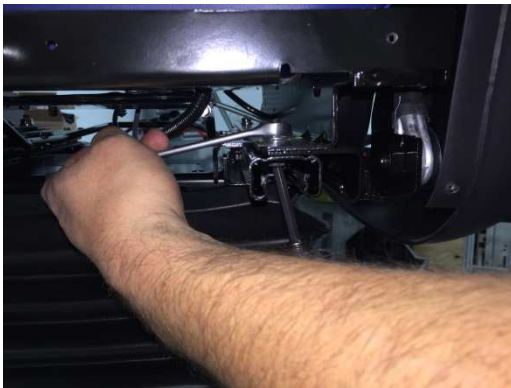
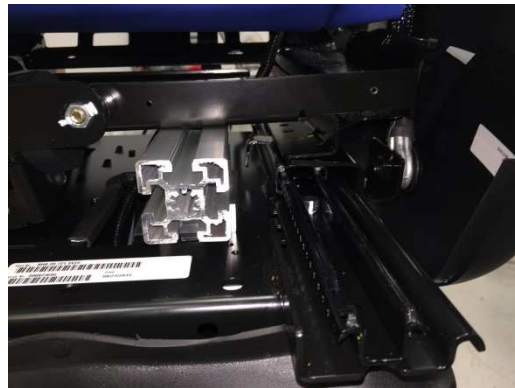
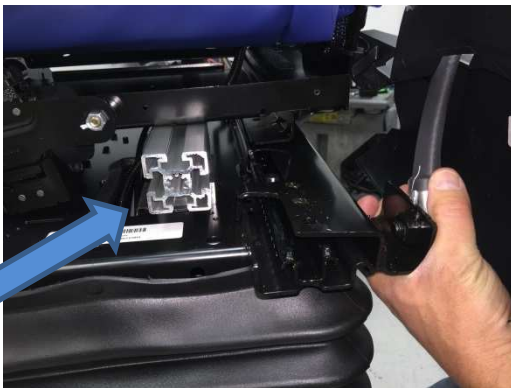
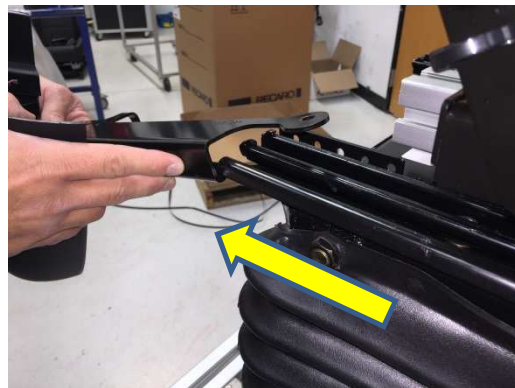
- Position the seat to “full rear”. Unfasten the rear track bolts from the cushion frame using an 6mm hex bit and a 13mm wrench. Place a 2 inch block between the cushion frame and suspension to create just enough clearance to remove the J-bracket by sliding it rearward along the path of the track.

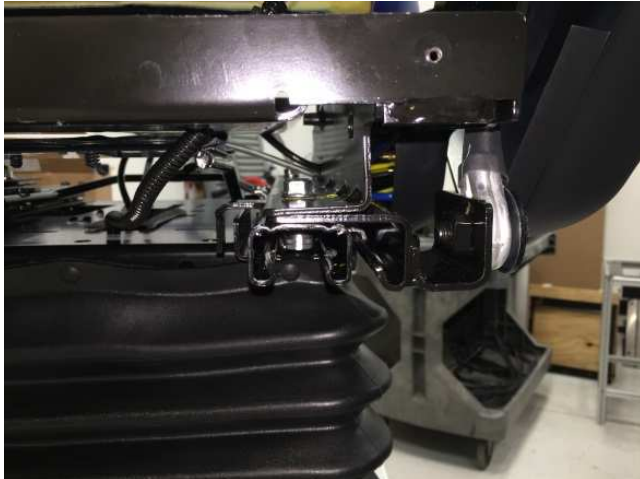
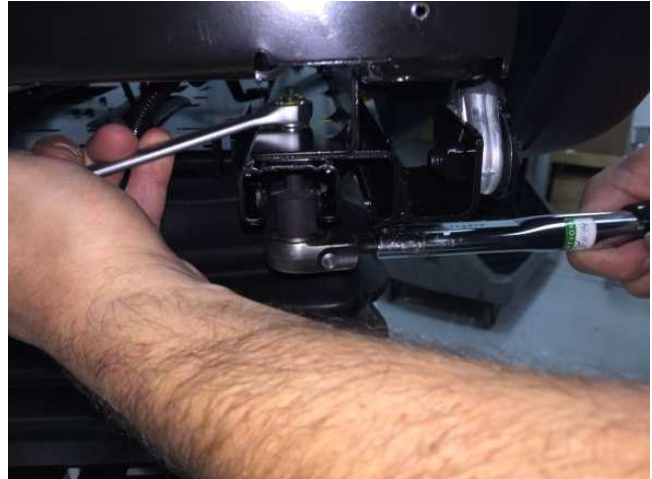
- Position the replacement part utilizing the same path and aligning all the mounting holes. Obtain replacement M8 bolts. Place rear fasteners thru the mounting holes from below and start the flange nuts by hand. Torque to 22 Nm.

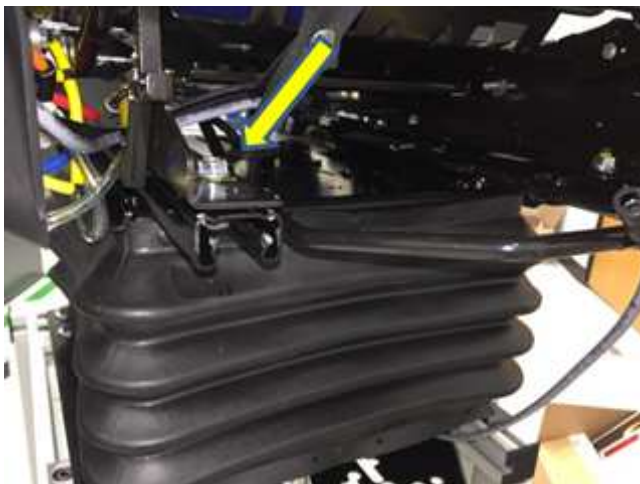
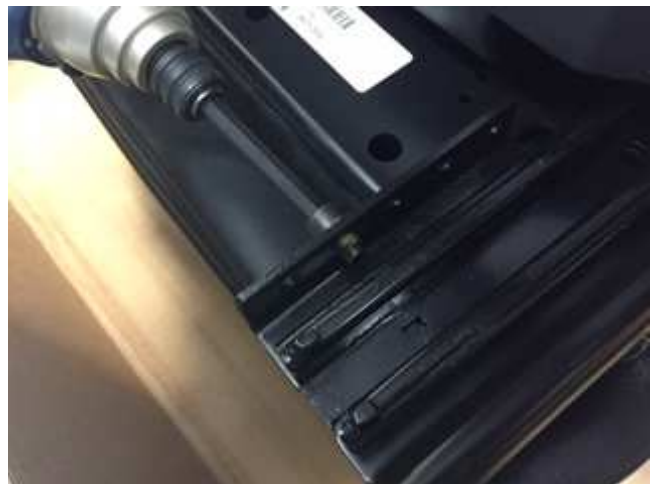
- Position the seat to “full forward”. Obtain replacement M8 bolts. Place front fastener thru the mounting holes from below and start, by hand, the flange nut. Torque to 22 Nm.
- If applicable, replace the track stop bolt previously removed.

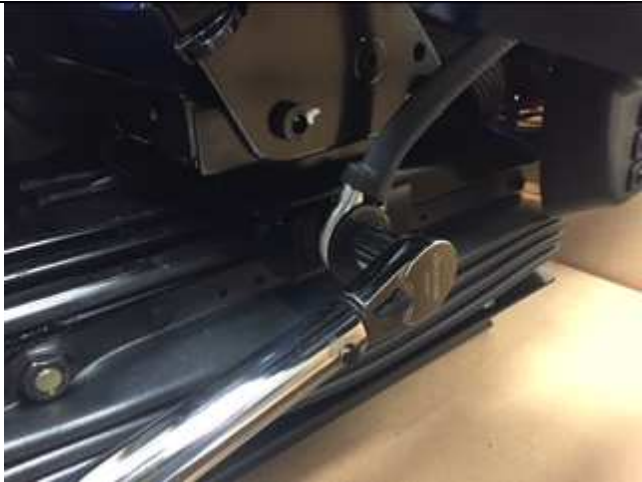
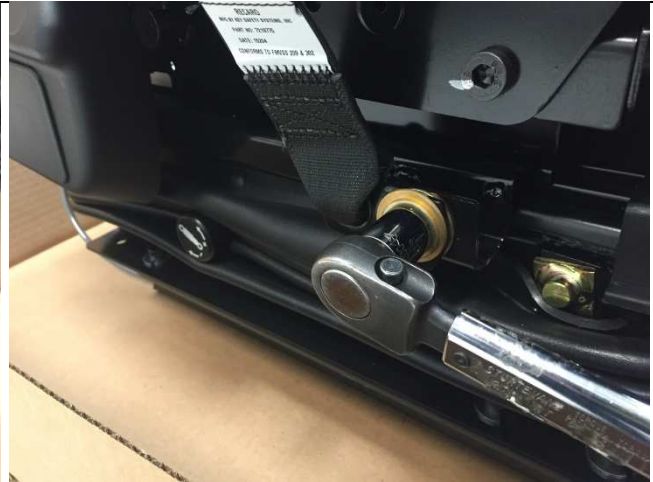
9. Route the buckle through the rear trim panel. Hand start the seat belt buckle bolt into the replacement J-Bracket part now in the seat. Torque to 50 Nm.
10. If needed, replace the other side J-bracket using the same procedure documented in steps 5-10.

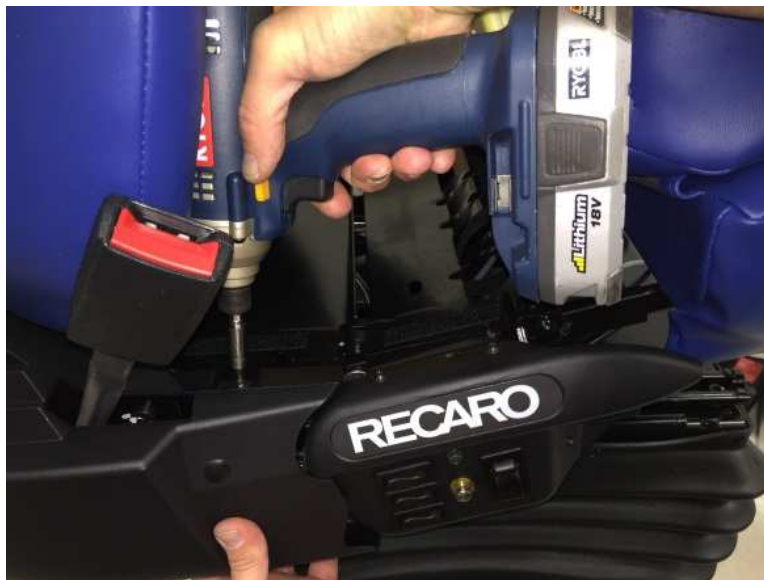
11. Replace the corner panel(s) in original position and secure with the mounting screw(s) previously removed.

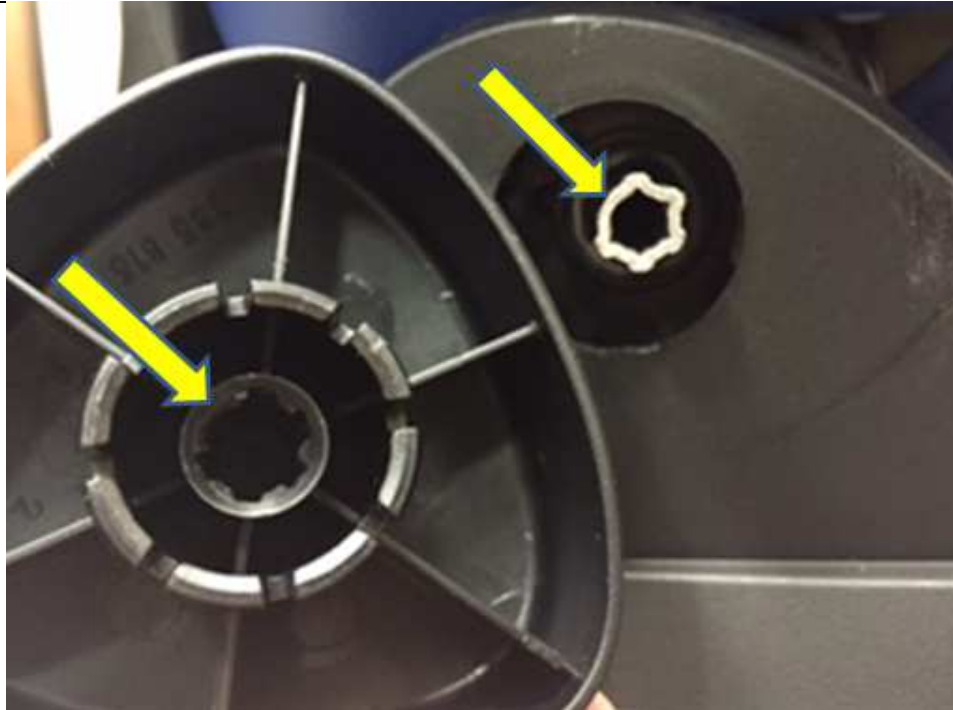
- Replace the recliner handwheel making sure to align the keyed pattern of the recliner rod to the handwheel.

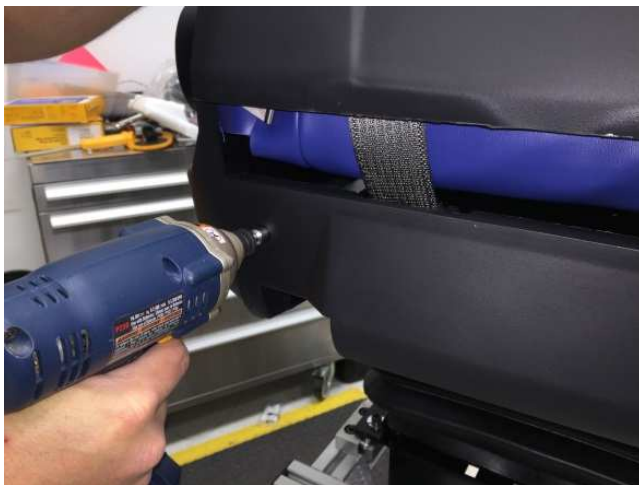
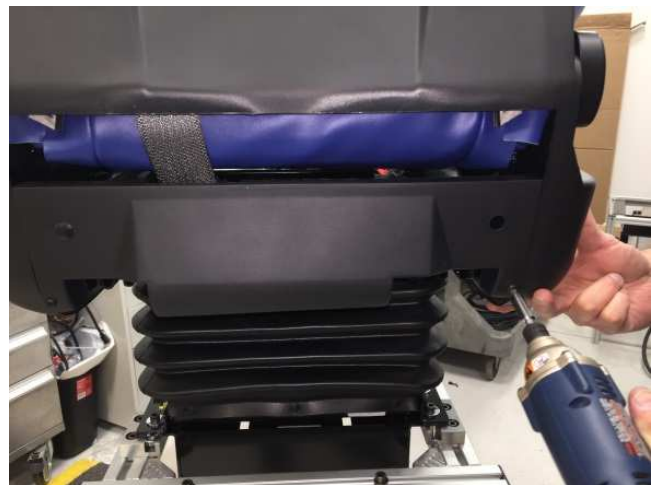
- Position the rear trim panel into its original position and secure with the mounting screws previously removed. Install the hole plugs into the rear trim panel that were previously removed.
