April 8, 2016

03187 Version 3

Safety Recall: Takata Driver's Airbag Inflator

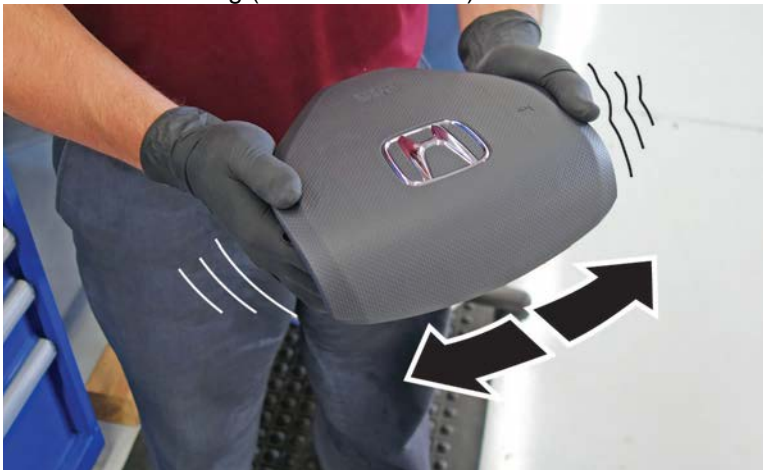
8. Use shop air to clean any debris that may be on the inflator, then remove the inflator from the airbag.

- Do not allow any debris to enter the inflator opening in the airbag.
 - Do not deploy the inflator. The inflator must be returned to its supplier in the box the new inflator came in. Follow the shipping instructions supplied with the inflator kit. If you have any questions about shipping, call Warranty Parts Inspection (WPI) at **937-642-2737**.
9. Turn over the airbag (inflator side down) and shake it to remove any debris from the inflator opening.

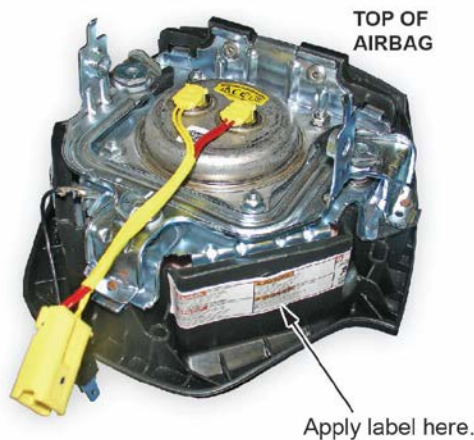
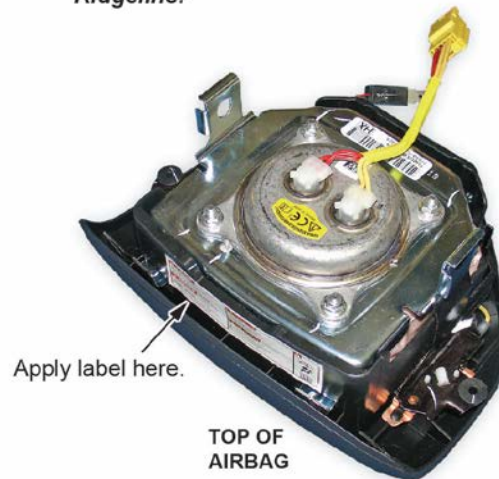
- Install and torque the new locknuts to **4.0 N·m (3.0 lb-ft, 36 lb-in)**.
- If the inflator kit came with a label, attach it to the airbag assembly as shown.
CR-V, CR-Z, Fit, Insight: Ridgeline:
