April 8, 2016

03186 Version 3

Safety Recall: Takata Driver's Airbag Inflator

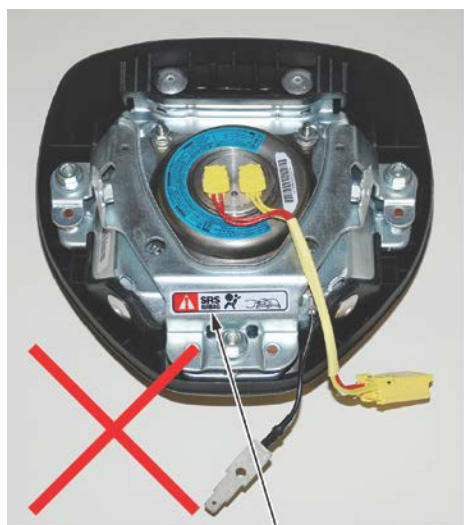
NON-STANDARD
SAFETY LABEL

- If there is nothing unusual about the airbag or the inflator, go to step 5.
- If there are any unusual markings, like an incorrect label or a model year written in marker, the airbag and inflator may not be the correct airbag and/or inflator for the vehicle or it may be a counterfeit part. For more information about counterfeit airbags, you can refer to safercar.gov, enter keywords **MANAGING COUNTERFEIT**, and select **Recommended Dealer Guidance for Managing Counterfeit Air Bags** from the list. **If you suspect that the airbag or inflator is counterfeit, do not continue this procedure.** Contact your DPSM for assistance.

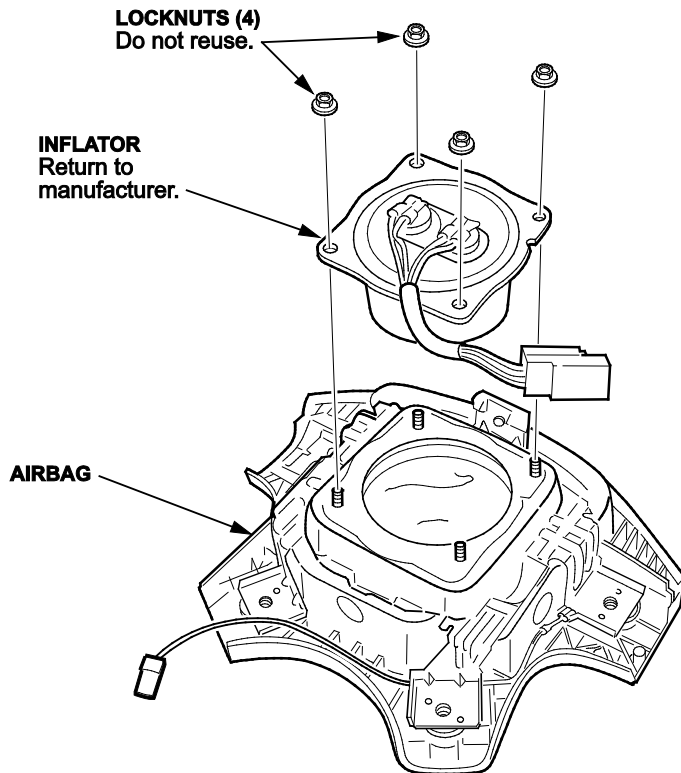
7. Remove the 4 locknuts from the airbag using needle-nose vise grips or a 3/8 in. 6-point socket. The locknuts will not be reused.

NOTE: Do not remove the inflator from the airbag until you complete step 8.

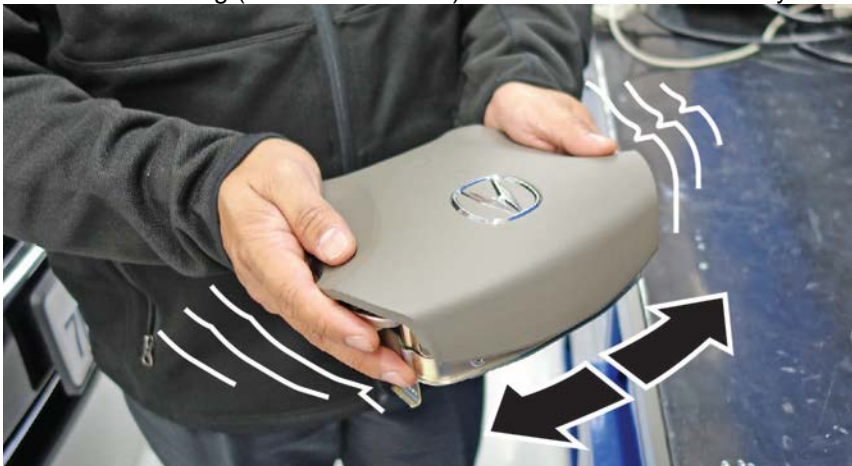
8. Use shop air to clean any debris that may be on the inflator, then remove the inflator from the airbag.

- Do not allow any debris to enter the inflator opening in the airbag.
 - Do not deploy the inflator. The inflator must be returned to its supplier in the box the new inflator came in. Follow the shipping instructions supplied with the inflator kit. If you have any questions about shipping, call Warranty Parts Inspection (WPI) at **937-642-2737**.
9. Turn over the airbag (inflator side down) and shake it to remove any debris from the inflator opening.
