April 6, 2016

03186 Version 2

Safety Recall: Takata Driver's Airbag Inflator

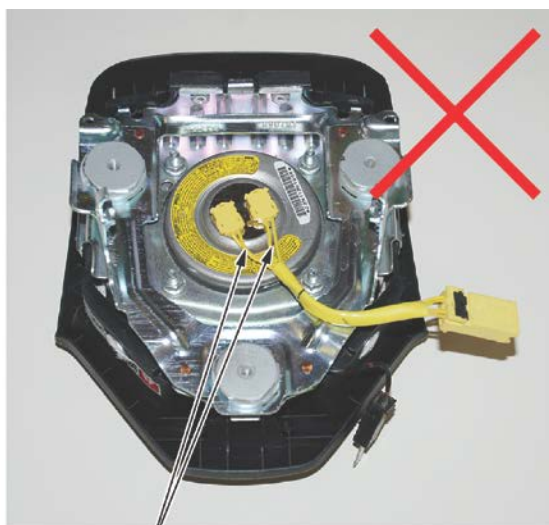
- If there is nothing unusual about the airbag or the inflator, go to step 5.
- If there are any unusual markings, like an incorrect label or a model year written in marker, the airbag and inflator may not be the correct airbag and/or inflator for the vehicle or it may be a counterfeit part. For more information about counterfeit airbags, you can refer to safercar.gov, enter keywords **MANAGING COUNTERFEIT**, and select **Recommended Dealer Guidance for Managing Counterfeit Air Bags** from the list. **If you suspect that the airbag or inflator is counterfeit, do not continue this procedure.** Contact your DPSM for assistance.

NON-STANDARD
WIRES

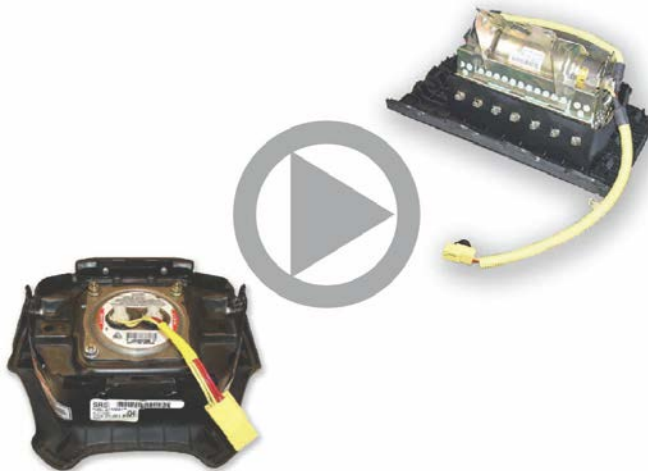
6. Remove the horn plate (if applicable).

There are different methods for removing the inflator. **Make sure you use the correct method for the vehicle you are working on** because some vehicles will require cutting or removing the horn plate. For more information about removing the horn place and replacing the airbag inflator, refer to the following video.

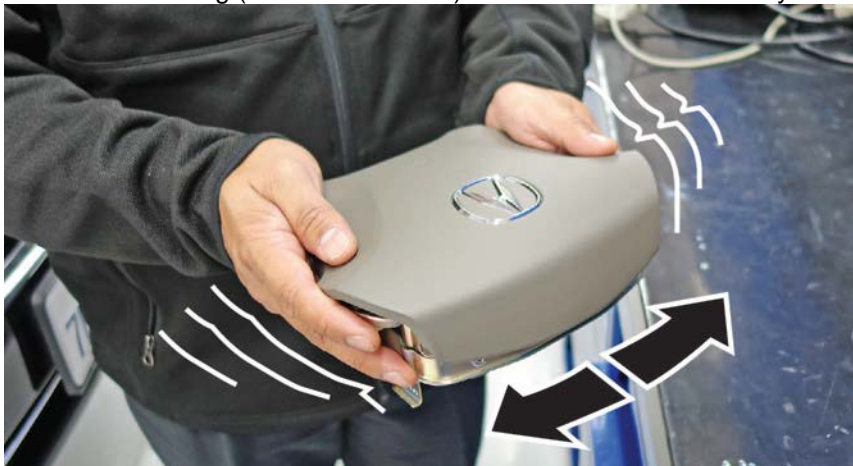
8. Use shop air to clean any debris that may be on the inflator, then remove the inflator from the airbag.

- Do not allow any debris to enter the inflator opening in the airbag.
 - Do not deploy the inflator. The inflator must be returned to its supplier in the box the new inflator came in. Follow the shipping instructions supplied with the inflator kit. If you have any questions about shipping, call Warranty Parts Inspection (WPI) at **937-642-2737**.
9. Turn over the airbag (inflator side down) and shake it to remove any debris from the inflator opening.
