**TECHNICAL INSTRUCTIONS**  
**FOR**  
**CAMPAIGN G0C**  
**CENTER AIRBAG SENSOR ASSEMBLY (SRS ECU)**  
**CERTAIN 2005 – 2006 MY TUNDRA**

**Updated 11-21-17**

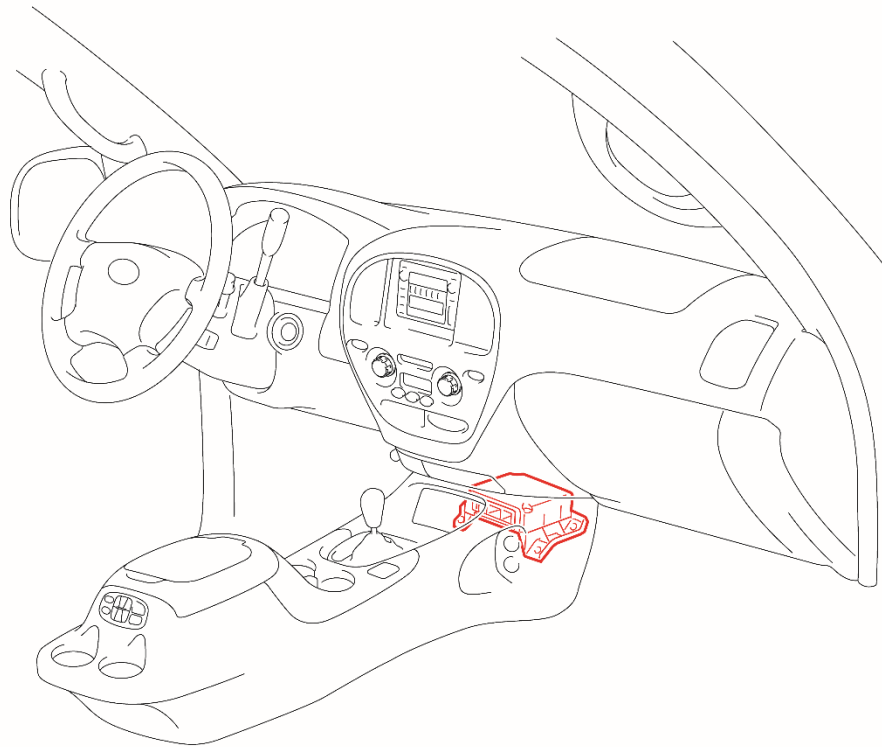
K1500260064a

The subject vehicles are equipped with side Curtain-Shield-Airbags (CSAs) which deploy from the roof rails in the event of certain types of crashes. Due to improper programming in the airbag control module, there is a possibility that, under certain specific and limited conditions shortly after vehicle startup, the CSAs and seat belt pre-tensioners could activate when not necessary. Unexpected activation of the CSAs could increase the risk of injury to the occupant.

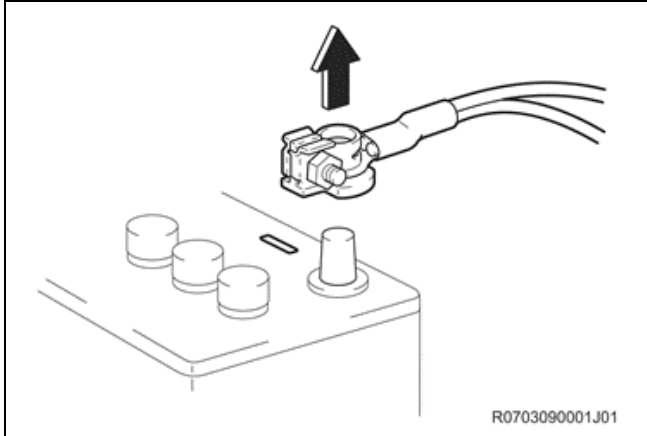
#### 1. DISCONNECT THE BATTERY TERMINAL

- Always disconnect the negative terminal and wait 90 seconds before performing work to prevent airbag and seatbelt pre-tensioner deployment due to back-up battery supply.

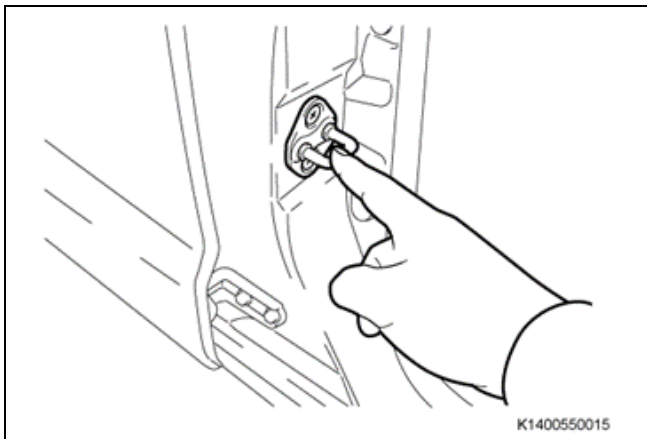
#### 2. ELIMINATE STATIC ELECTRICITY

- a) Before removing ECU ground yourself by touching a metallic part of the vehicle.

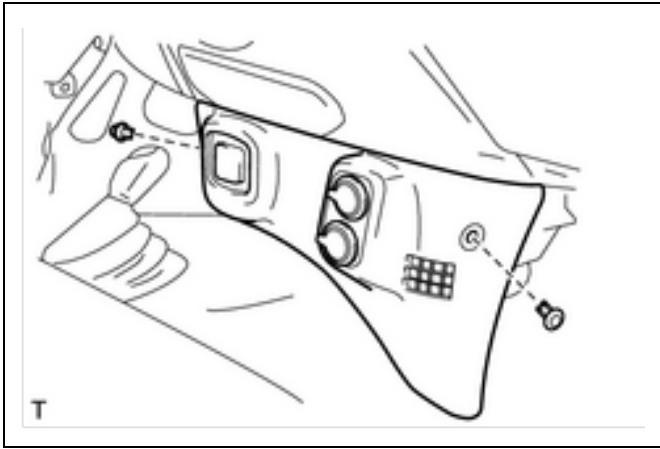
**5. REMOVE LOWER CENTER COVER**

- a) Remove the 2 clips and lower center cover.
- b) Disconnect the connectors.

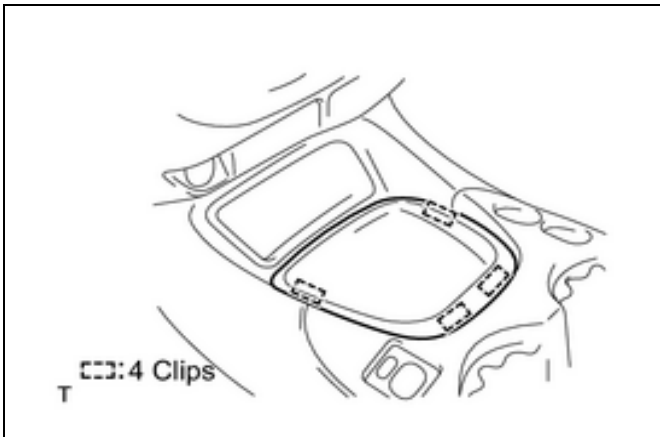
**6. REMOVE SHIFTING HOLE COVER**

- a) Using a screwdriver, disengage the 4 clips and remove the shifting hole cover.

**NOTE:** Tape the screwdriver tip before use.

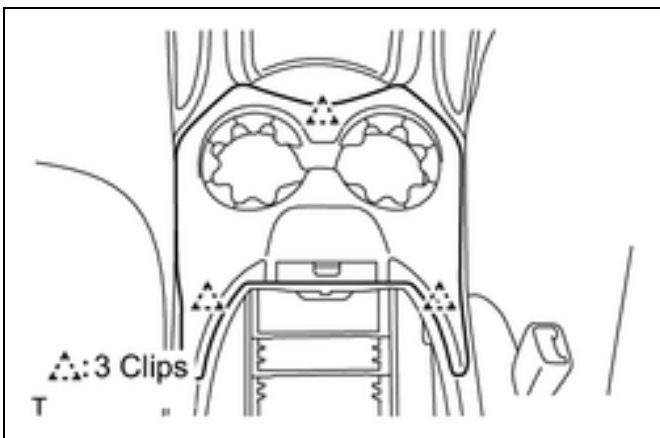
**7. REMOVE CONSOLE PANEL UPPER**

- a) Using a screwdriver, disengage the 3 clips and remove the console panel upper.

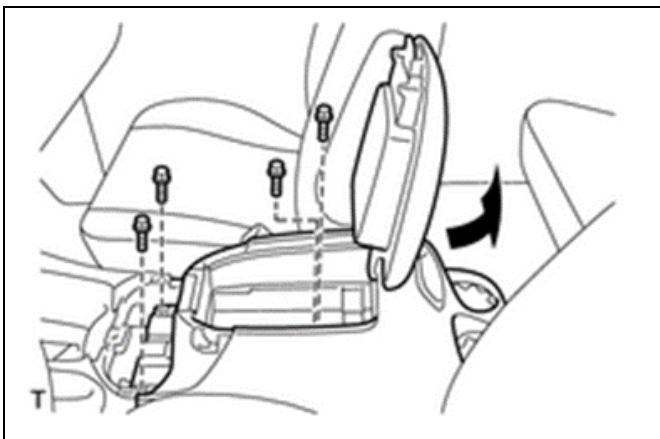
**8. REMOVE CONSOLE REAR END PANEL**

- a) Remove the 4 bolts and No. 2 console rear end panel.

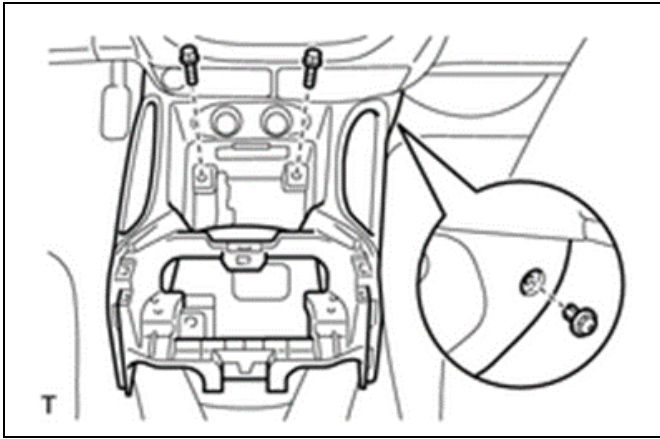
**9. REMOVE FRONT CONSOLE BOX (Access Cab W/ Large Type Console Box)**

- a) Remove the 2 bolts, clip and the front console box.
- b) Disconnect the connector.

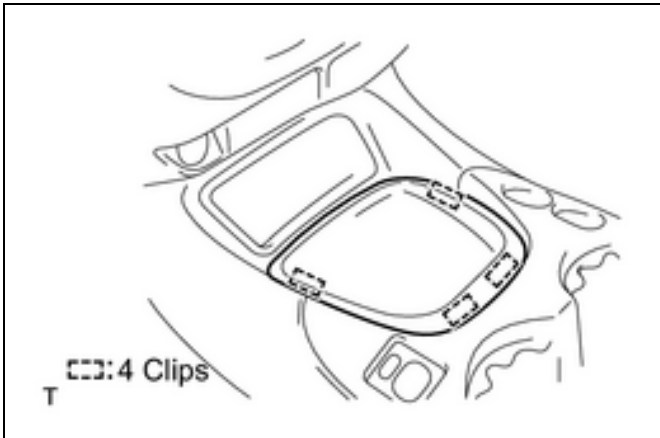
**10. REMOVE SHIFTING HOLE COVER (Double Cab)**

- a) Using a screwdriver, disengage the 4 clips and remove the shifting hole cover.

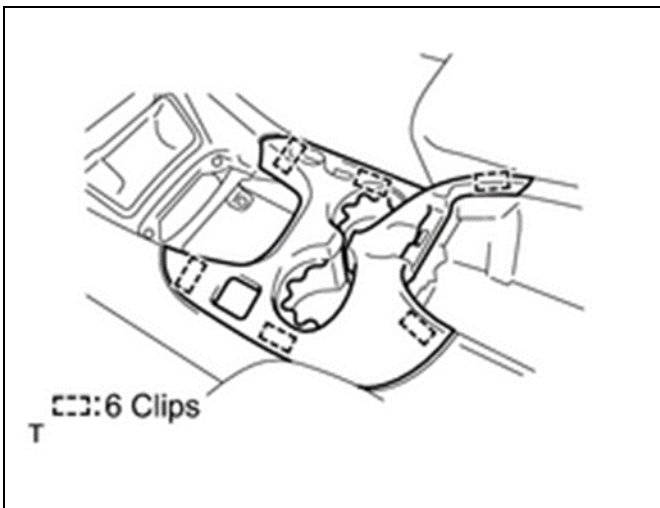
**11. REMOVE UPPER CONSOLE PANEL (Double Cab)**

- a) W/ Seat heater:
  - 1) Using a screwdriver, remove the seat heater switches, then disconnect the connectors.
  - 2) Using a screwdriver, remove the power mirror control switch, then disconnect the connector.
  - 3) Using a screwdriver, disengage the 6 clips and remove the upper console panel.

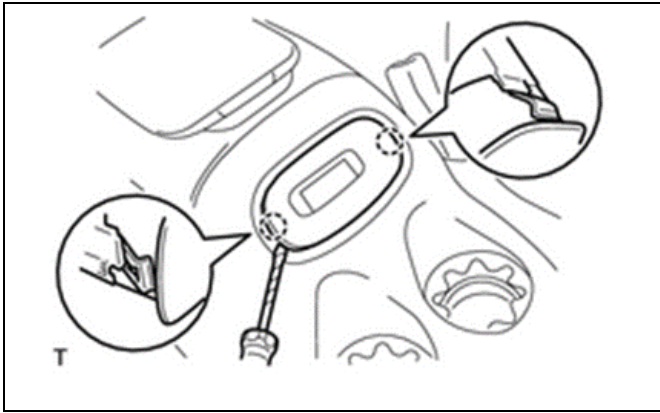
## 12. REMOVE REAR CONSOLE BOX (Double Cab)

- a) W/ VTR control garnish:
- 1) Using a screwdriver, disengage the 2 claws and remove the VTR control garnish and connector
  - 2) Disconnect the connector.

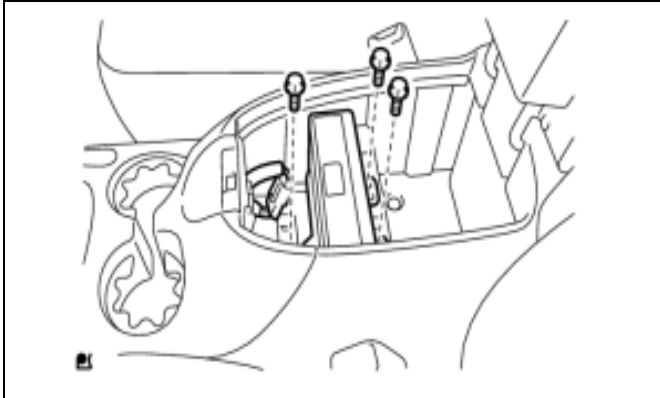
## 13. REMOVE REAR CONSOLE BOX (Double Cab)

- a) W/ rear seat entertainment
- 1) Remove the disc bracket.
  - 2) Remove the 3 bolts and disc player.
  - 3) Disconnect the connector.
  - 4) Remove the 4 bolts and rear console box.

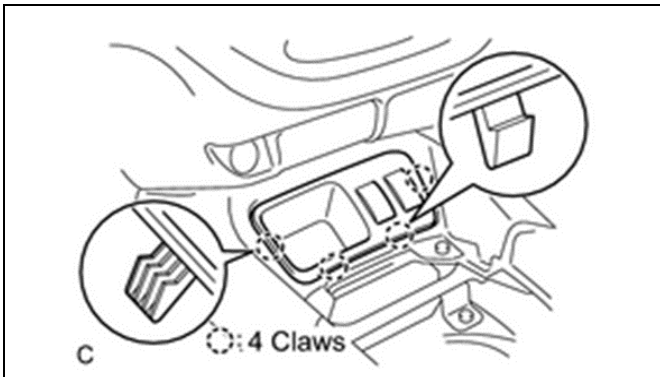
## 14. REMOVE CONSOLE BOX POCKET (Double Cab)

- a) Using a screwdriver, disengage the 4 claws.
- b) Disconnect the connectors and remove the console box pocket.

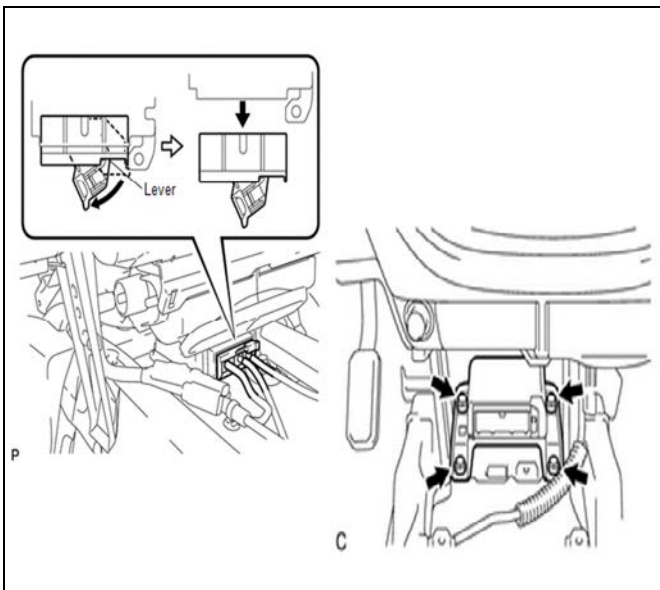
## 15. REMOVE THE CENTER AIRBAG SENSOR

- Confirm that the negative battery terminal is disconnected before performing the operation. Even an impact to only the airbag sensor will cause the airbag to deploy.
- Wait at least 90 seconds after disconnecting the negative battery terminal to prevent airbag and seat belt pre-tensioner deployment.

- a) Pull the lever and detach the connector holder.
- b) Remove the 3 bolts and remove the airbag sensor.

**NOTE: DO NOT use power or pneumatic tools to remove the fasteners that secure the sensor to the vehicle.**

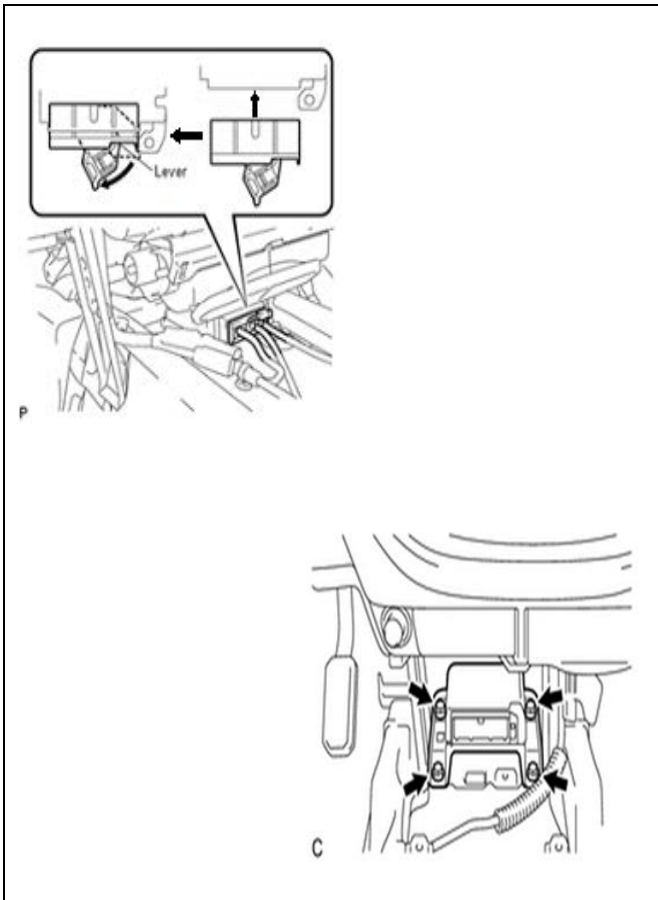
### 1. INSTALL THE NEW CENTER AIRBAG SENSOR

- b) Install the center airbag sensor with the 4 bolts.  
c) Tighten the 3 bolts to the specified torque.

**Torque:**

**17.5 N•m {179 kgf•cm, 13ft•lbf}**

- d) Connect the holder (with connectors) to the center airbag sensor.  
e) Check that the waterproof sheet is properly set.

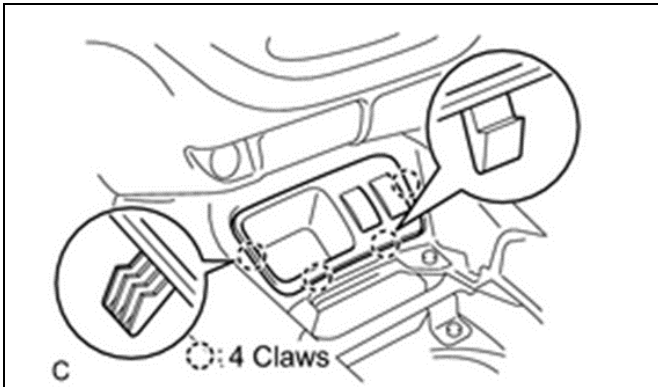
### 2. REINSTALL CONSOLE BOX POCKET (Double Cab)

- a) Reconnect the connectors.  
b) Engage the 4 claws and reinstall the console box pocket.

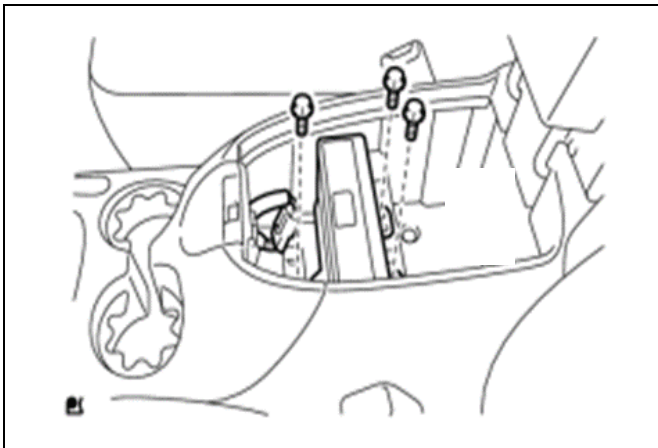
### 3. REINSTALL REAR CONSOLE BOX

- a) With rear seat entertainment:
- 1) Reinstall the disc bracket.
  - 2) Reconnect the connector.
  - 3) Reinstall the 3 bolts and disc player.
  - 4) Reinstall the 4 bolts and rear console box.

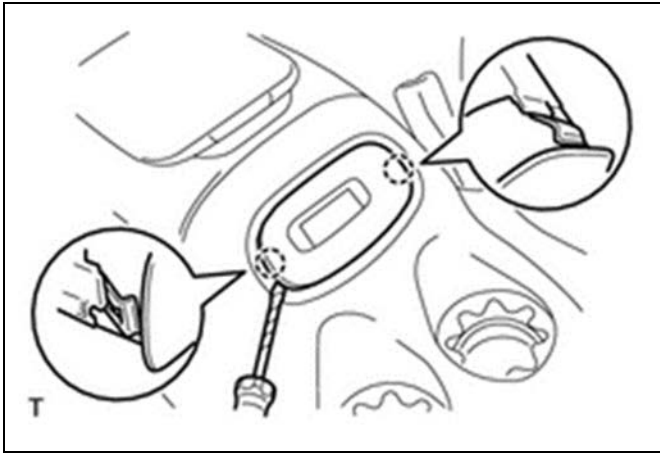
#### 4. REINSTALL REAR CONSOLE BOX (Double Cab)

- a) W/ VTR control garnish:
  - 1) Reconnect the connector.
  - 2) Engage the 2 claws and reinstall the VTR control garnish and connector

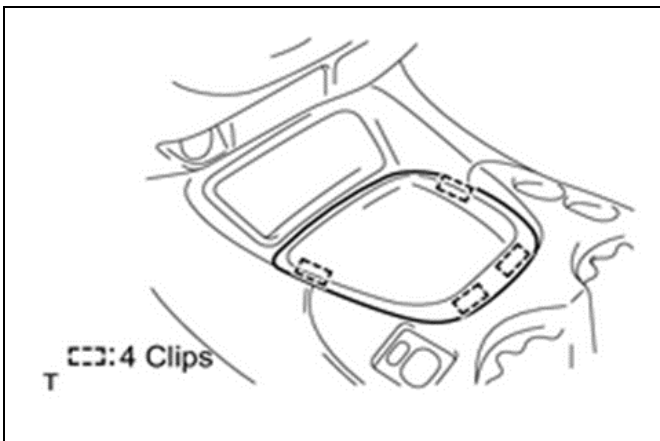
#### 5. REINSTALL UPPER CONSOLE PANEL (Double Cab)

- a) W/ Seat heater:
  - 1) Reconnect the connectors, then reinstall the seat heater switches.
  - 2) Reconnect the connector, then reinstall the power mirror control switch.
  - 3) Engage the 6 clips and reinstall the upper console panel.

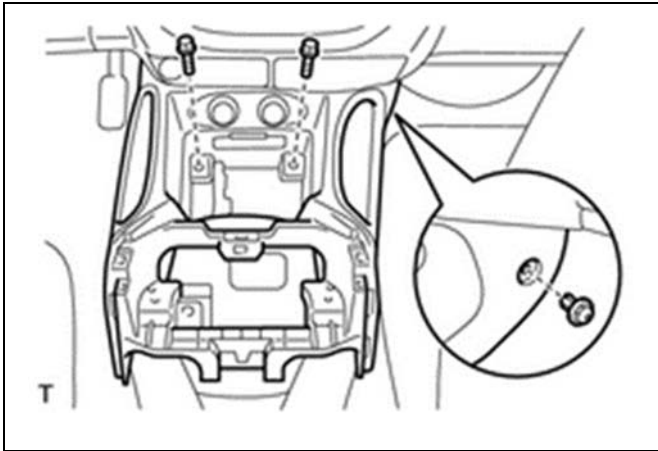
#### 6. REINSTALL SHIFTING HOLE COVER

- a) Engage the 4 clips and reinstall the shifting hole cover.

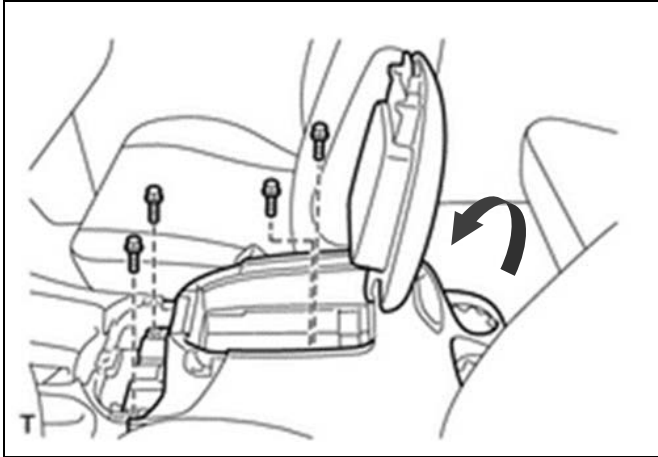
**7. REINSTALL FRONT CONSOLE BOX (Access Cab W/ Large Type Console Box)**

- a) Reconnect the connector.
- b) Reinstall the 2 bolts, clip and the front console box.

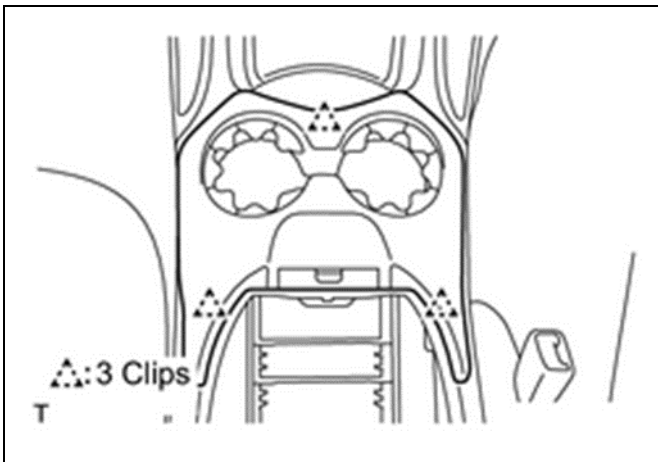
**8. REINSTALL CONSOLE REAR END PANEL**

- a) Reinstall the 4 bolts and No. 2 console rear end panel.

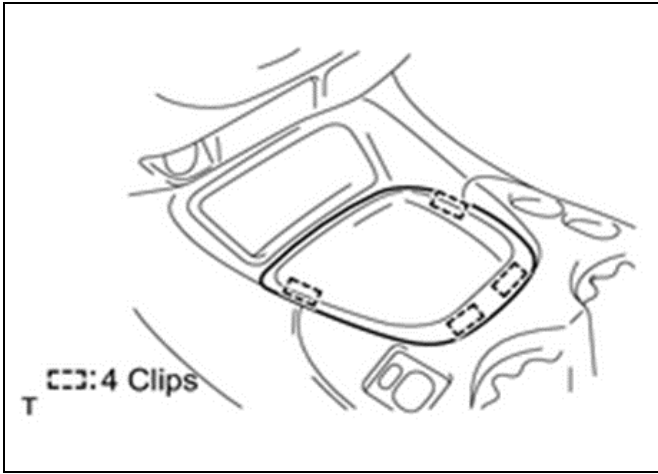
**9. REINSTALL CONSOLE PANEL UPPER**

- a) Engage the 3 clips and reinstall the console panel upper.

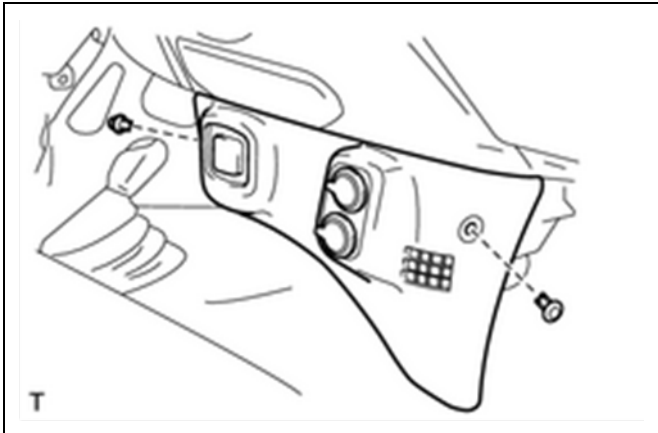
**10. REINSTALL SHIFTING HOLE COVER**

- a) Engage the 4 clips and reinstall the shifting hole cover.

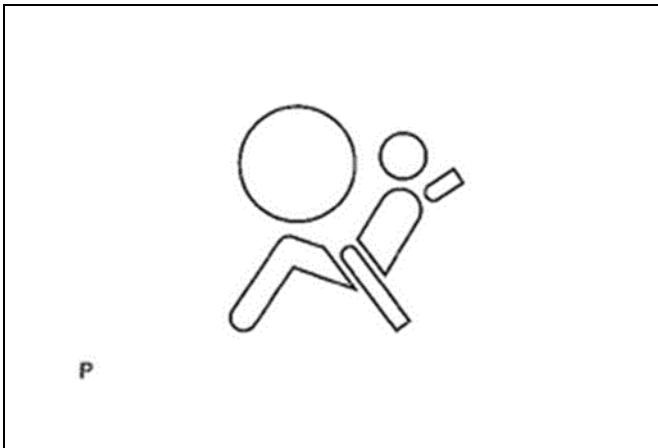
**13. INSPECT SRS WARNING LIGHT**

- a) Turn the ignition switch to the ON position, and check that the SRS warning light comes on for approximately 6 seconds (primary check).
- b) Check that the SRS warning light goes off approximately 6 seconds after the ignition switch is turned to the ON position (constant check).

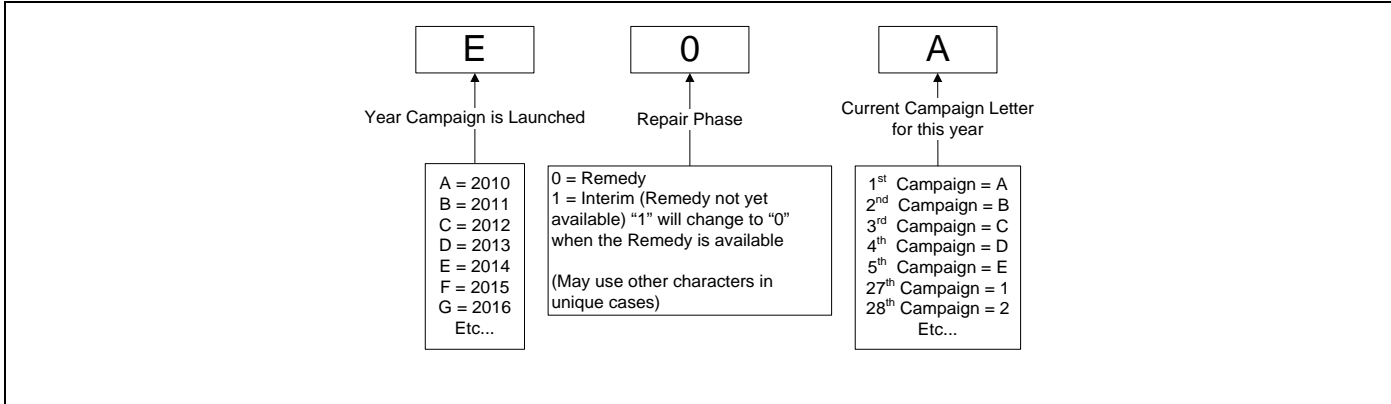
### A. CAMPAIGN DESIGNATION DECODER

A0D = Launched in 2010, Remedy Phase, 4<sup>th</sup> Campaign Launched in 2010
