TECHNICAL INSTRUCTIONS
FOR
CAMPAIGN G0C
CENTER AIRBAG SENSOR ASSEMBLY (SRS ECU)
CERTAIN 2005 – 2006 MY SEQUOIA

IV. BACKGROUND

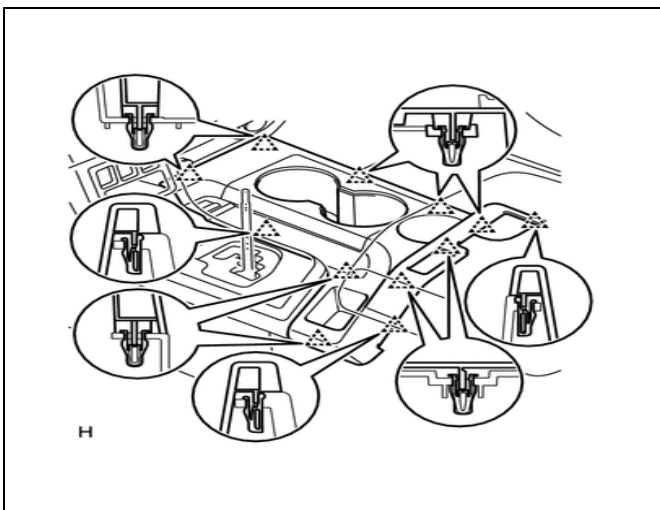
7. REMOVE UPPER CONSOLE PANEL

- a) Detach the 12 clips and remove the console panel.
