Safety Recall: Piston Pin Snap Ring Inspection

AFFECTED VEHICLES

| Year | Model | Trim | VIN Range |
|---|---|---|---|
| 2016 | Civic with 2.0L engine | ALL | Check the iN VIN status for eligibility |

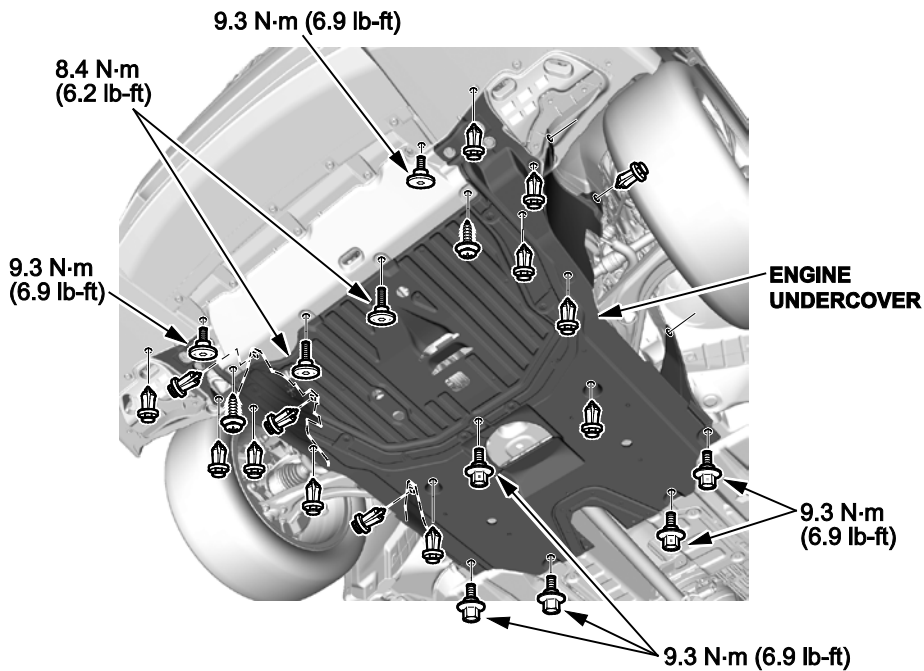
5. Remove the engine undercover.

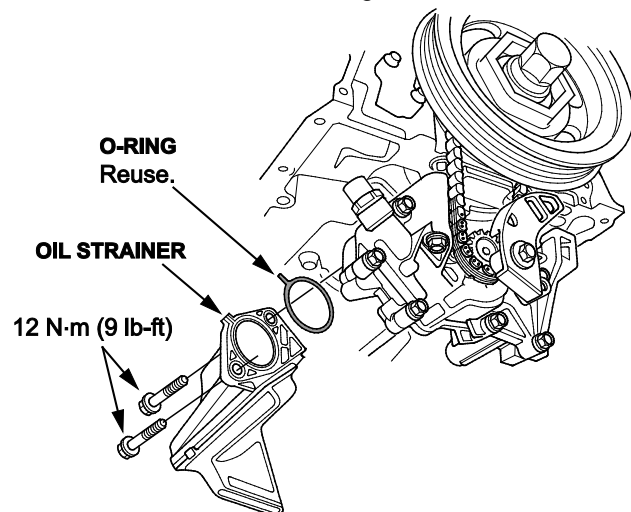
15. Remove the oil strainer.
NOTE: Reuse the oil strainer gasket unless it has been damaged during removal.

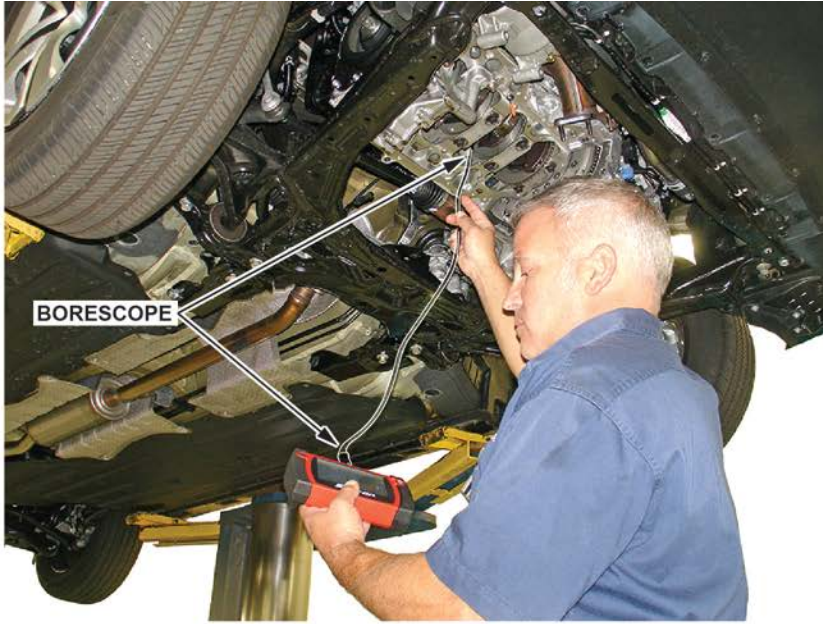
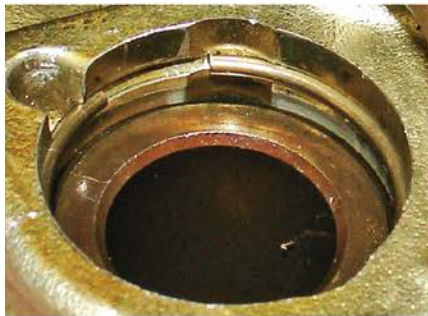
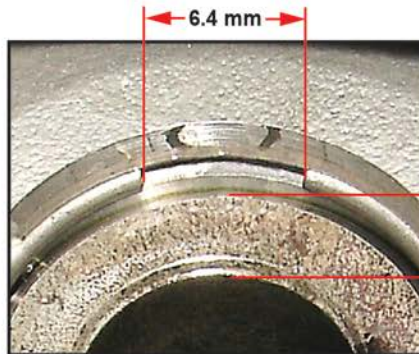
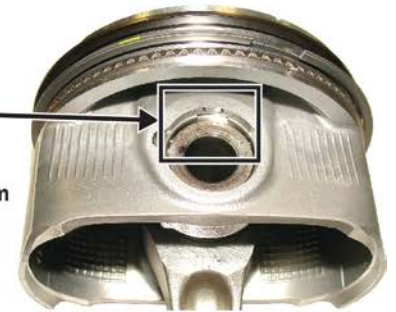
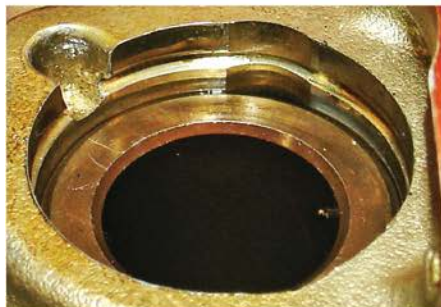
16. Using the Snap-on BK5600 with the 90-degree tip installed, rotate the engine so the No.1 cylinder is at TDC. Carefully insert the tip of the borescope and inspect cylinders No.1 and No.4. Then, rotate the engine so the No.2 cylinder is at TDC and repeat the process with cylinders No.2 and No.3.

17. Rotate the probe to confirm that the snap ring is fully engaged in the piston pin groove. A properly seated snap ring will have a 6 mm gap at the ends of the snap ring, as shown above. A misset snap ring will have a much smaller gap, around 2 mm.
18. Take a photo of each snap ring. Focus on getting a clear picture of each snap ring gap. You will need to take a picture of each side of all four pistons for a total of eight pictures.

19. Repeat for the remaining three pistons.
 - If all snap rings are installed properly, no further action is necessary. Reassemble in the reverse order of disassembly.
 - If the snap ring is misset, take a clear picture of the misset snap ring and contact Tech Line to assist you with obtaining replacement piston assemblies.
 - If a snap ring is missing and the engine cylinder wall does not have any damage, take a clear picture of the piston pin with the missing snap ring and contact Tech Line. They will assist you with obtaining the replacement piston assemblies.
 - If the snap ring is missing and the engine has cylinder wall damage, order a replacement short block.

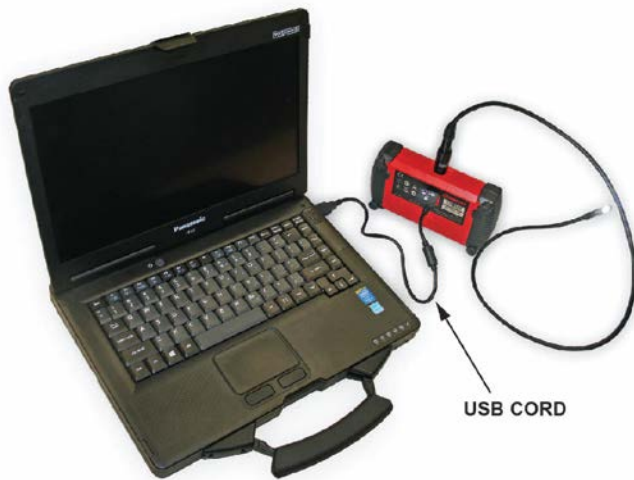
20. After all photos are taken, save them to your computer by connecting the borescope to it using the included USB cable. Give the photos to your warranty administrator for the warranty claim to be paid. Eight images of the snap rings must be included in the warranty claim or it may be rejected.
