# HONDA

Service Bulletin

06137 Version 9

# Safety Recall: Piston Pin Snap Ring Inspection

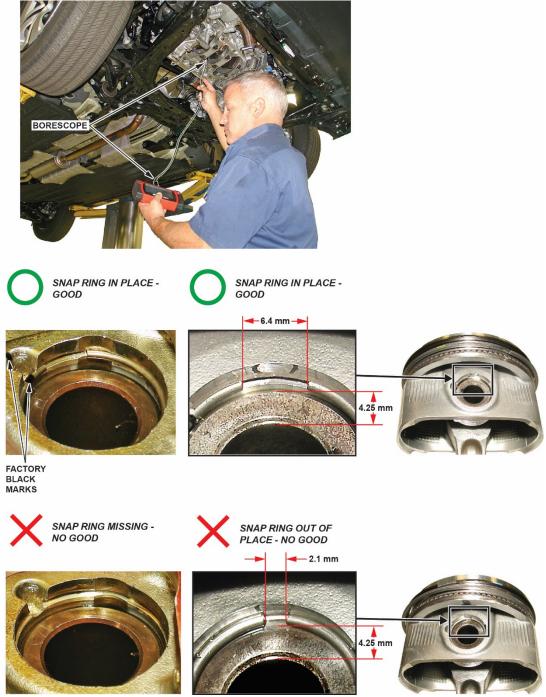
NOTE: You may notice a black mark on the snap ring and piston. This is a factory check mark and could be mistaken for the snap ring gap.

- 17. Rotate the probe to confirm that the snap ring is fully engaged in the piston pin groove. A properly seated snap ring will have a 6 mm gap at the ends of the snap ring as shown above. A misset snap ring will have a much smaller gap (around 2 mm.)
- 18. Take a photo of each snap ring. Focus on getting a clear shot of each snap ring gap. You will need to take a photo of each side of all four pistons for a total of eight photos.

- If the snap ring is misset, take a clear photo of the misset snap ring and go to REPAIR PROCEDURE A.
- If a snap ring is missing and the engine cylinder wall does not have any damage, take a clear photo of the piston pin with the missing snap ring and go to REPAIR PROCEDURE A.
- If the snap ring is missing and the engine has cylinder wall damage, take a clear photo of the block and damage, then go to REPAIR PROCEDURE B.

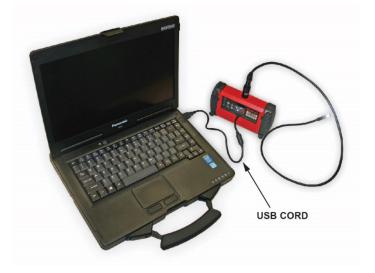
20. After all photos are taken, save them to your computer by connecting the borescope to it using the included USB cable. Give the photos to your warranty administrator for the warranty claim to be paid. Eight photos of the snap rings must be included in the warranty claim or it may be rejected.
