### SAFETY RECALL DSF and E04

### FRONT PASSENGER AIRBAG “MODULE” REPLACEMENT ONLY

### CERTAIN 2003 – 2008 MODEL YEAR MATRIX

**Note: This TI is for front passenger airbag “Module” replacement only. If replacing the “Inflator”, refer to the DSF/E04 Matrix Inflator TI located on TIS.**

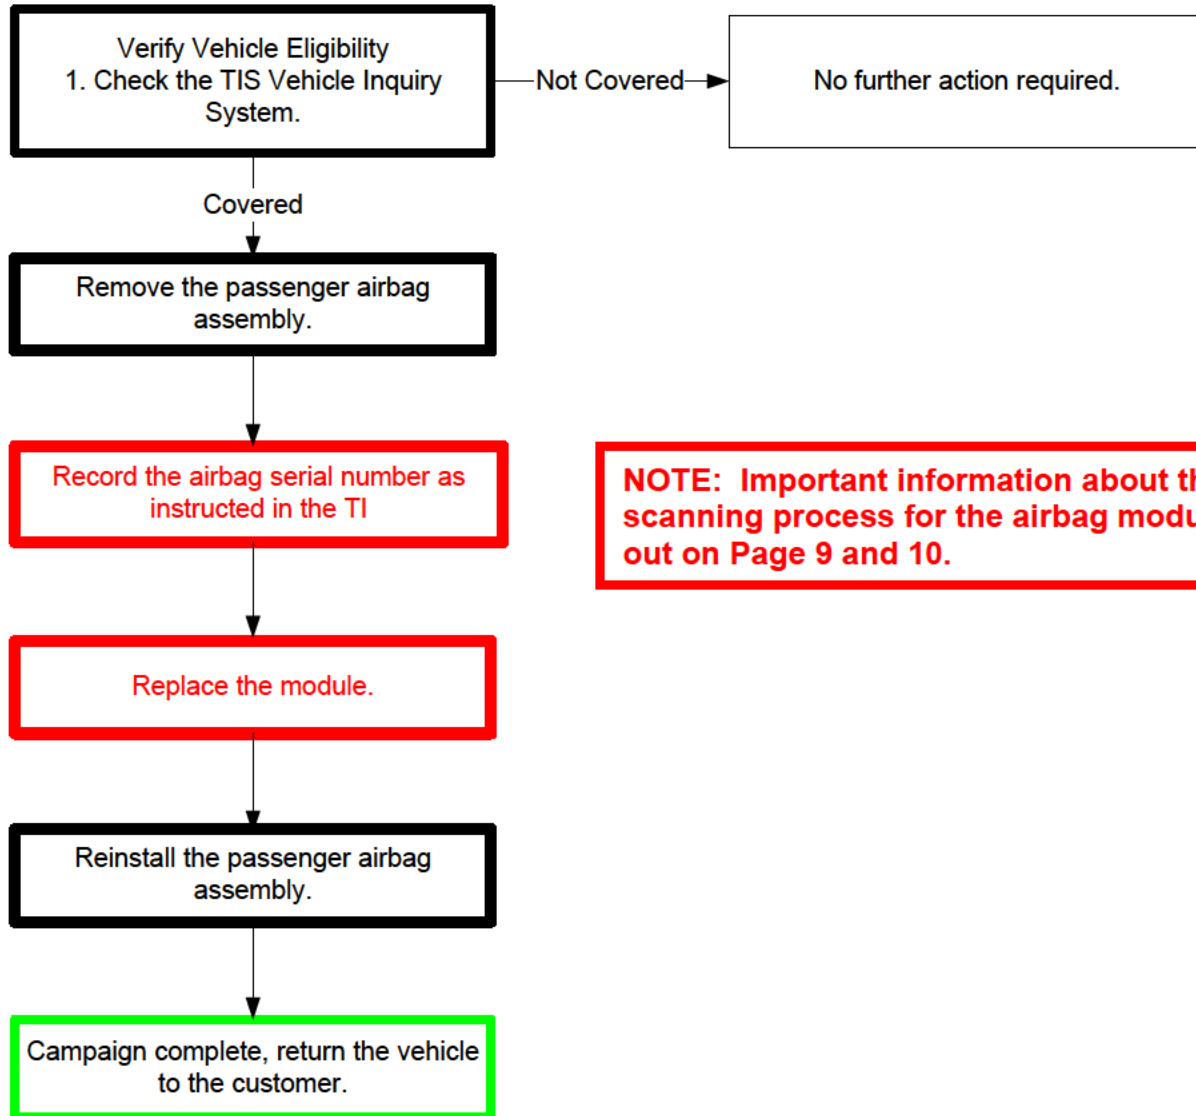
## I. OPERATION FLOW CHART

The flow chart is for reference only. **DO NOT** use it in place of the full technical instructions. Follow **ALL** steps as outlined in the full technical instructions to confirm the campaign is completed correctly.

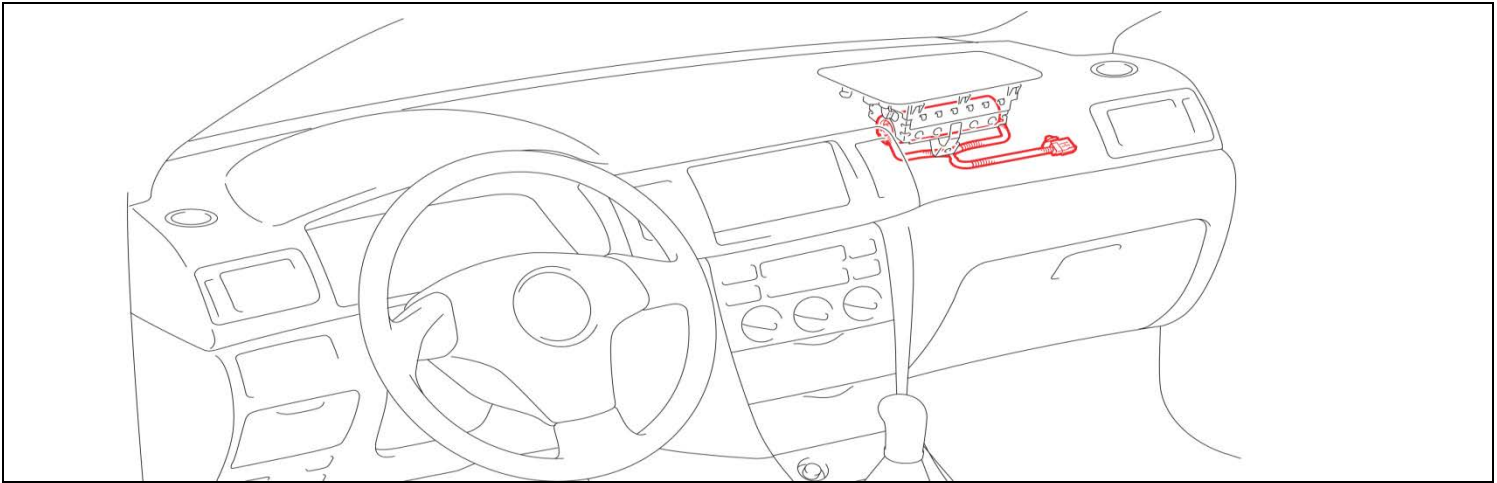
The subject vehicles are equipped with front passenger airbag inflators which may have been manufactured in such a way as to have a potential for the intrusion of moisture over time. Depending on the circumstances, this could create excessive internal pressure when the airbag is deployed and cause the inflator to rupture. In the event of an inflator rupture, metal fragments could pass through the airbag cushion material, striking the vehicle occupants and potentially resulting in serious injury or death.

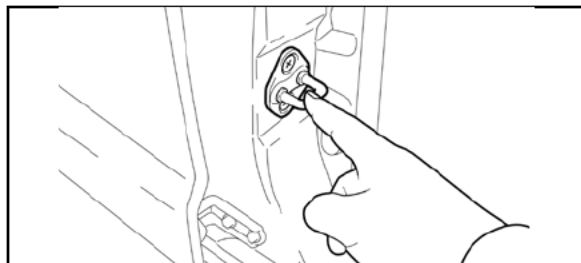
#### 1. ELIMINATE STATIC ELECTRICITY

- a) Before starting work and periodically while working on the vehicle, touch a metallic part of the vehicle to discharge static electricity in the body.

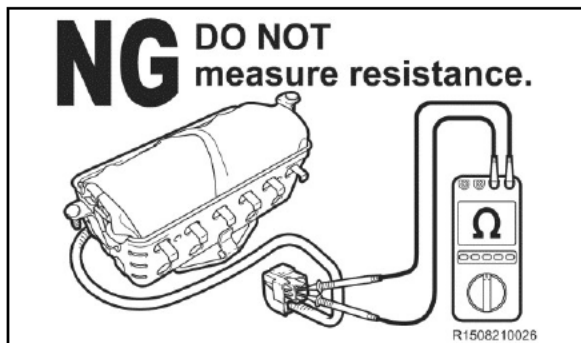
#### 2. DO NOT MEASURE RESISTANCE

- a) **DO NOT** measure resistance of airbag components, this may cause accidental activation.

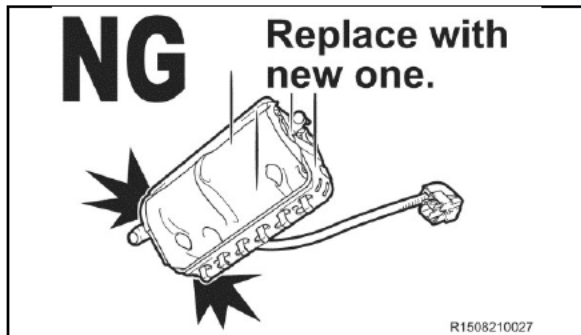
#### 3. HANDLE THE AIRBAG CAREFULLY

- a) If an inflator is dropped, replace it with a **NEW** inflator.

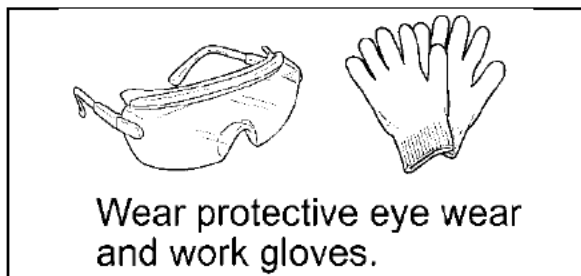
#### 4. WEAR PROTECTIVE EQUIPMENT

- a) Always wear appropriate protective equipment when working on the SRS.

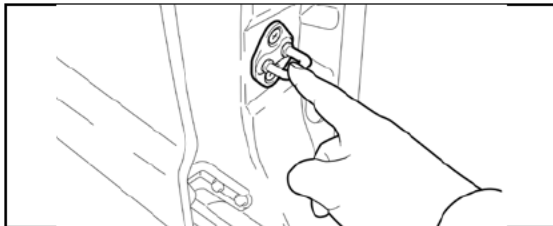
The anti-static mat set that is an essential SST may be available at your dealership and is optional to use during inflator replacement. If the anti-static kit is not available, before starting work and periodically while working on the vehicle, touch a metallic part of the vehicle to discharge static electricity in the body.

If the anti-static kit is not available, before starting work and periodically while working on the vehicle, touch a metallic part of the vehicle to discharge static electricity in the body.

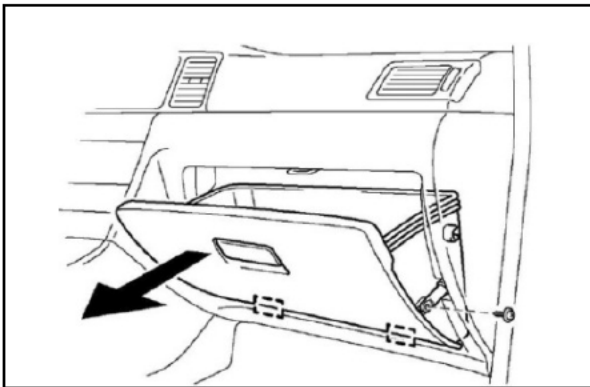
## 2. REMOVE THE GLOVE BOX

- Open the glove box door.
- Press in on both sides of the door and swing it down to remove it from the vehicle.

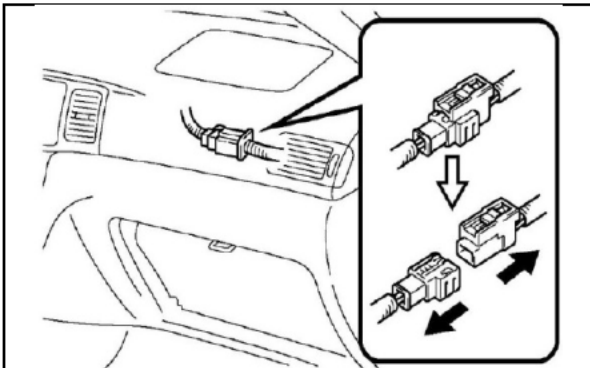
## 3. REMOVE THE AIRBAG ASSEMBLY

- Disconnect the negative battery cable.

- Wait at least 90 seconds after disconnecting the cable from the negative battery terminal to prevent airbag and seat belt pre-tensioner deployment.
- Follow all precautions as outlined on TIS before servicing the SRS system.

- Disconnect the airbag connector.

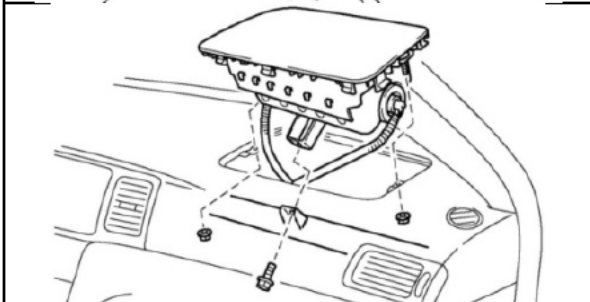
## 4. REMOVE THE FRONT PASSENGER AIRBAG

- Remove the 2 nuts and release the 6 clips.
- Remove the airbag assembly.

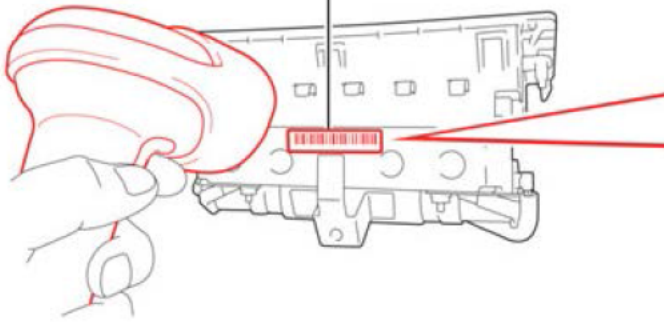
#### Airbag Serial Number Label Example

- The airbag serial number is **ALWAYS** the 12 **DIGITS** located between the asterisks.
- The 3 digits before the asterisk **ARE NOT** part of the serial number, and **SHOULD NOT** be entered or an inaccurate response may be returned.

The **AIRBAG ASSEMBLY** serial number **MUST** be recorded prior to replacement.

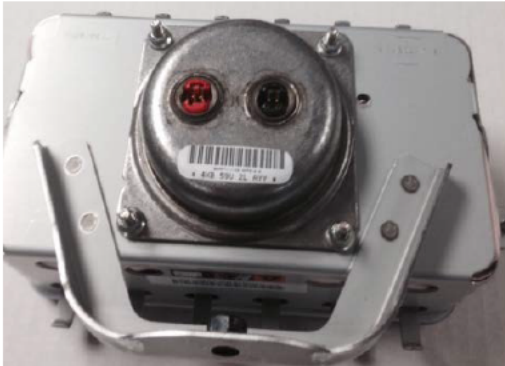
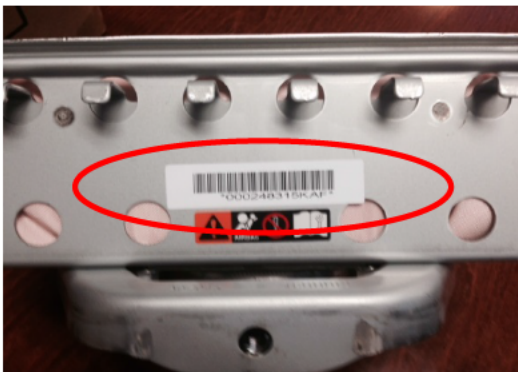
- Because this new part is a complete airbag assembly with a different style inflator installed, **you do not need to record the old or new inflator serial numbers.**

Note: The old tube style inflator may still be available. If you have that part you need to refer to the old set of instructions which will require the old and new inflators to be recorded.

- The New 12 digit Airbag Serial number on the side of the assembly will need to be recorded
- To record the new Airbag Serial number, in the scanning application you will need to **check the box indicating the old Inflator serial number is not readable or missing.** This will take you to the screen that allows you to enter the new airbag serial number.  
Go to step C on page 10

**Remember: You will need to check the box indicating the old inflator serial number is not readable or missing to move to the next screen.**

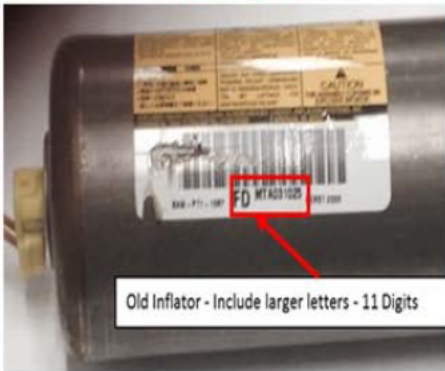
#### Original Inflator

Old Inflator - Include larger letters - 11 Digits

The first two characters of the **Original Inflator Serial code** will be from [AA, AB, AJ, FD or JD].

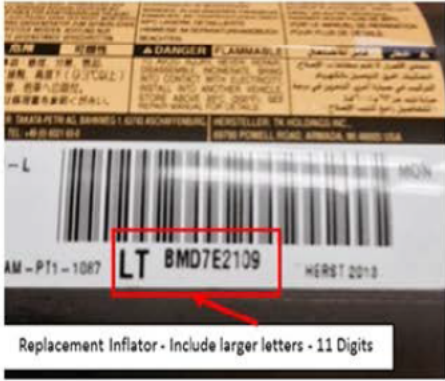
#### Replacement Inflator

Replacement Inflator - Include larger letters - 11 Digits

The first two characters of the **Replacement Inflator Serial code** will be either 'LT' or 'LR'.

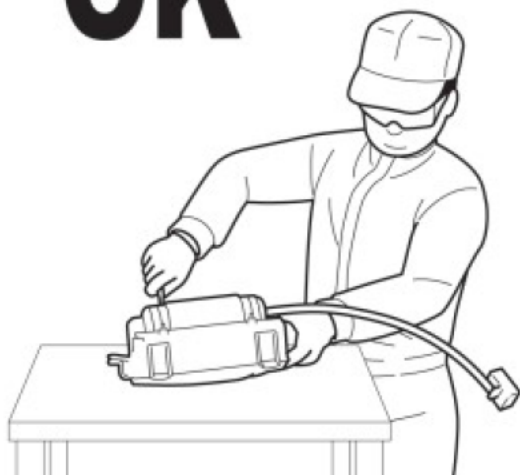
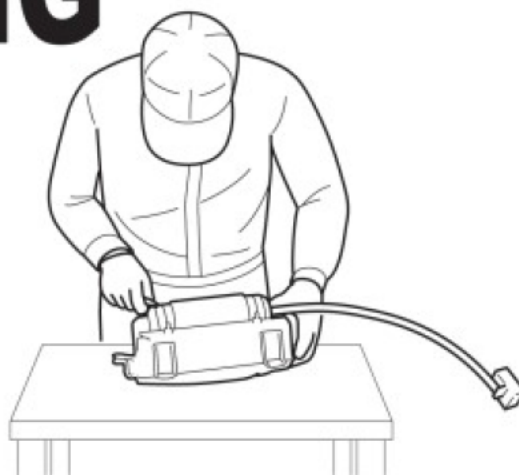
- Carefully place the airbag on the bench inflator side up.

- Avoid standing directly over the inflator.

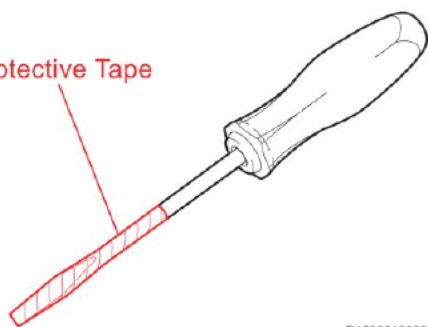
Protective Tape

- Wrap a screwdriver with tape.

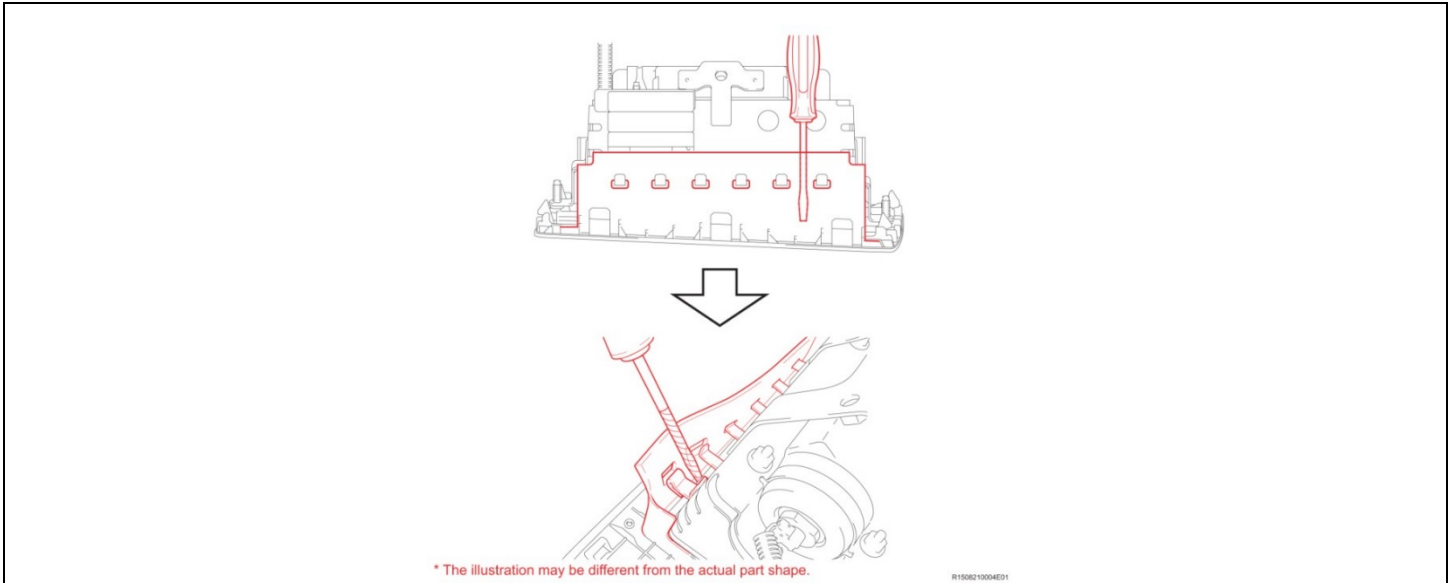
### 3. REMOVE THE COVER

- a) Gently insert the screwdriver between the airbag door and module and disengage the claws holding the door to the module. Please refer to the video below.

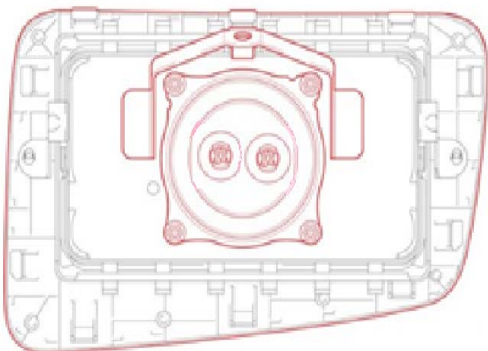
- b) After all the claws have been disengaged separate the module from the door.
- c) Mark the old module so it is not reused.
- d) Inspect the door for damage to the mounting slots.

**Take care not to mistake the mounting direction.**

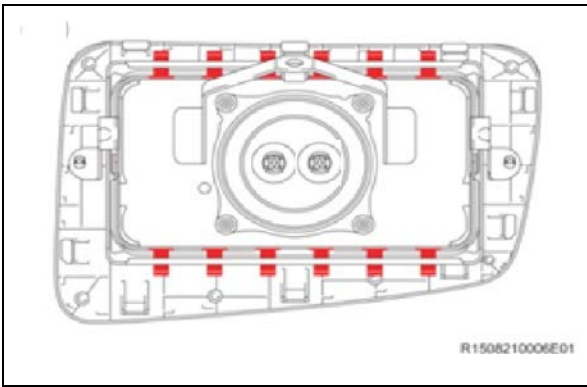
### 4. INSTALL THE NEW MODULE

- a) Carefully slide the new module into the airbag door.

**NOTE: Mounting direction.**

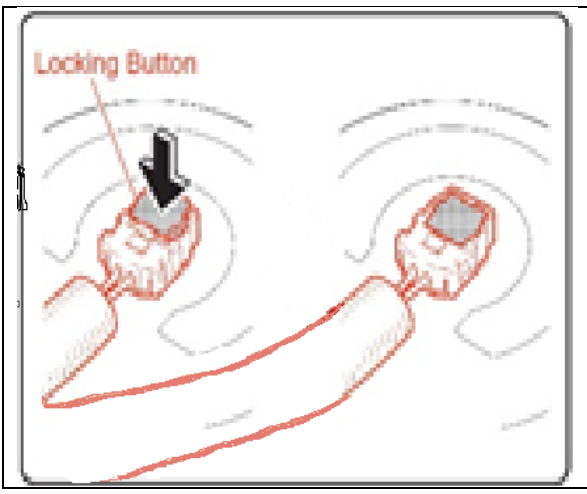
- b) Reengage the tangs of the module into the door using the screwdriver with the shaft wrapped in tape.

- c) Connect the new harness to the new module.
- d) Press the lock tab down.
