Recall 16V-173 : Replace "Electronic Control Unit" for the Airbags

This Service Information bulletin supersedes SI B65 11 16 **dated May 2016** .

G12 (7 Series)

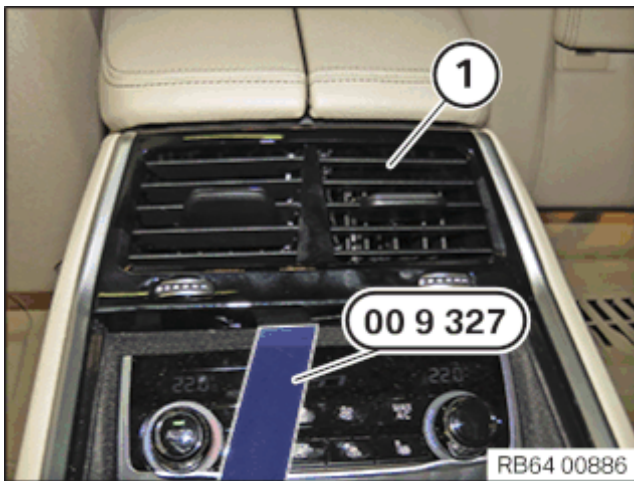
3–Remove fresh air grille in rear passenger compartment

- Unclip the fresh air grille (1) using special tool **0 496 571 (00 9 327)**.
- Disconnect the associated connector and remove the fresh air grille (1).

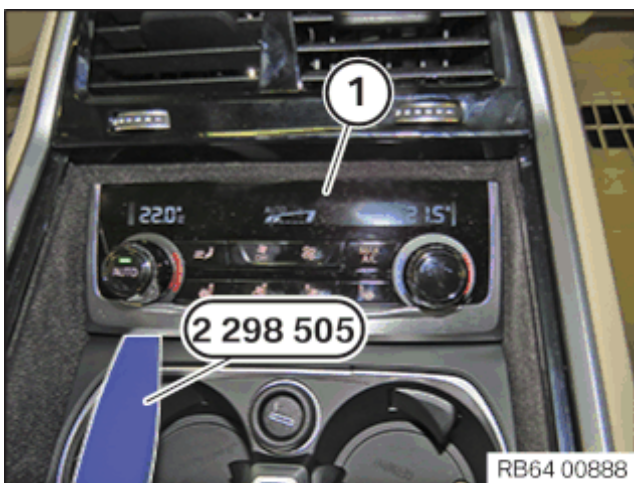
4–Removing the control panel of the rear passenger compartment air conditioning

- Unclip the control panel (1) using special tool **2 298 505**.
- Disconnect the associated connector and remove the control panel (1).

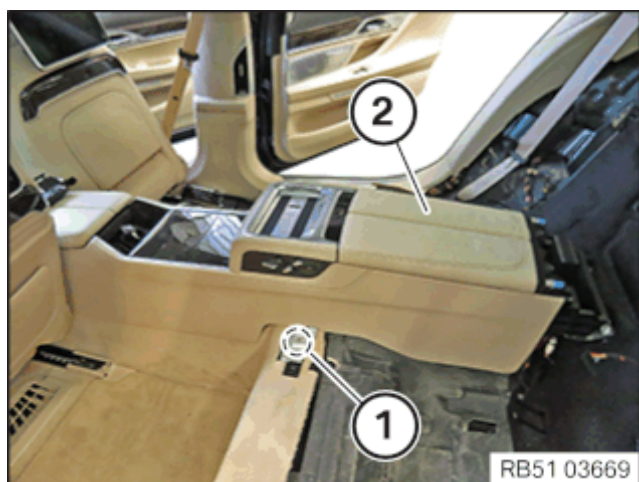
- Loosen left and right screw (1).
- Slightly lift the rear console (2) at the rear.
If necessary, unlock and disconnect additional plug connections.
- Remove the rear console (2) with an additional person.

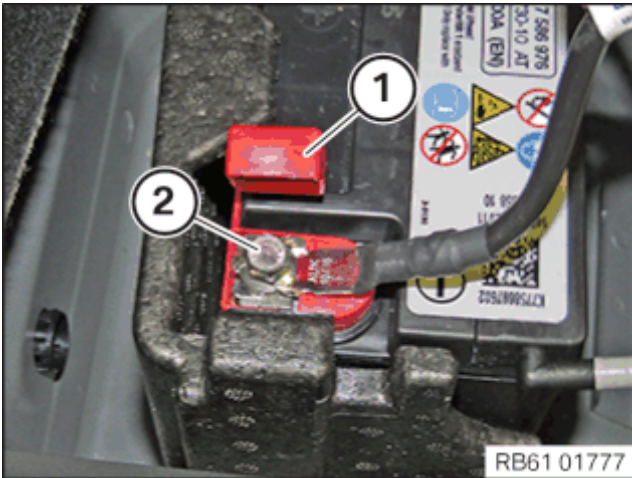
- Open the protective cap (1).
- Loosen the screw on the negative battery terminal (2).
- Put the battery earth lead to one side and secure it.

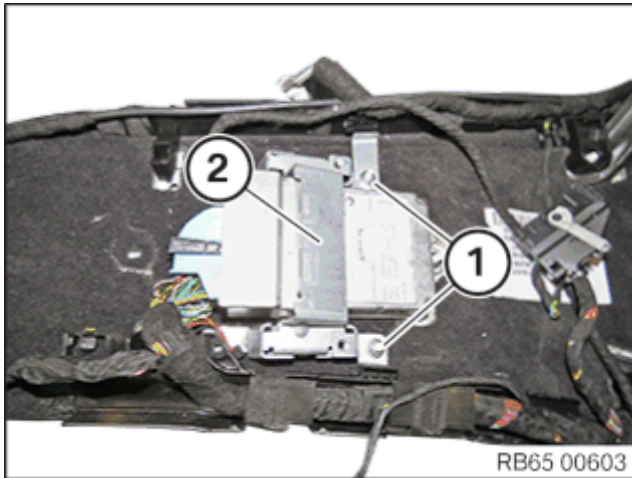
- Loosen nuts (1).
- Remove the holder (2).

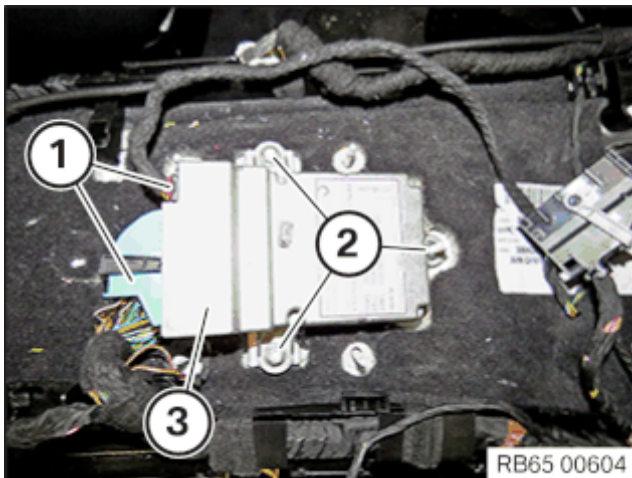
10-Removing the airbag control unit

- Unlock and disconnect connector (1).
- Loosen nuts (2).
- Remove airbag control unit (3).

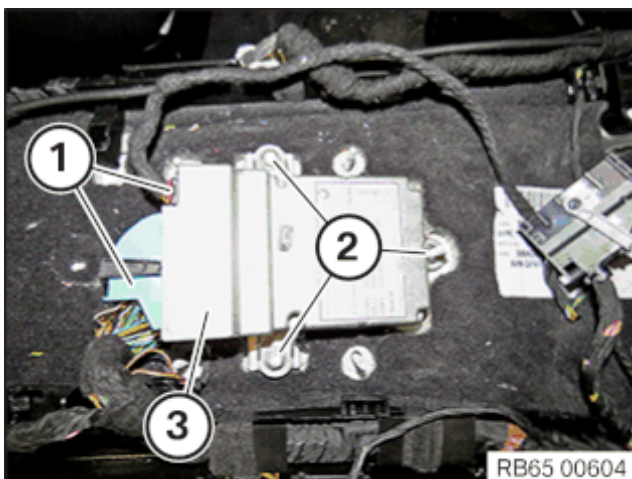
11-Installing the airbag control unit

- Position airbag control unit (3) correctly.
- Tighten nuts (2).
- Connect connectors (1) and lock.

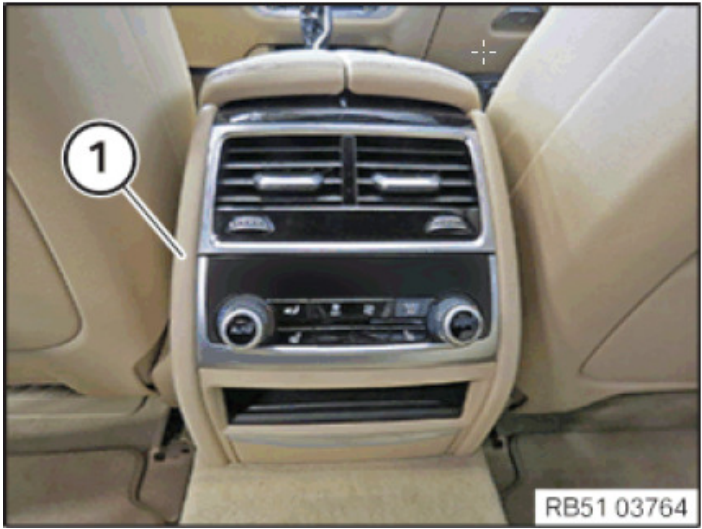
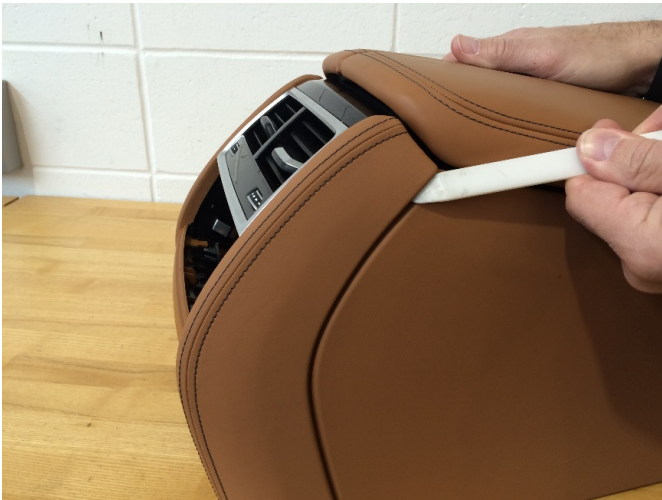
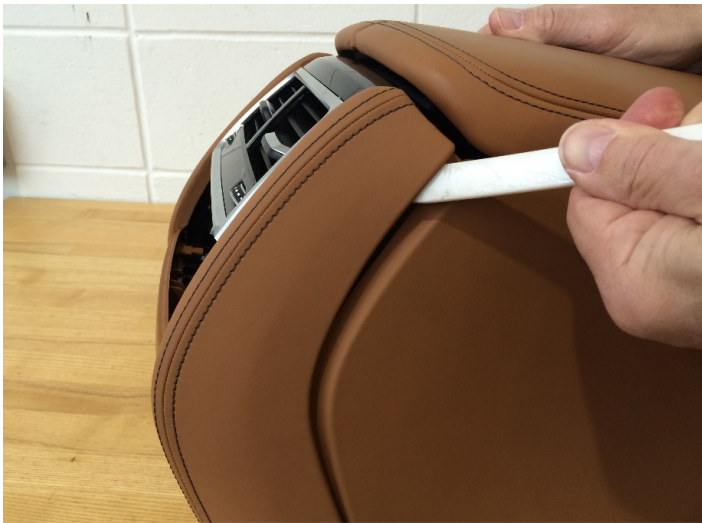
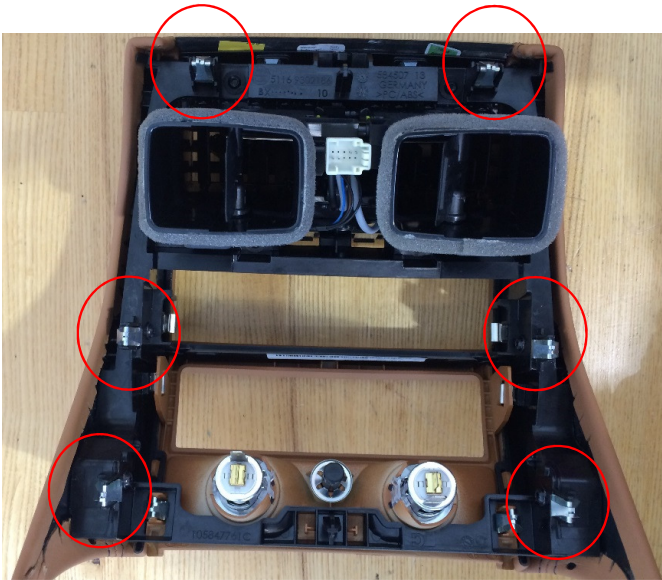
Removal of the Back of the Center Console – Step 5 REP 6577018

6 Spring clips

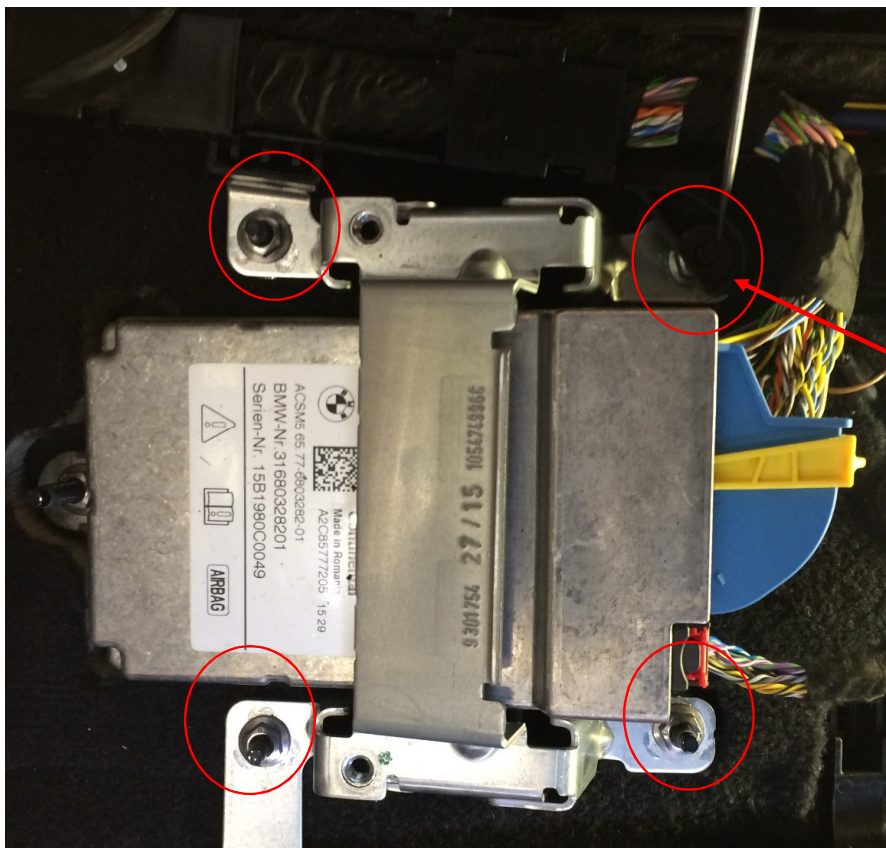
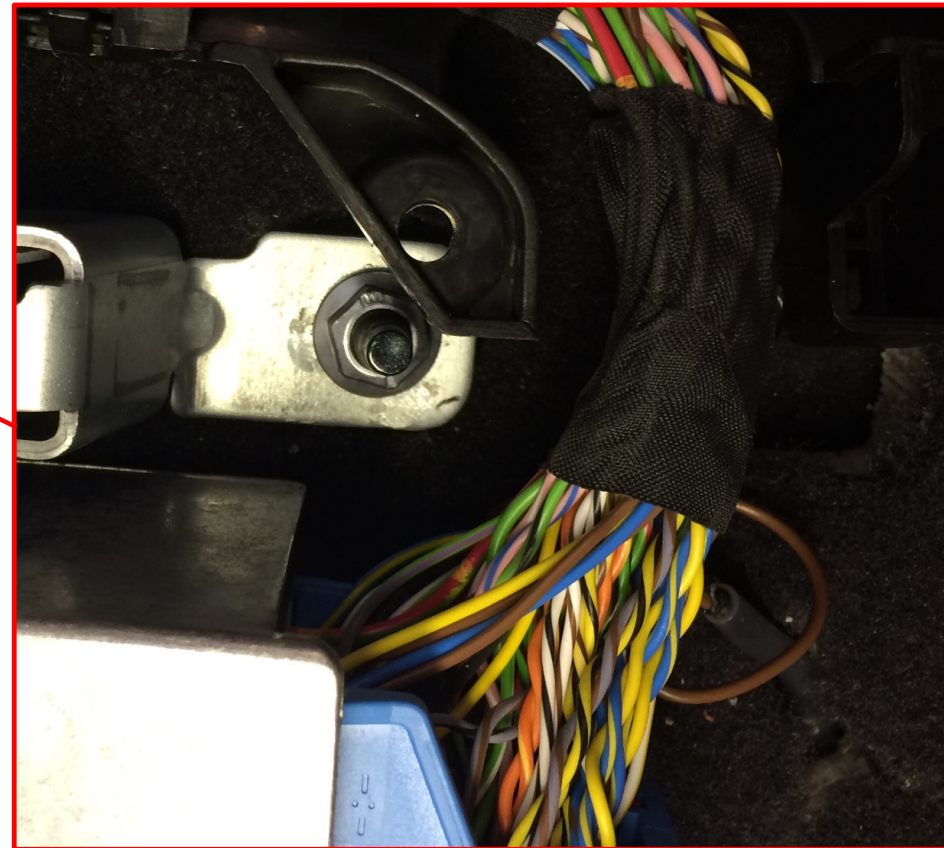
ACSM 4 Mounting Nuts – Step 10 REP 6577018

- Reference the attachment on this SIB for tips on ACSM5 removal.
 - All four ACSM5 mounting nuts are to be reused and tightened to 8 Nm of torque.
 - On G12 vehicles with option 4F5 "Executive Lounge rear console", the rear console must be removed, see "Remove and refit the rear console" Repair Instructions **RA 52 25 350** . Copy of RA attached.
 - The front and rear consoles have sharp edges that can cut into the dashboard or rear seat during removal. Take precautions to prevent contact that can damage the interior.
2. After ACSM5 replacement program the vehicle with ISTA/P.
- **Always connect a BMW approved battery charger / power supply ([SI B04 23 10](#)).**
