ITB16-018

VOLUNTARY SAFETY RECALL CAMPAIGN OCCUPANT CLASSIFICATION SYSTEM CONTROL UNIT REPLACEMENT

CAMPAIGN ID #: R1606
NHTSA #: 16V-244
APPLIED VEHICLE: 2013 JX (L50)
2014-2016 QX60 (L50)
2014-2016 QX60 Hybrid (L50)
2014-2016 Q50 (V37)
2014-2016 Q50 Hybrid (V37)

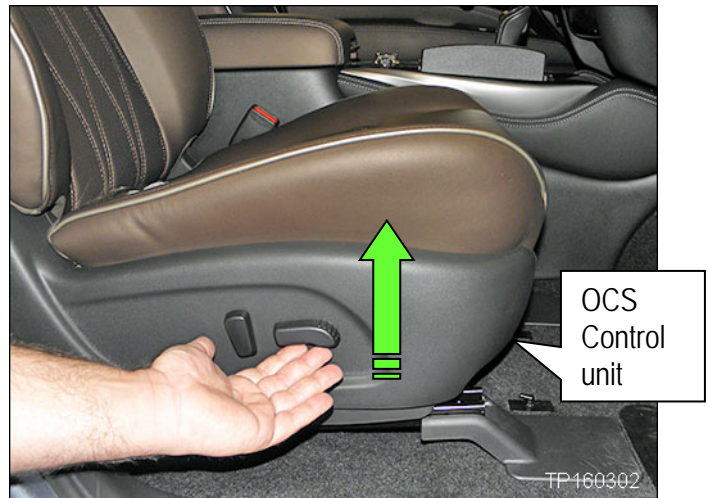
Figure 1

2. Raise the front passenger seat cushion all the way up.
 - Raising the seat cushion will give additional working space to access the OCS control unit.

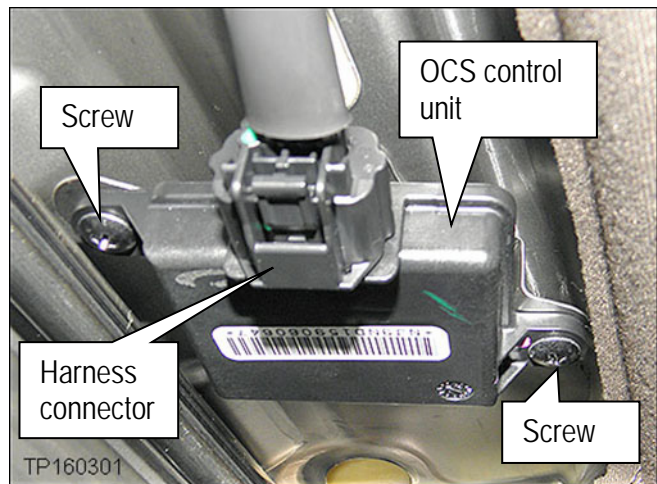
Figure 2

3. Locate the OCS control unit under the front edge of the seat cushion.
4. Disconnect the harness connector.
5. Remove the two screws and then remove the OCS control unit.
6. Select the correct OCS control unit (ODS ECU) from Parts Information and confirm that the pin count is the same as the OCS control unit being replaced.

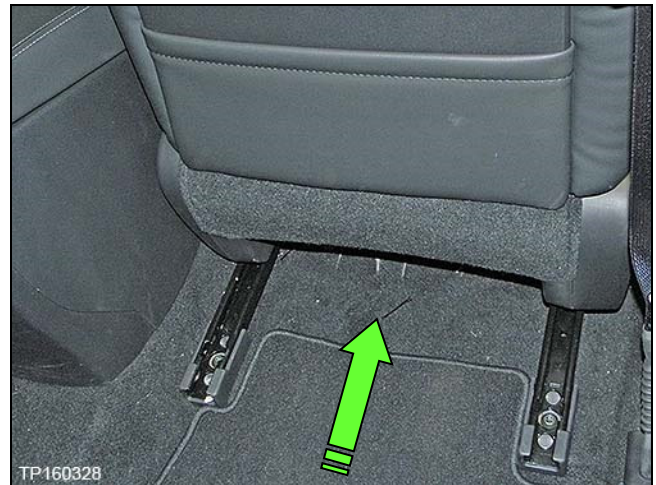
Figure 3

2. Move the passenger seat forward to gain access to the OCS control unit.
3. Locate the OCS control unit under the center left side of the seat cushion (see Figures 3, 4 and 5).

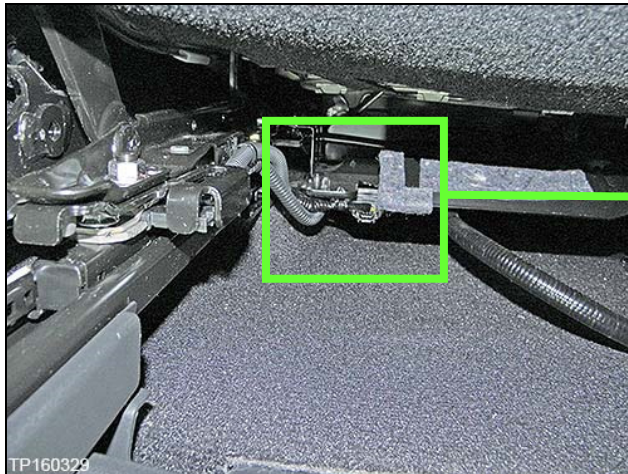
Figure 4

4. Disconnect the OCS harness connector.

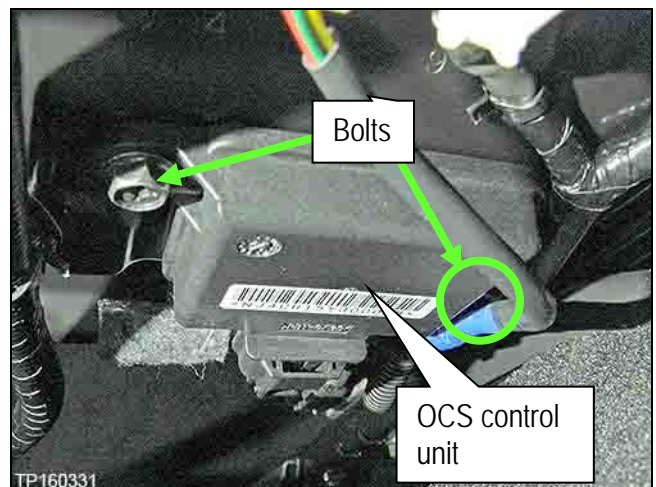
Figure 6

5. Remove the two bolts and then remove the OCS control unit.
 - The second bolt is located on the opposite side of the OCS control unit where indicated in Figure 6.
6. Select the correct OCS control unit (ODS ECU) from Parts Information and confirm that the pin count is the same as the OCS control unit being replaced.
7. Install the new OCS control unit in reverse order.

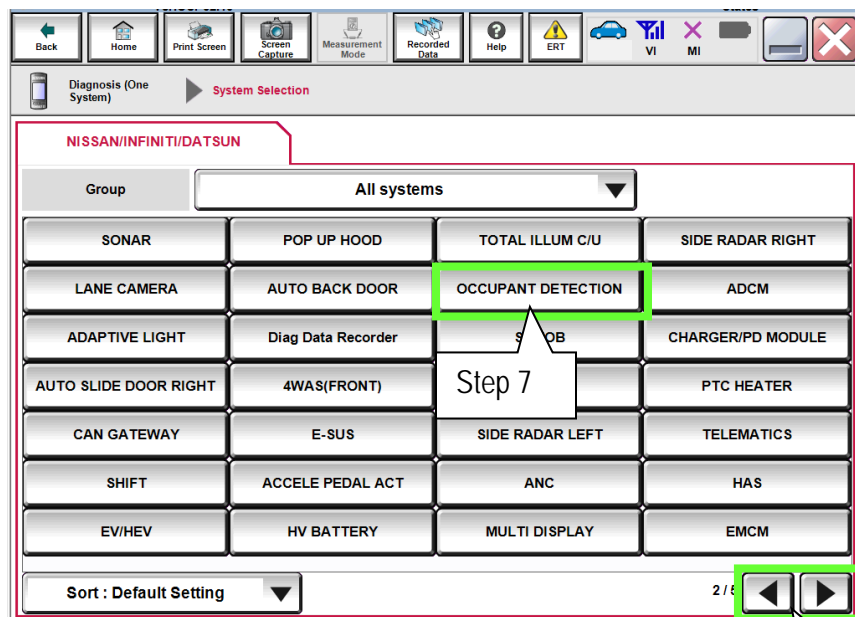
Figure 7

1. Prepare the vehicle for OCS zero point reset as follows:
 - Level the vehicle
 - No objects on the passenger seat.
 - No occupants in the vehicle – including the servicing technician.
 - PC is outside of the vehicle on a suitable support.
 - Do not set the PC on the vehicle.
 - Do not touch the vehicle during the OCS zero point reset.
 - Minimize vibrations of the vehicle.
2. Connect the CONSULT PC to the vehicle with plus VI.
3. Open / start CONSULT-III PLUS (C-III plus).
4. Turn the ignition ON, with engine OFF (engine not running/not in ready mode).
5. Wait for the plus VI to be recognized.
 - The **Serial No.** will display when the plus VI is recognized.
6. Select **Diagnosis (One System)**.
7. Scroll C-III plus (All systems) and select **OCCUPANT DETECTION**.

Scroll here

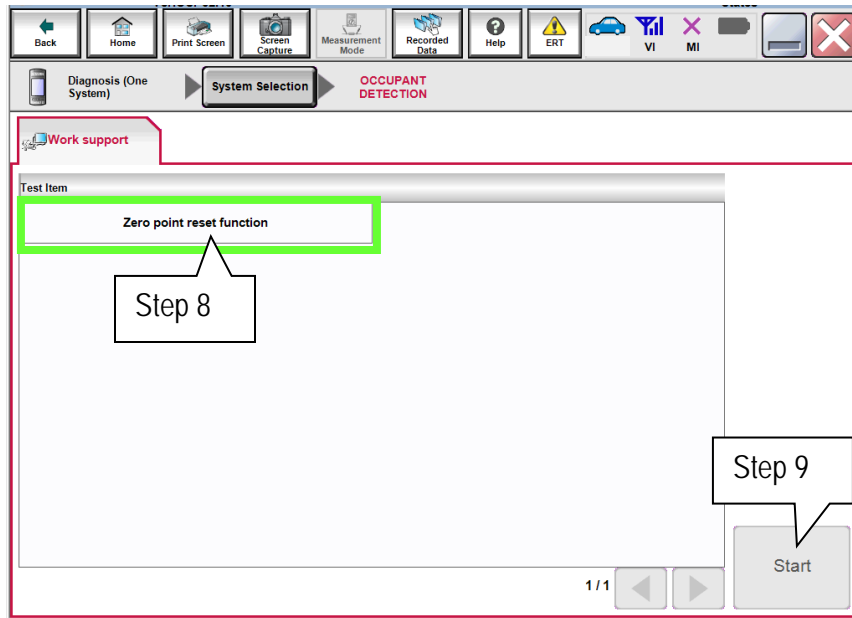
Figure 8

8. Select Zero point reset function.

9. Select Start.

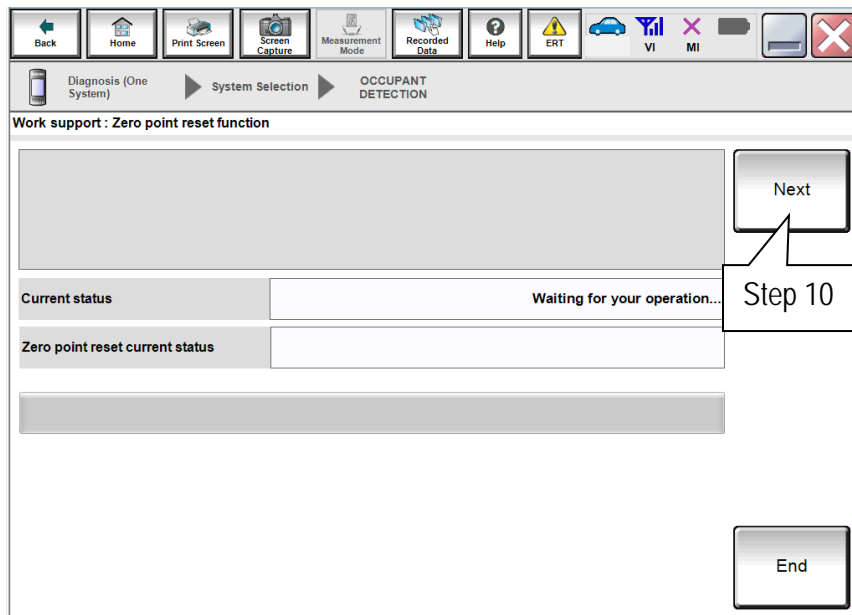
Figure 9

10. Select Next.

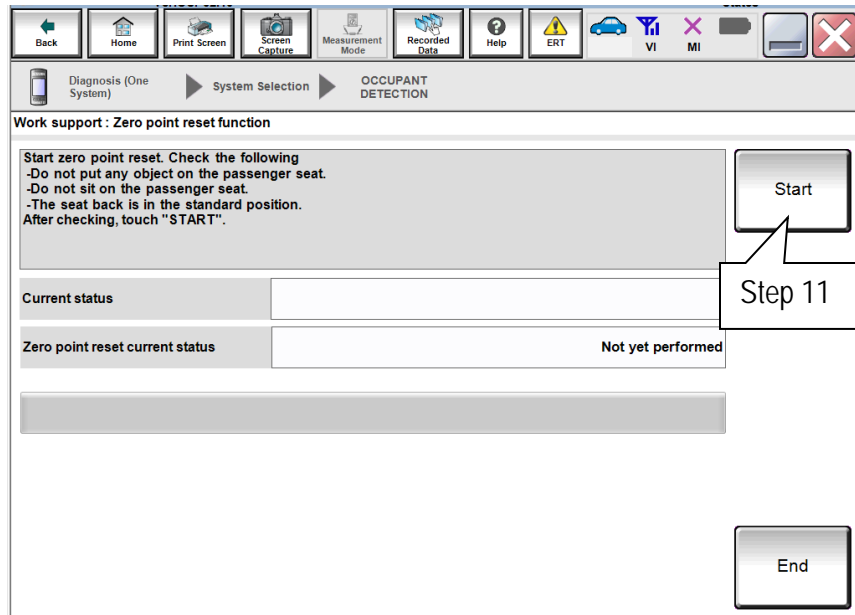
Figure 10

11. Select **Start** and then proceed to step 12.

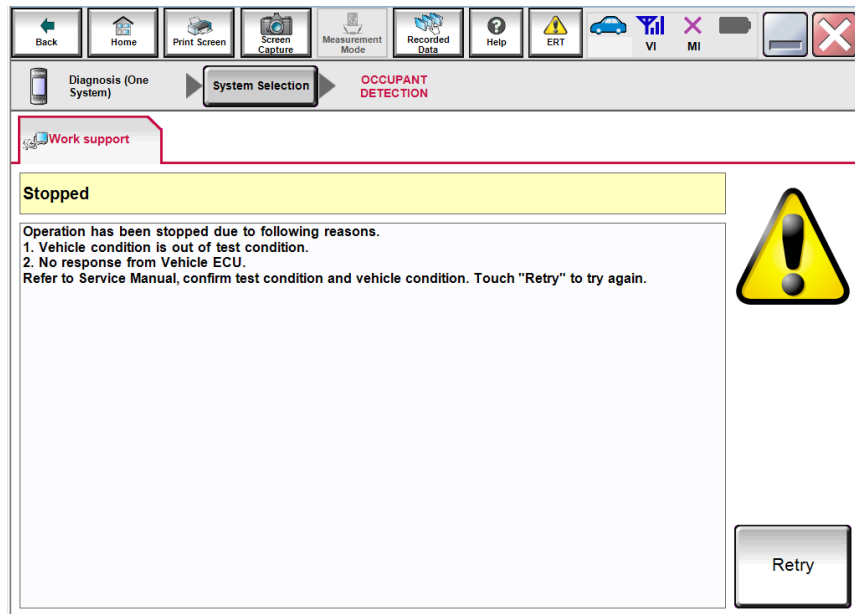
- After selecting **Start** if Figure 11 is displayed:
 - a. Check the OCS control unit and confirm that harness connector is completely seated.
 - a. Turn the ignition OFF and then restart procedure from step 4 on page 6.

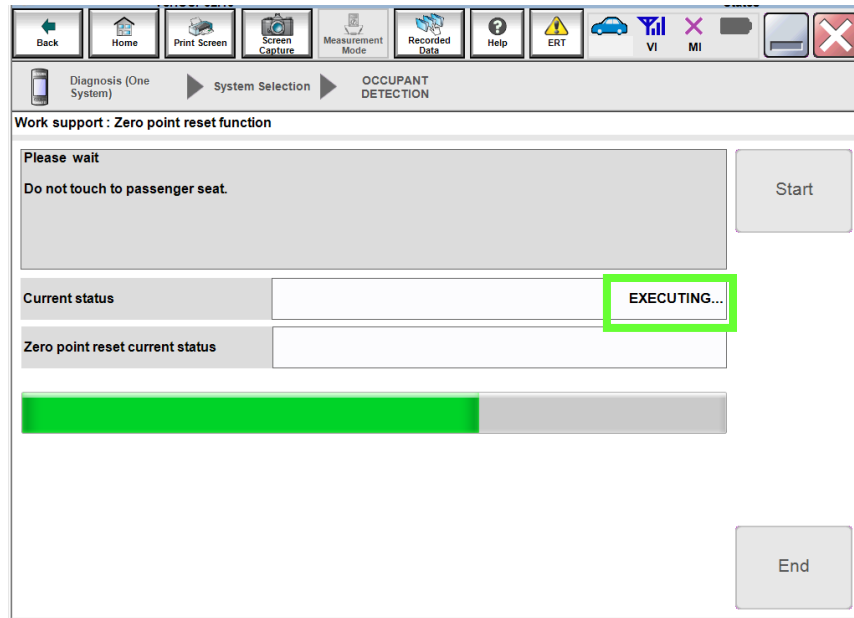
Figure 12

12. Zero point reset will display "EXECUTING".

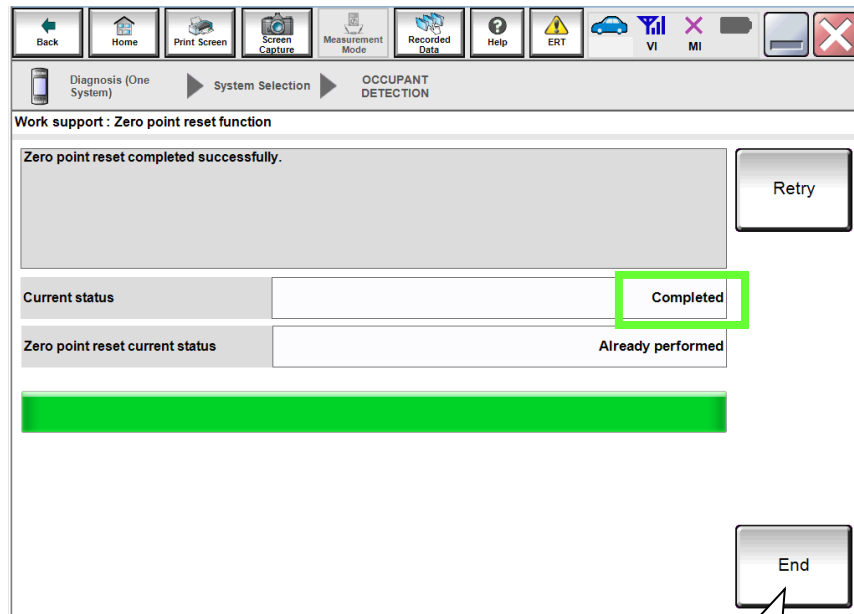
Figure 13

13. When finished, "Completed" will display next to "Current status".

- Select **End** and then proceed to step 14.

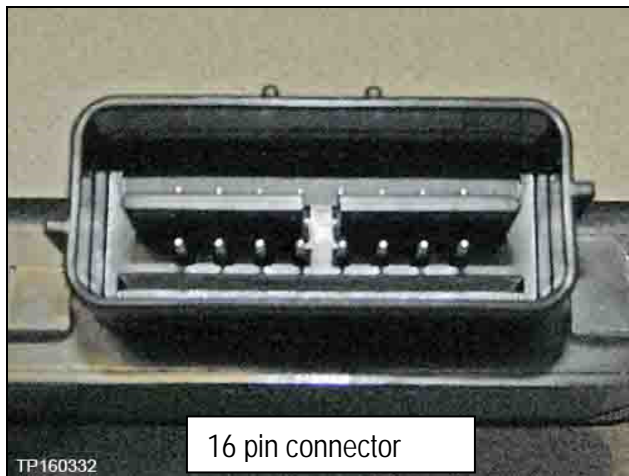
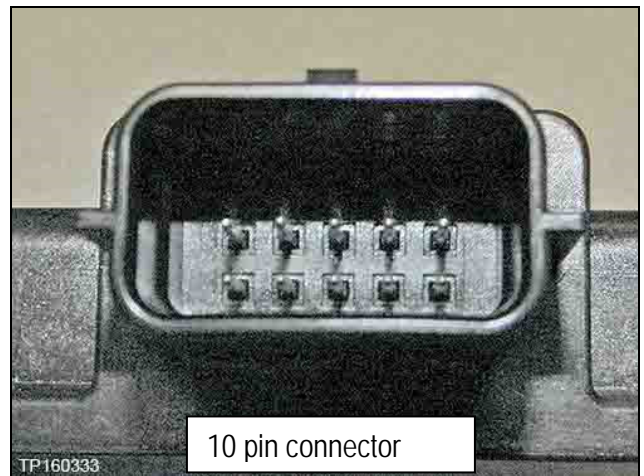
(1) Confirm that the number of pins of the new part are the same as the original (see Figures 14 and 15 below).
