# Recall Bulletin 160429REV

**PRODUCT(S) AFFECTED:**  
Holiday Rambler Brand Endeavor and Endeavor XE manufactured between 11/17/2015 and 4/7/2016

**SUBJECT:**  
Providing Front Passenger's Side Tire Clearance

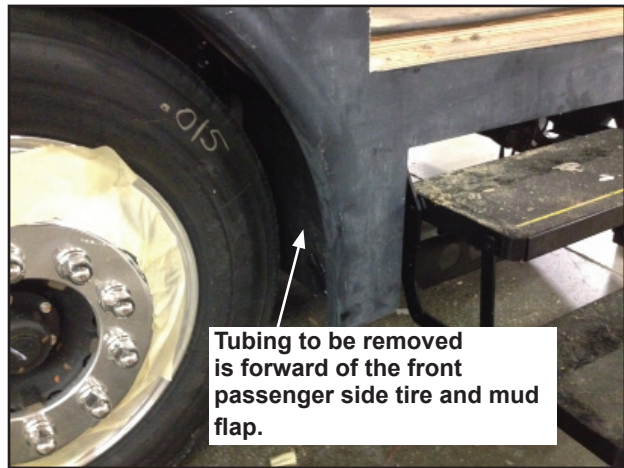
Figure 1

On motor homes affected by this recall, a diagonally-oriented section of tube steel, designed as a support framework component for the fiberglass wheel-well skirt, has the potential to contact the front passenger-side tire, or force the front passenger-side mud flap into contact with the tire.

4. Referring to Figures 1 and 2, locate the angled section of tube forward of the front passenger's side front tire, near the entry step assembly. Use a metal cutting tool to remove this tube. **DO NOT REMOVE ANY COMPONENTS OTHER THAN THE TUBE IDENTIFIED BY THE ARROWS IN FIGURE 2.**
