GROUP Safety Recall Campaign	MODEL 2013MY Forte (TD)
	NUMBER SC 132 (REV 2 7/19/2016)	DATE June 2016
VOLUNTARY SAFETY RECALL CAMPAIGN		
SUBJECT: FRONT SEAT BELT ASSEMBLY (SC 132)

This bulletin provides the procedure to inspect, and replace if necessary, the front seat belt assemblies on certain 2013MY Forte vehicles produced from 9/10/2012 through 10/31/2012. The screws holding the seat belt retractor's retaining plate in a small number of vehicles may not have been properly tightened due to a machining error in the screw threads by the supplier. As a result, the plate can break during certain frontal impact collisions. The broken piece of the plate may come in contact with an occupant thereby increasing the risk of injury.

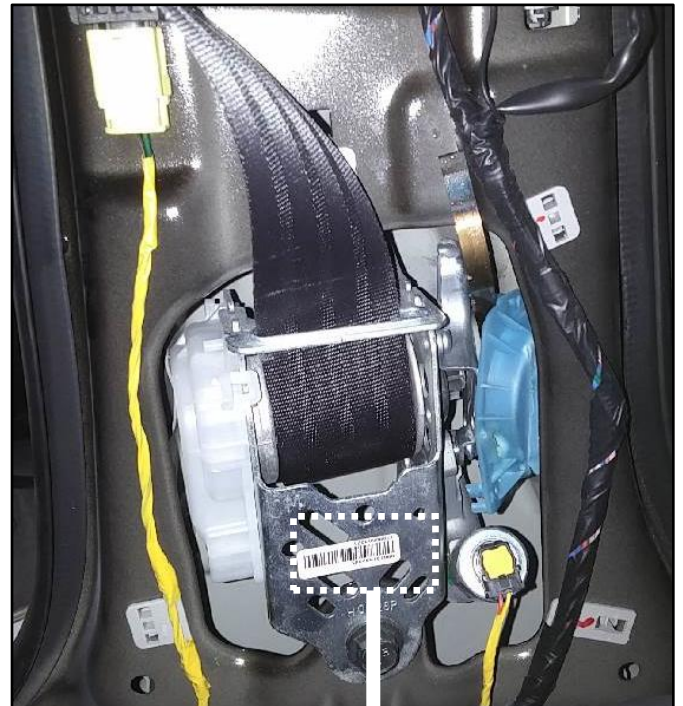
1. Remove the center pillar lower trim by referring to “Body (Interior and Exterior) → Seat Belt → Front Seat Belt → Repair Procedures” in the applicable Workshop Manual.
2. Check the manufacturing date in the LOT number on the front seat belt assembly as shown.

3. If the LOT number indicates a manufacturing date (A) of “120905,” replace the seat belt assembly.
(Refer to the “Replacement Procedure” on Page 3.)

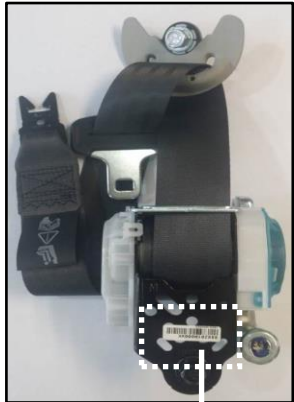
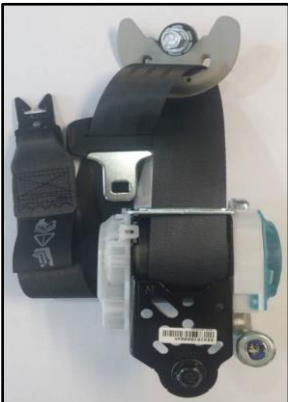
Replace only those parts manufactured on September 5, 2012 (shown as “120905” on the label).
