## TECHNICAL INSTRUCTIONS FOR SAFETY RECALL GLG FRONT PASSENGER AIRBAG INFLATOR REPLACEMENT CERTAIN 2007 – 2012 MY ES 350

### UPDATE 4-18-18

The subject vehicles are equipped with front passenger airbag inflators produced by Takata. The propellant in these inflators may degrade after prolonged exposure to high absolute humidity and fluctuating high temperatures. Degraded propellant can cause inflator rupture during airbag deployment. In the event of an inflator rupture, metal fragments could pass through the airbag cushion material, striking the vehicle occupants, and result in serious injury or death.

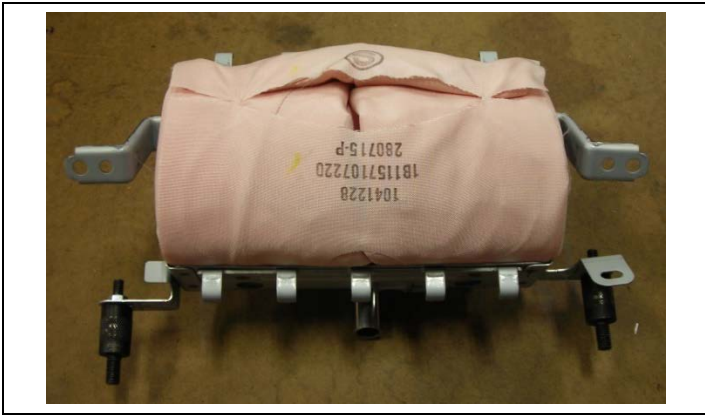
- b) Mount the adaptors (579943-3R3) to the airbag as shown.

**NOTE: The 6mm stud mounts to the airbag.**

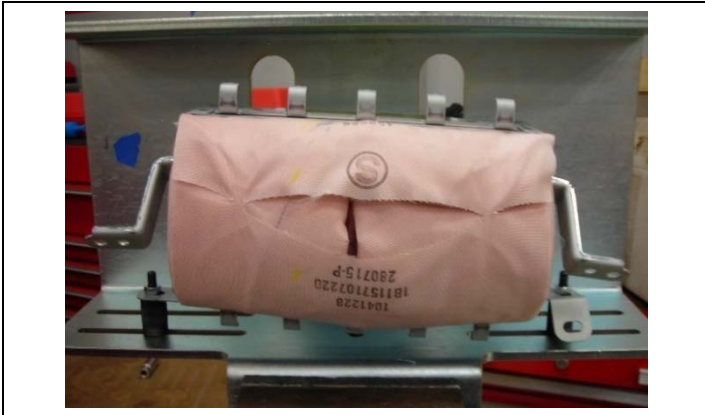
- c) Mount the airbag to the mounting bracket as shown.

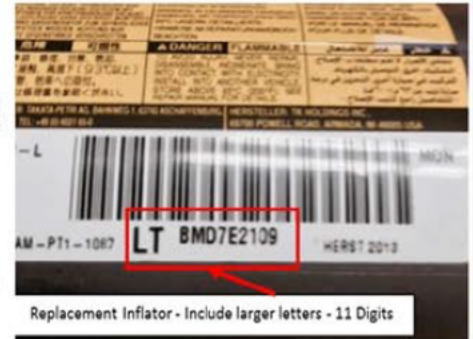
### Replacement Inflator

The Inflator serial code is an 11 digit code on the Inflator can. It can be found with a bar code on removing the Inflator can from the Airbag Assembly unit.

The first two characters of the Replacement Inflator Serial code will be either 'LT' or 'LR'.

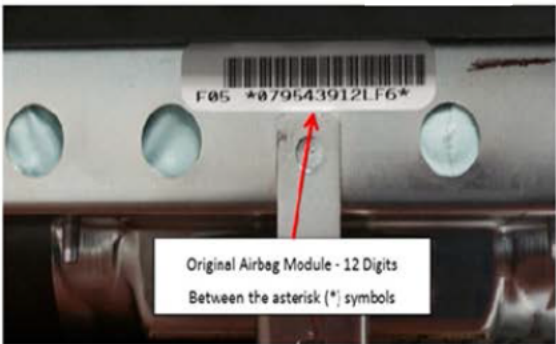
How to Identify an Airbag module Assembly number?

The Airbag module Assembly serial number is a **12 digit code**. It can be found along with a bar code on opening the Airbag assembly unit. To manually enter these details into the application, the technician has to identify the 12 digit code between two Asterisks (\*) inside the Airbag assembly unit. The first seven characters of this 12 digit code are numbers and the 10<sup>th</sup> digit is either 'K' or 'L' always.

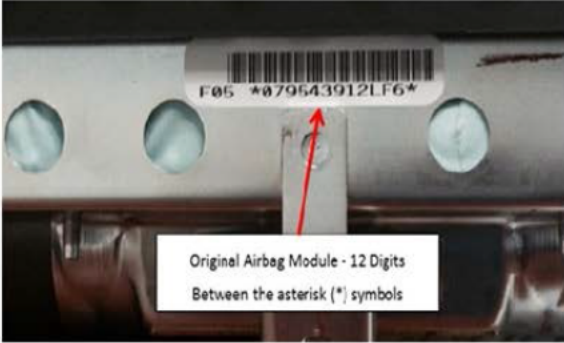
Original Airbag Module - 12 Digits  
Between the asterisk (\*) symbols
