# TECHNICAL INSTRUCTIONS FOR SAFETY RECALL G0R FRONT PASSENGER AIRBAG INFLATOR MODULE CERTAIN 2008 - 2010 MY SCION xB

**UPDATED 1-9-2018**

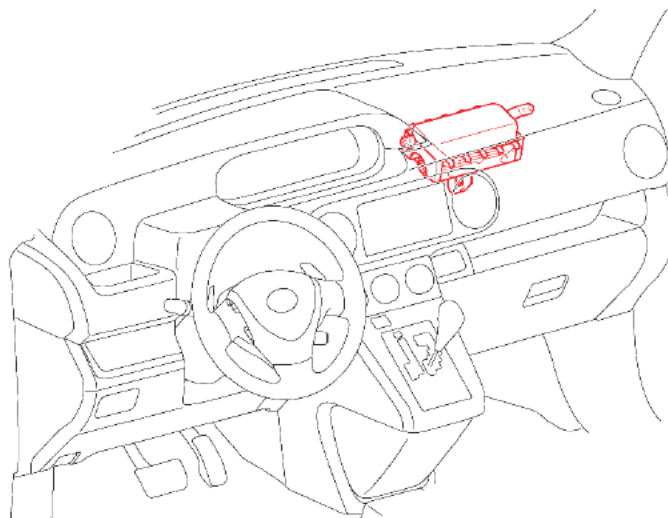
C162294

The subject vehicles are equipped with front passenger airbag inflators produced by Takata. According to Takata, the propellant in these inflators may degrade after prolonged exposure to high absolute humidity and fluctuating high temperatures. Degraded propellant can cause inflator rupture during airbag deployment. In the event of an inflator rupture, metal fragments could pass through the airbag cushion material, striking the vehicle occupants, and result in serious injury or death.

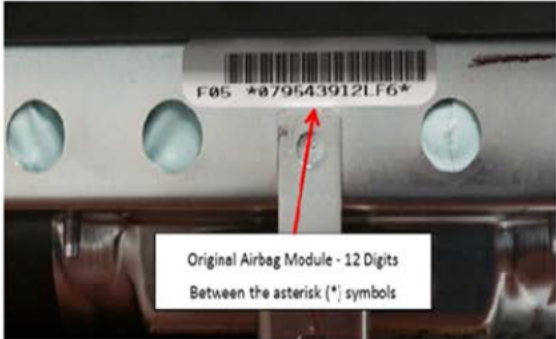
Original Airbag Module - 12 Digits  
Between the asterisk (\*) symbols

Check this box if the label is damaged or missing

a) If the airbag serial number cannot be scanned or is not present check the box as shown below.
