**TECHNICAL INSTRUCTIONS
FOR
SAFETY RECALL G0P
FRONT PASSENGER AIRBAG INFLATOR MODULE
CERTAIN 2011-2012 MODEL YEAR SIENNA**

Updated 08-31-17

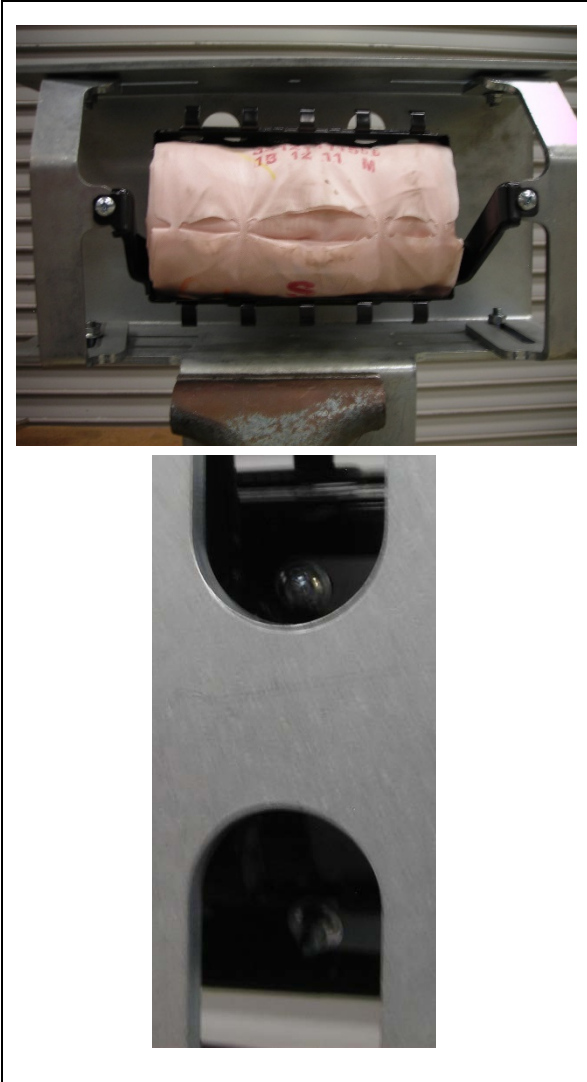
e) Mark all 5 nuts so they will not be reused.
