# IMPORTANT UPDATE

## TECHNICAL INSTRUCTIONS FOR SAFETY RECALL G0P/G0R/H0A FRONT PASSENGER AIRBAG INFLATOR MODULE CERTAIN 2007 – 2012 MY YARIS SEDAN AND 2006 – 2011 MY YARIS HATCHBACK

**Updated 07-17-18**

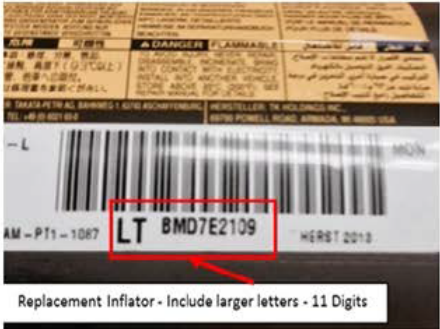
**Replacement Inflator**

The first two characters of the **Replacement Inflator Serial code** will be either 'LT' or 'LR'.

Replacement Inflator - Include larger letters - 11 Digits

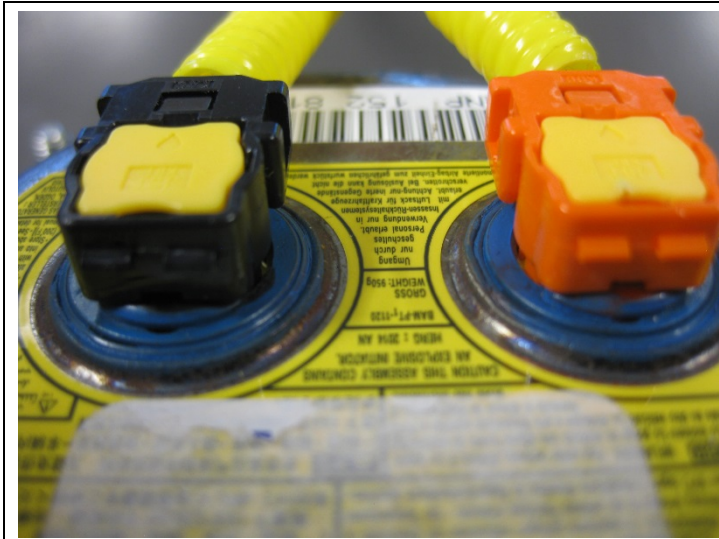
- b) Engage the secondary locks.
