# IMPORTANT UPDATE

## TECHNICAL INSTRUCTIONS FOR SAFETY RECALL G0P FRONT PASSENGER AIRBAG INFLATOR MODULE CERTAIN 2009 –2013 MODEL YEAR MATRIX

**Updated 4-18-18**

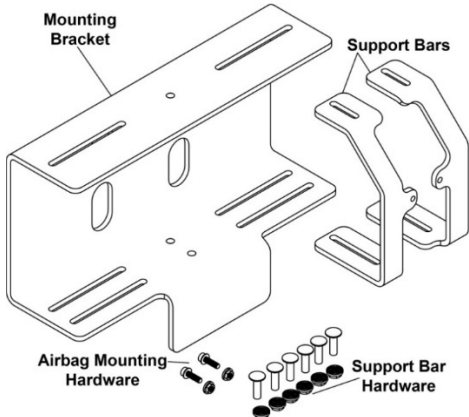
| Image | Name | Quantity |
|---|---|---|
| | Airbag Mounting Bracket & hardware | 1 |

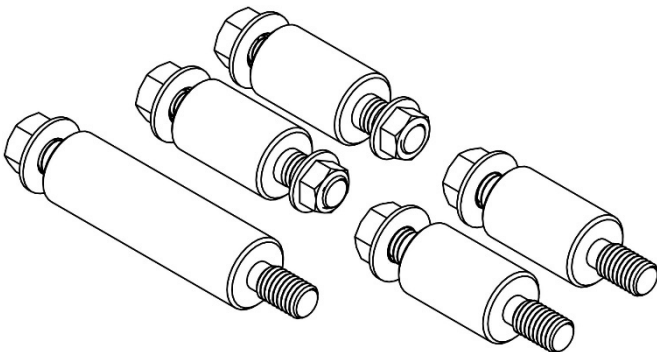
| Image | Name | Quantity |
|---|---|---|
| | Adaptor set* | 1 |

\*The adaptor set was sent to dealers at the start of this campaign.

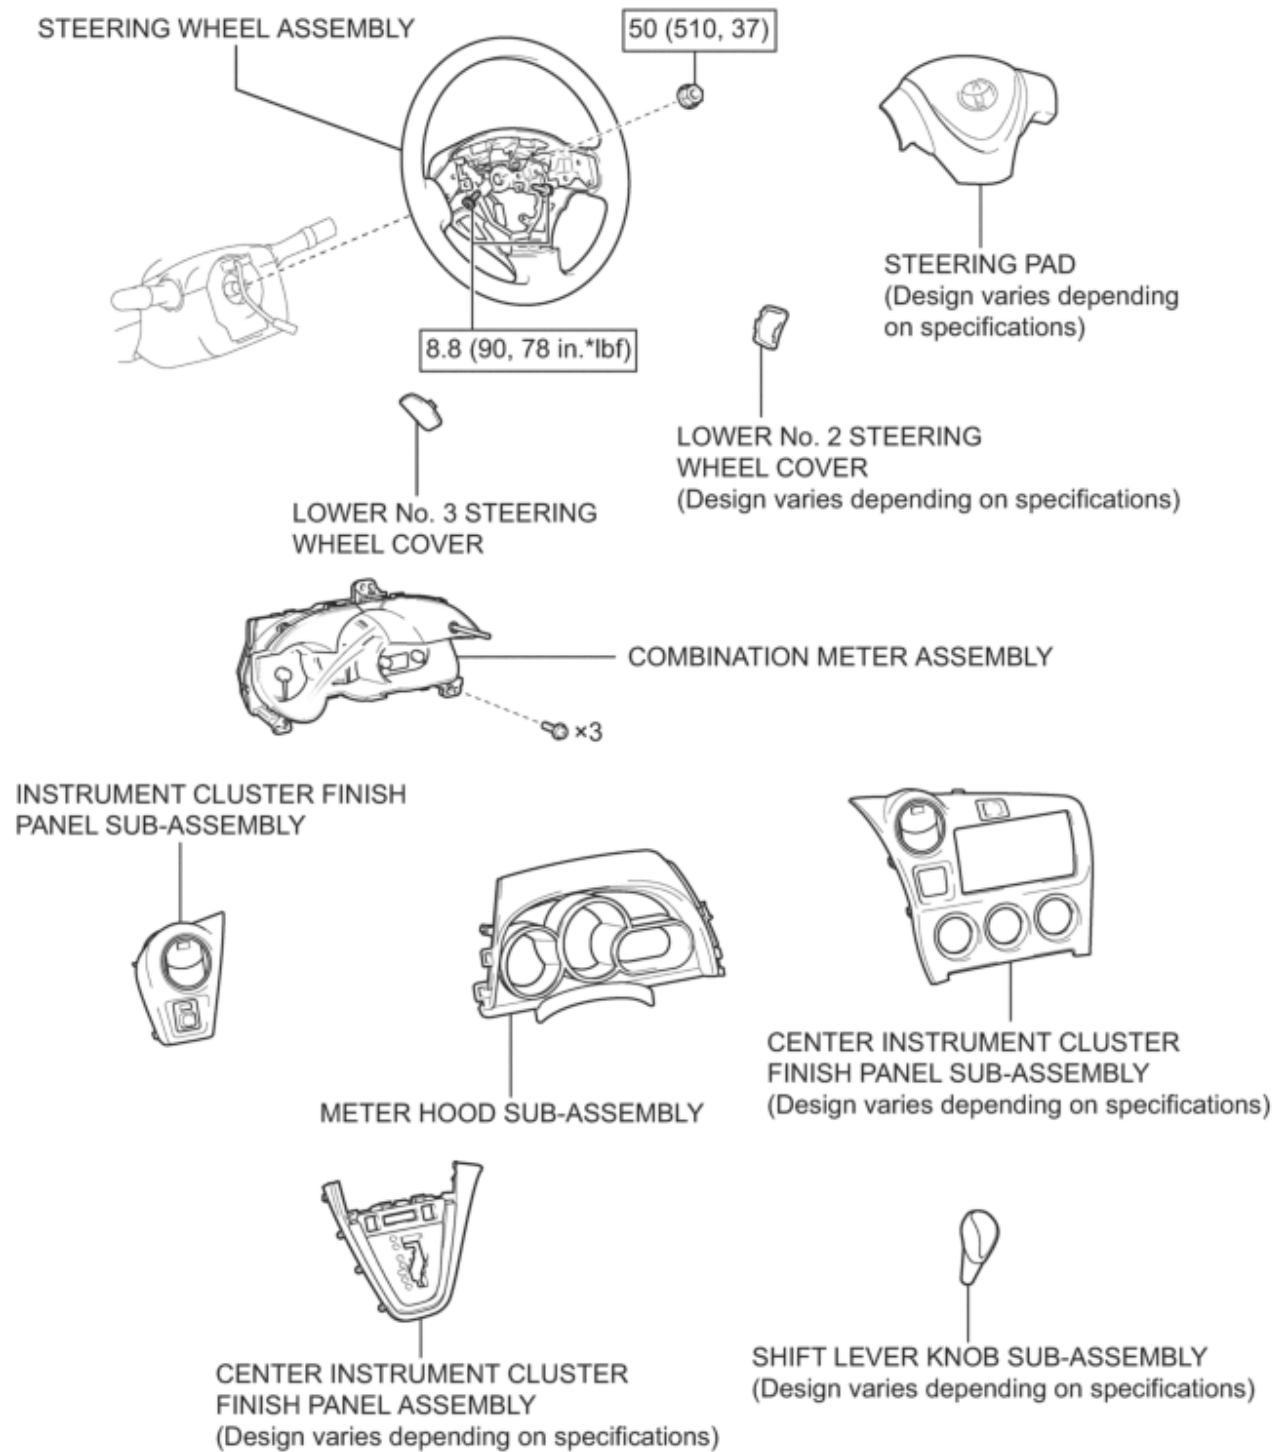
R1703010002

**N\*m (kgf\*cm, ft\*lbf)** : Specified torque

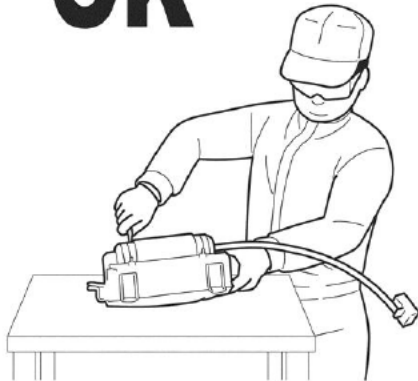
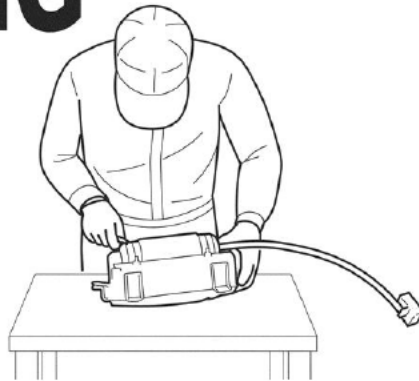
R1301230008E

- Carefully place the airbag on the bench inflator side up.

**NOTE:** Place clean sheet(s) of paper on the bench to protect the airbag.

- Avoid standing directly over the inflator.

# OK

# NG

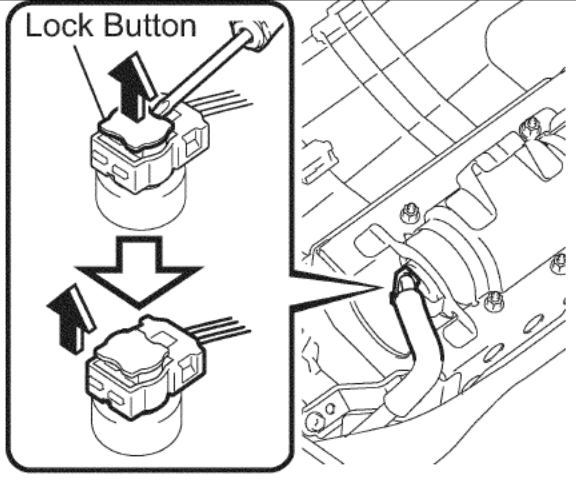
Lock Button

- Use a screwdriver to release the lock button.
- Disconnect the connector.
- Disconnect the wire harness clamps.

**NOTE:** Disconnect the connector where the fixed stop plate is located.

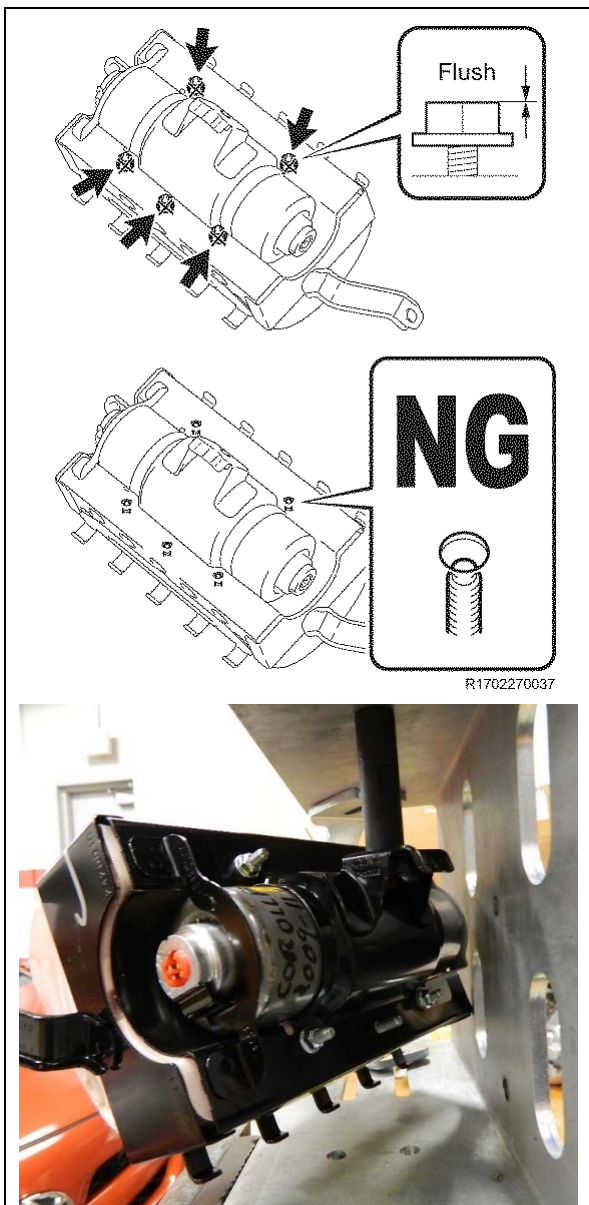
g) Mount the airbag into the mounting bracket as shown. Pass the stud on the adaptor through the hole in the middle of the bracket with the nut.

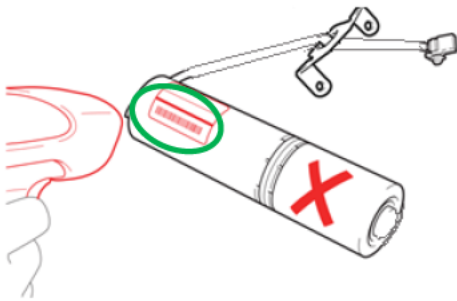
Step a) Old Inflator (bar code)

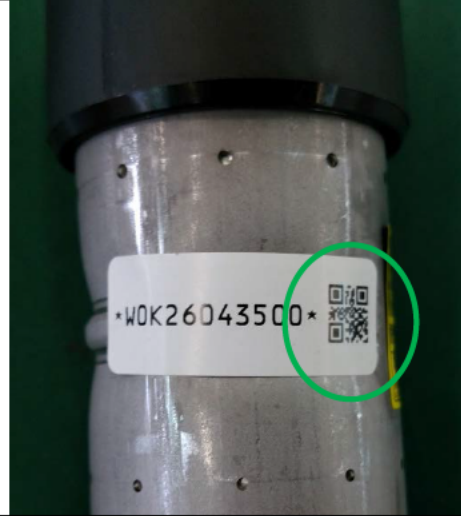
Step b) New Inflator (QR code)

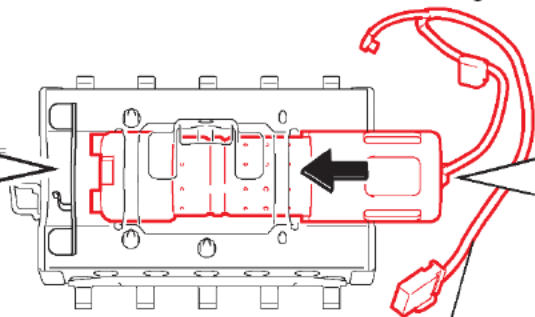
R1702270040

a) Carefully slide the new inflator into the airbag assembly and align as shown.

- **DO NOT** connect the inflator harness at this time. It is **CRITICAL** to first confirm that the inflator is installed in the correct position before connecting the harness.

**DO NOT** insert fully.

Check orientation

Upper side

Bottom

Instrument panel wire

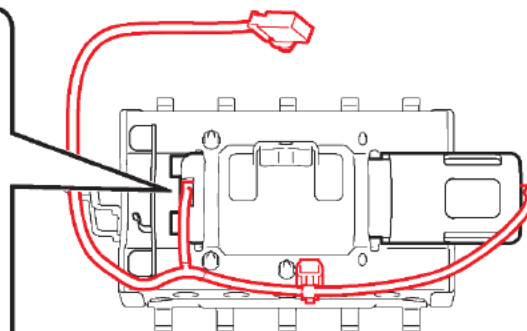
R1702270041

b) Connect the connector to the inflator and ensure that the connector lock is fully engaged as shown.

c) Route and secure the wire harness as shown.

**ALIGN CONNECTORS**

Wire Harness Side:

Inflator Side:

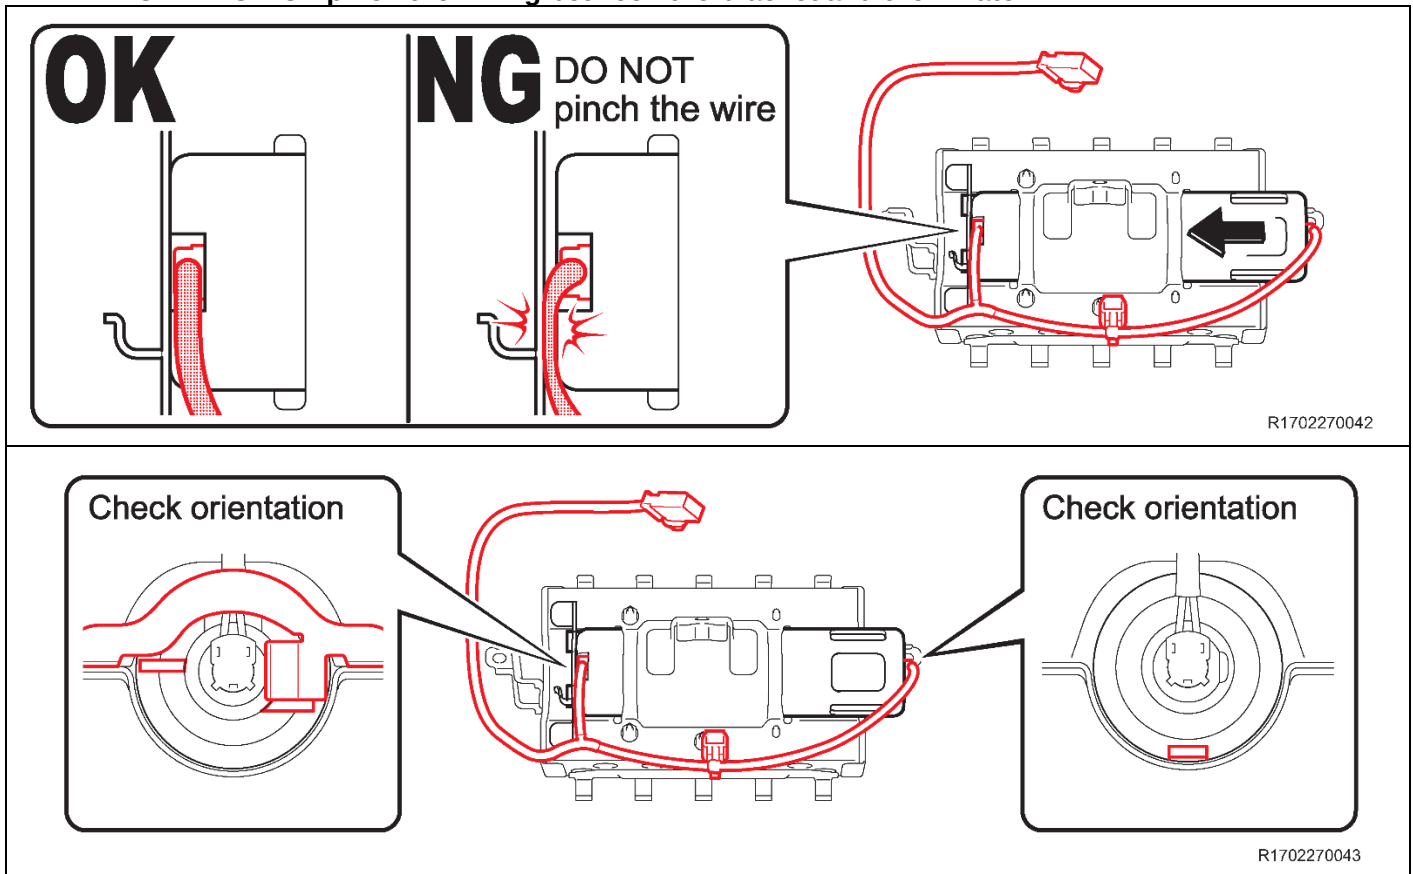
R1703080015

- d) Fully insert the inflator and ensure that the inflator is correctly oriented as shown.

**NOTE: DO NOT pinch the wiring between the bracket and the inflator.**

for MATRIX:

Install temporarily by hand.

**OK**

Install the plate so that there is no float

**NG**

DO NOT mistake the orientation of the plate

- e) Install the **NEW** stopper plate.  
f) Install 2 **NEW** nuts by hand.

**NOTE: Ensure that the stopper plate is the one from the bracket kit and installed in the correct orientation.**

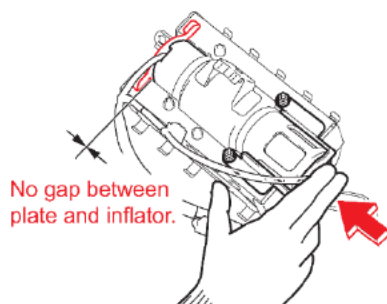
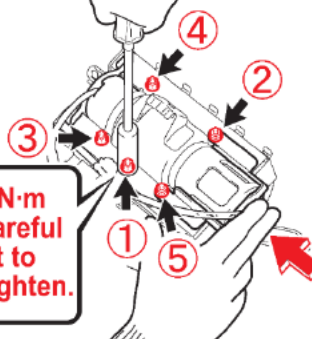
R1702270046

- a) Tighten the 5 nuts evenly in several increments in the sequence shown. Use a socket driver or torque wrench to tighten the nuts.

Torque: 35in. lbf (3.9N·m)

- There will be some resistance when tightening the nuts because they are self-locking, confirm the nuts are tightened correctly.
- **DO NOT** use a power tool, T-handle, or ratchet when tightening the nuts to avoid over torqueing and deforming the studs.
- You may need to turn the airbag to the left or right with in the mounting bracket to access the center nut.

**OK**

Socket Driver

**NG**

**These tools cause overtightening !**

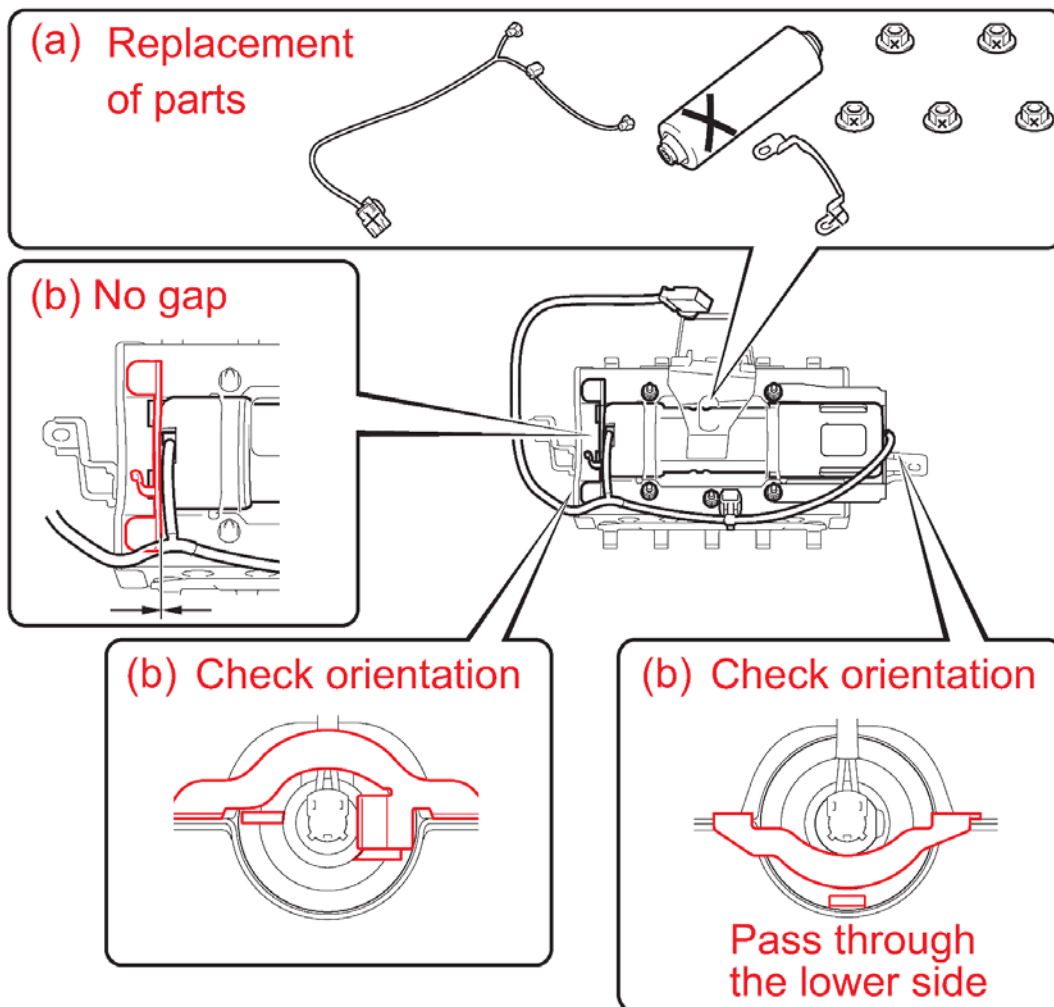
R1703080022

- a) Confirm the **NEW** inflator and 5 **NEW** nuts have been installed.
- b) Confirm the position of the inflator and position determining plates are correct.
- c) Confirm the routing of the inflator wire harness.
