TECHNICAL INSTRUCTIONS
FOR
SAFETY RECALL G0P
FRONT PASSENGER AIRBAG INFLATOR MODULE
CERTAIN 2008 – 2009 MY SCION xB

II. BACKGROUND

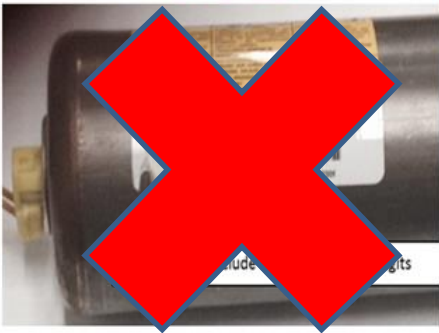
The Inflator serial code is an 11 digit code on the Inflator can. It can be found with a bar code on removing the Inflator can from the Airbag Assembly unit.

The first two characters of the Original Inflator Serial code will be from [AA, AB, AJ, FD or JD].

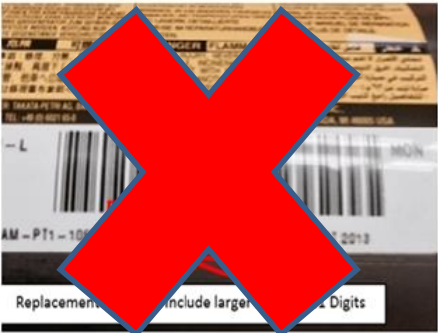
The first two characters of the Replacement Inflator Serial code will be either 'LT' or 'LR'.
