# TECHNICAL INSTRUCTIONS FOR SAFETY RECALL G0R FRONT PASSENGER AIRBAG INFLATOR MODULE CERTAIN 2008 - 2010 MY SCION xB

**UPDATED 4-18-2018**

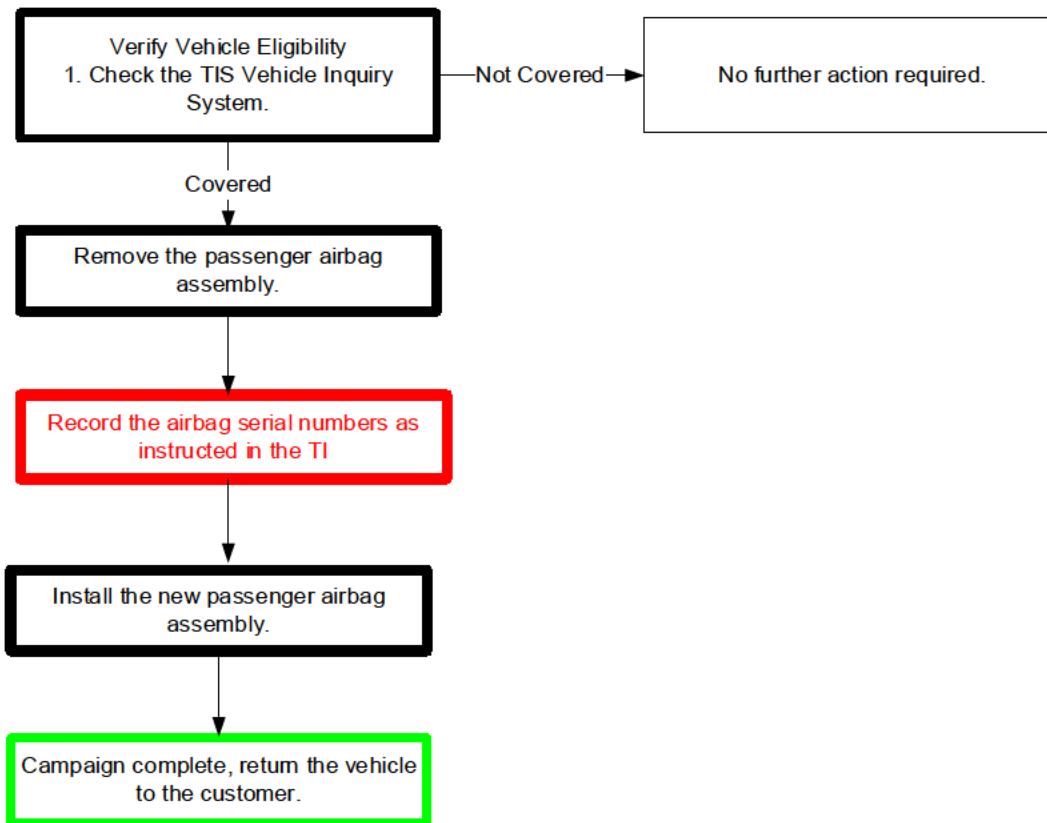
## I. OPERATION FLOW CHART

The flow chart is for reference only. **DO NOT** use it in place of the full technical instructions. Follow **ALL** steps as outlined in the full technical instructions to confirm the campaign is completed correctly.

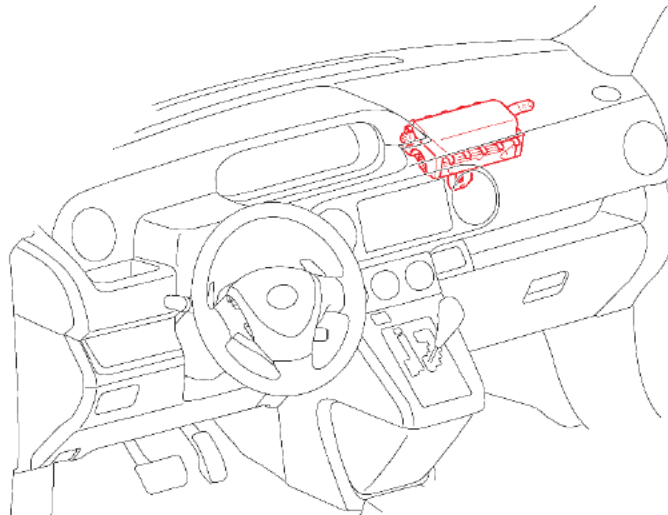
C162294

The subject vehicles are equipped with front passenger airbag inflators produced by Takata. According to Takata, the propellant in these inflators may degrade after prolonged exposure to high absolute humidity and fluctuating high temperatures. Degraded propellant can cause inflator rupture during airbag deployment. In the event of an inflator rupture, metal fragments could pass through the airbag cushion material, striking the vehicle occupants, and result in serious injury or death.

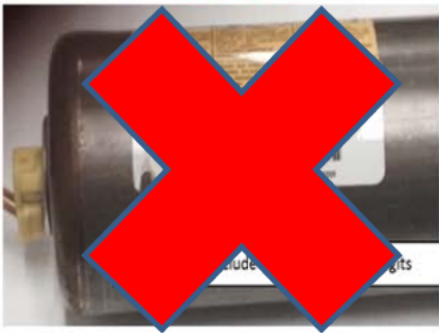
**Original Inflator**

The Inflator serial code is an 11 digit code on the Inflator can. It can be found with a bar code on removing the Inflator can from the Airbag Assembly unit.

The first two characters of the Original Inflator Serial code will be from [AA, AB, AJ, FD or JD].

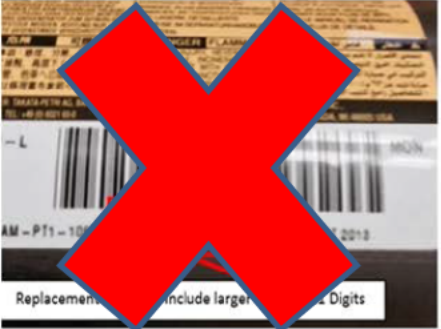
**Replacement Inflator**

The first two characters of the Replacement Inflator Serial code will be either 'LT' or 'LR'.

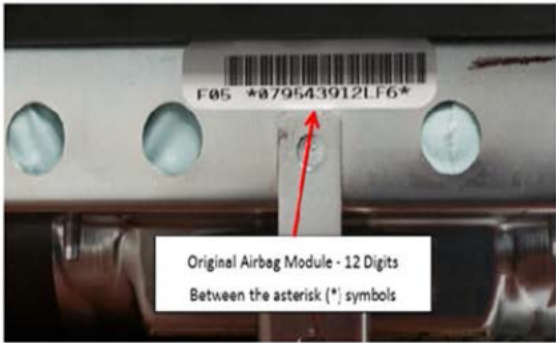
a) If the airbag serial number cannot be scanned or is not present check the box as shown below.

Original Airbag Module - 12 Digits  
Between the asterisk (\*) symbols

Check this box if the label is damaged or missing

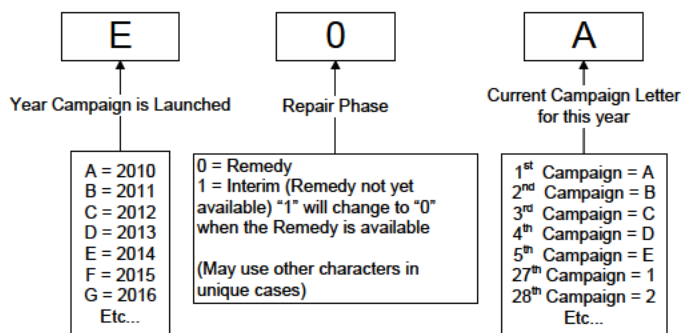
### A. CAMPAIGN DESIGNATION DECODER

Examples:

A0D = Launched in 2010, Remedy Phase, 4<sup>th</sup> Campaign Launched in 2010

B1E = Launched in 2011, Interim Phase, 5<sup>th</sup> Campaign Launched in 2011

C1C = Launched in 2012, Interim Phase, 3<sup>rd</sup> Campaign Launched in 2012
