## TECHNICAL INSTRUCTIONS FOR SAFETY RECALL G0P FRONT PASSENGER AIRBAG INFLATOR CERTAIN 2008 – 2013 MY SCION xB

**Updated 7-17-2018**

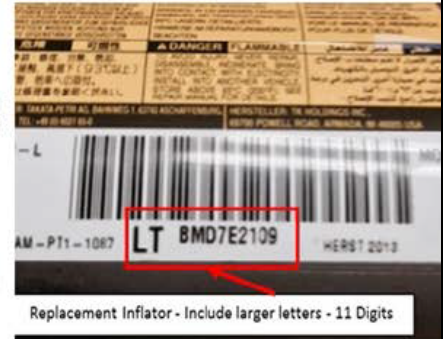
### Replacement Inflator

The first two characters of the **Replacement Inflator Serial code** will be either 'LT' or 'LR'.
