## TECHNICAL INSTRUCTIONS FOR SAFETY RECALL G0P FRONT PASSENGER AIRBAG INFLATOR MODULE CERTAIN 2010-2013 MY 4Runner

### UPDATE 4-18-18

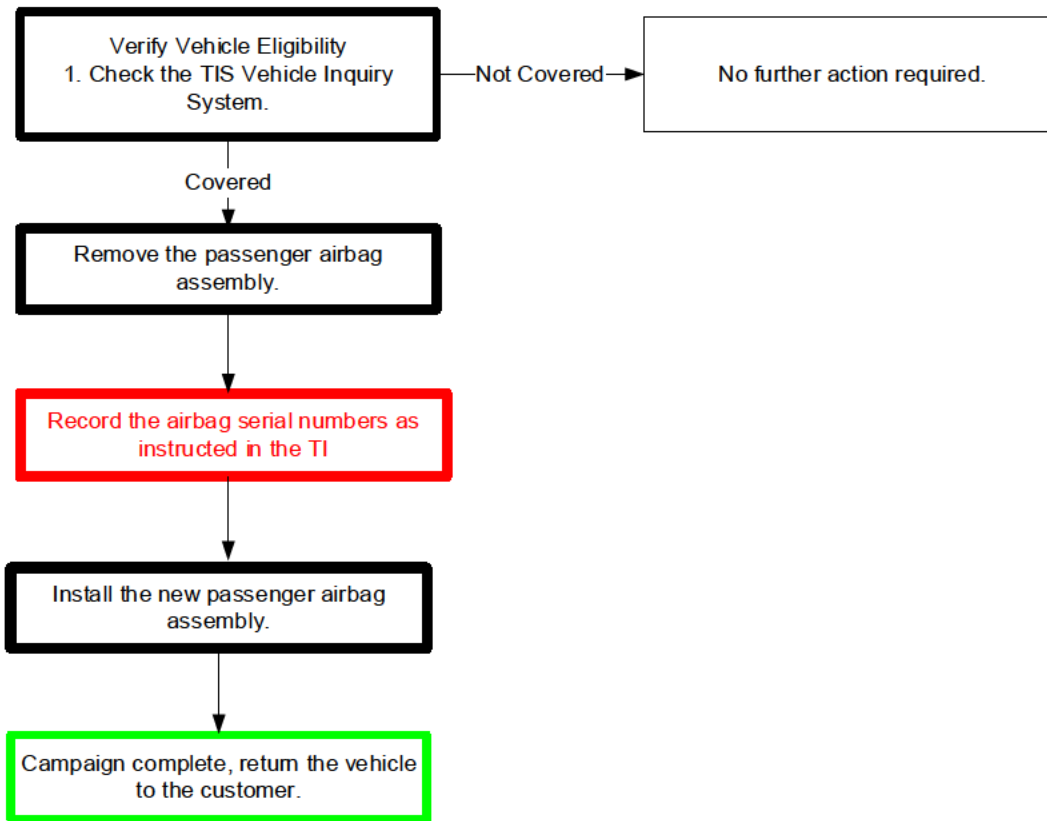
## I. OPERATION FLOW CHART

The flow chart is for reference only. **DO NOT** use it in place of the full technical instructions. Follow **ALL** steps as outlined in the full technical instructions to confirm the campaign is completed correctly.

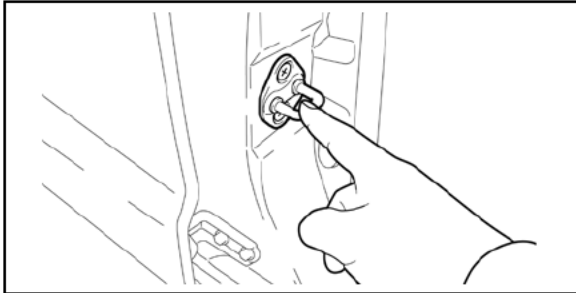
#### 1. ELIMINATE STATIC ELECTRICITY

- Before starting work and periodically while working on the vehicle, touch a metallic part of the vehicle to discharge static electricity in the body.

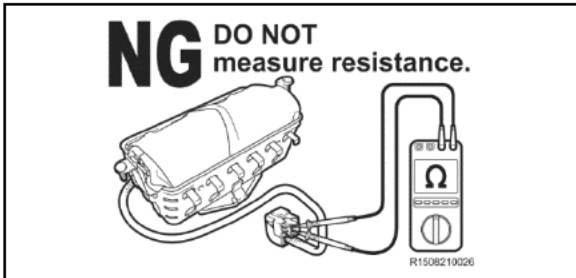
#### 2. DO NOT MEASURE RESISTANCE

- DO NOT** measure resistance of airbag components, this may cause accidental activation.

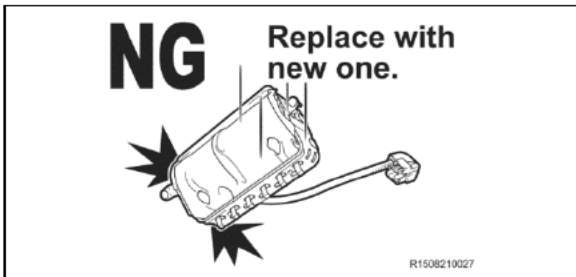
#### 3. HANDLE THE AIRBAG CAREFULLY

- If an airbag is dropped, replace it with a **NEW** one.

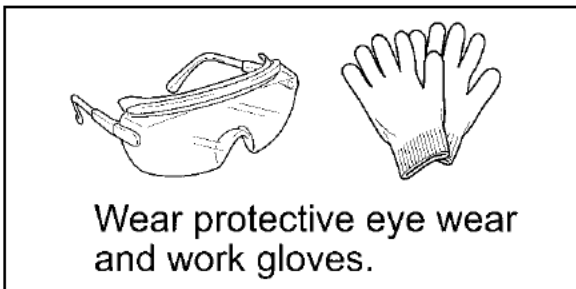
#### 4. WEAR PROTECTIVE EQUIPMENT

- Always wear appropriate protective equipment when working on the SRS.

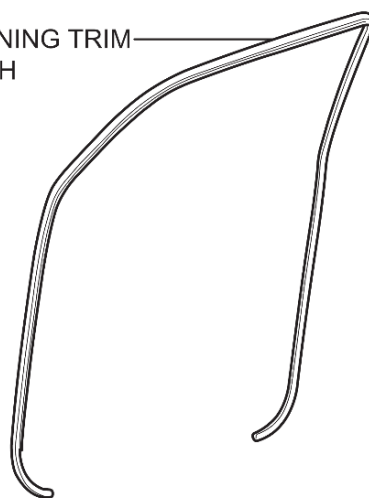
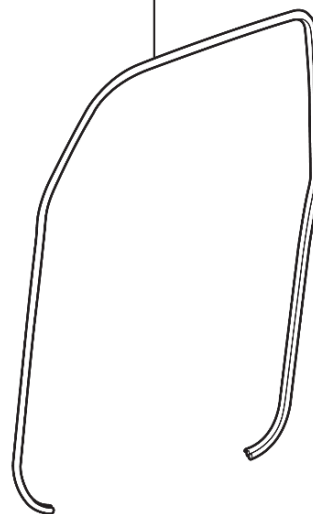
R1703160011

Part manufactured  
before August 2013:

Part manufactured  
after August 2013:

● FRONT PILLAR  
GARNISH LH

No. 1 FRONT PILLAR  
GARNISH COVER LH

FRONT PILLAR  
GARNISH LH

FRONT DOOR OPENING TRIM  
WEATHERSTRIP LH

COWL SIDE TRIM BOARD LH

DOOR SCUFF PLATE ASSEMBLY LH

● Replacement part

\*The left front A-Pillar garnish needs to be replaced on vehicles manufactured prior to August 2013. Only one garnish is required per vehicle depending upon color code. The kit contains the garnish and the non-reusable clip.

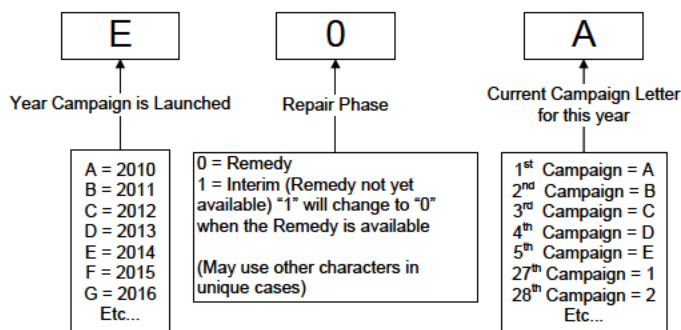
### A. CAMPAIGN DESIGNATION DECODER

Examples:

A0D = Launched in 2010, Remedy Phase, 4<sup>th</sup> Campaign Launched in 2010

B1E = Launched in 2011, Interim Phase, 5<sup>th</sup> Campaign Launched in 2011

C1C = Launched in 2012, Interim Phase, 3<sup>rd</sup> Campaign Launched in 2012
