December 7, 2018

Version 4

Safety Recall: Front Passenger's Airbag Inflator Can Be Over-Pressurized (Phase 1)

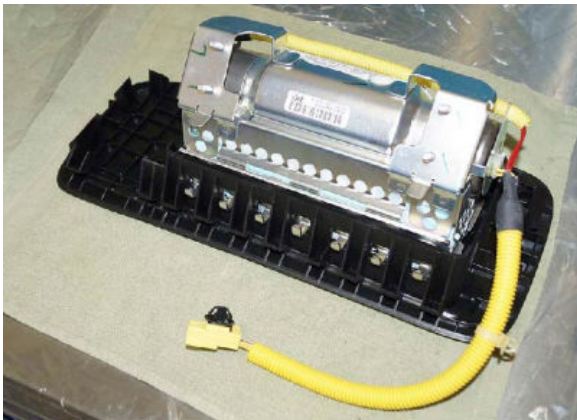
4. Place the airbag, face-down, on a clean shop towel.

- The orientation of the airbag is critical because if the inflator is installed incorrectly, the harness will be too short when you reinstall the airbag.
- The brackets between the various models are similar but may differ from the example shown.

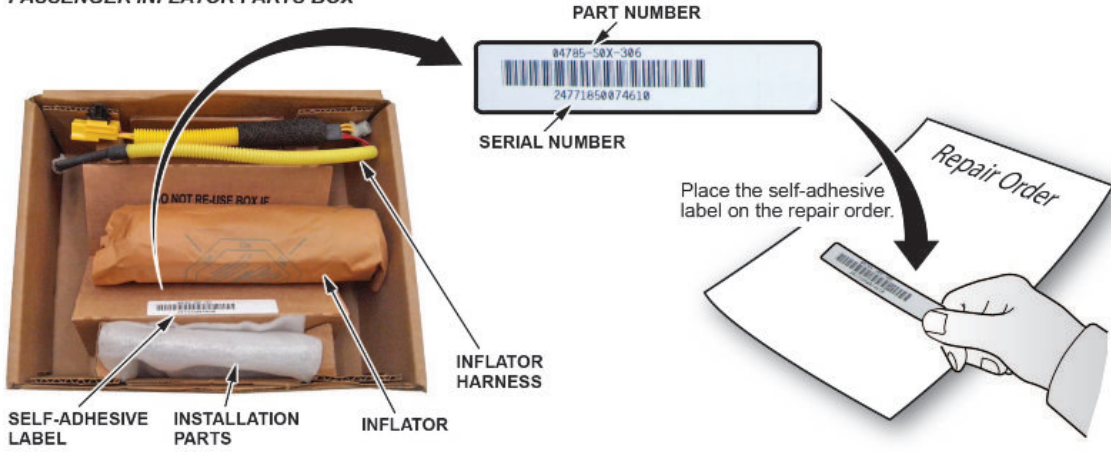
PASSENGER INFLATOR PARTS BOX

- The replacement part number is printed on the top part of the label and the serial number is printed on the bottom. **Make sure you attach the label to the RO and give it to the warranty clerk**.
- There may also be a colored sticker located in the kit, ignore it because it is not used.

- Not all inflator kits have a label included. In those cases, write the serial number and part number from the side of the inflator box on the RO. The part number always starts with 047.

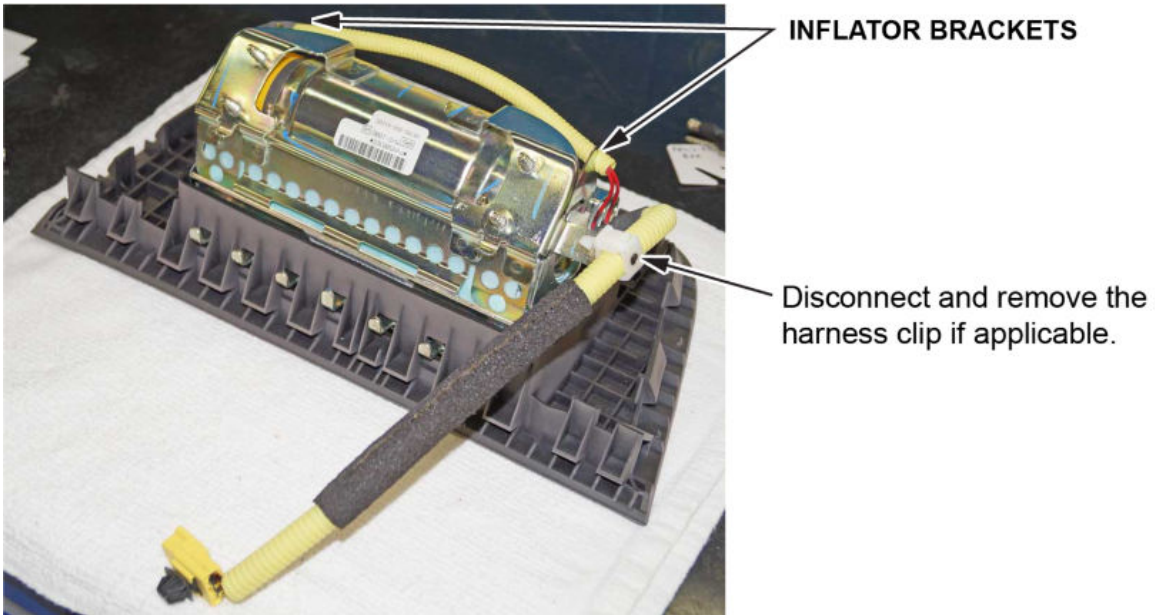
7. Remove the harness from both ends of the inflator bracket.

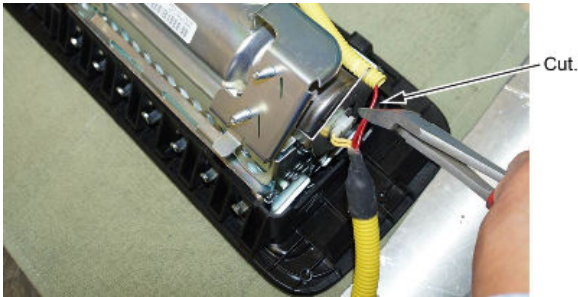
8.1. Cut the red wires as shown.

You must cut and short the wires as indicated to prevent accidental deployment.

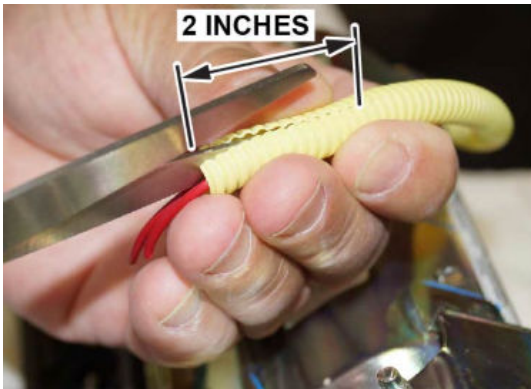
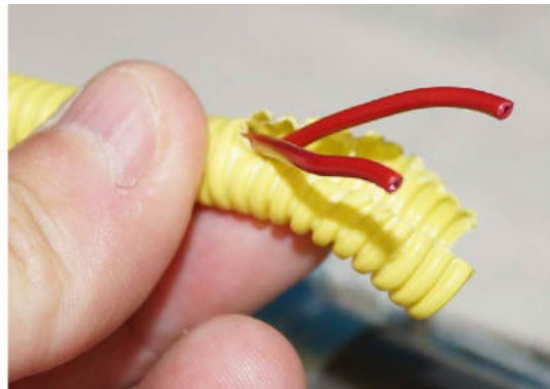
8.2. Cut about 2 inches of the corrugated tube, then pull out the two red wires.

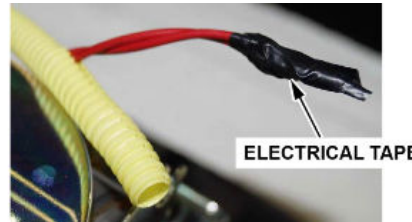
8.3. Strip away about 1 inch of the wire insulation, then twist the wires together.

8.4. Tape the twisted ends with electrical tape.

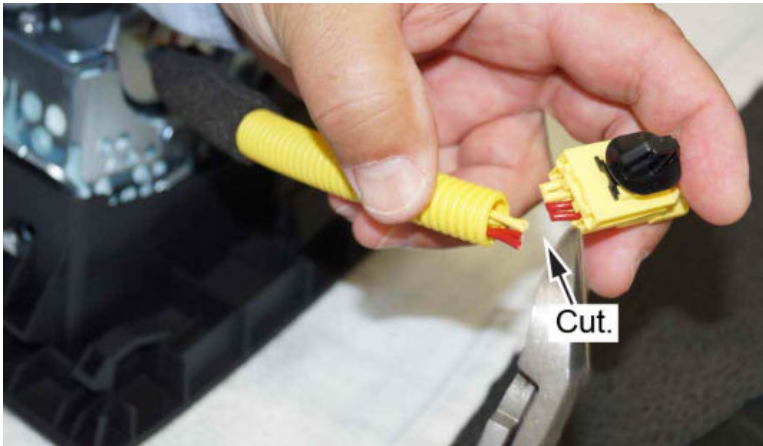
9.1. Cut all four wires to remove the connector.

You must cut and short the wires as indicated to prevent accidental deployment.

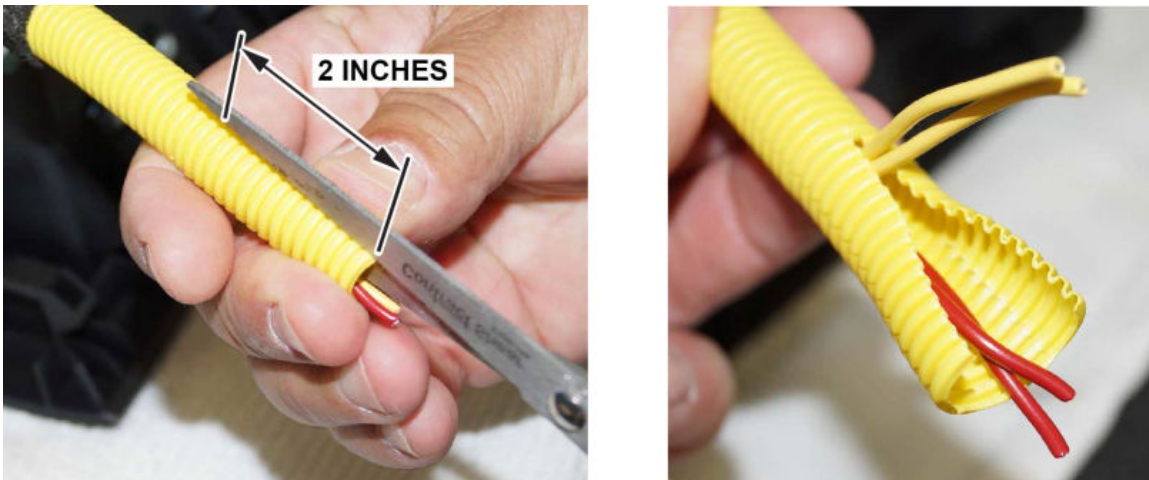
9.2. Cut about 2 inches of the corrugated tube, then pull out the yellow wires.

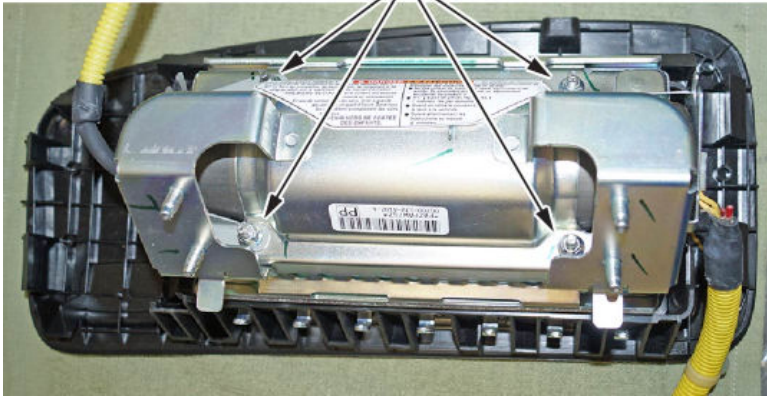
INFLATOR NUTS

10. Remove the four inflator nuts.

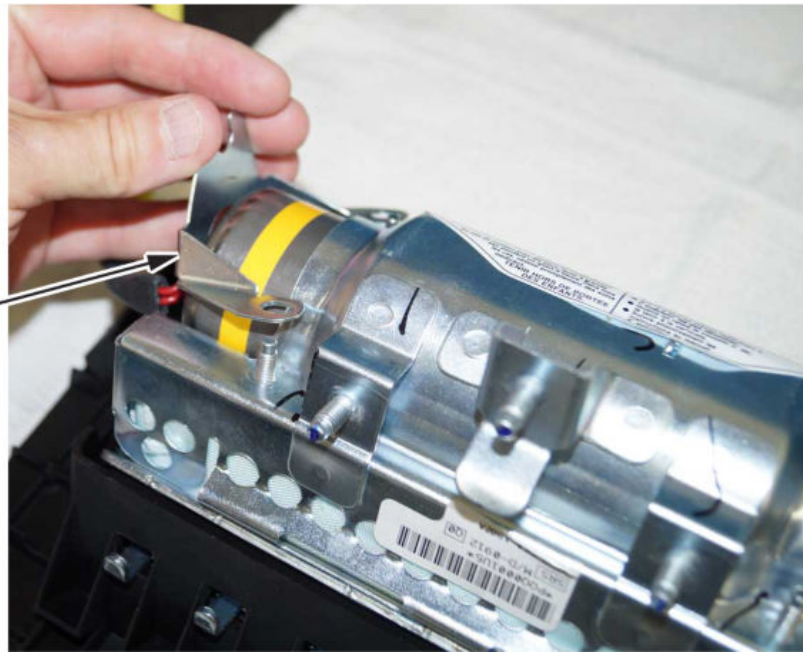
INFLATOR BRACKET

11. Remove the inflator bracket.

You can only remove one of the brackets, as the other is welded to the airbag housing.

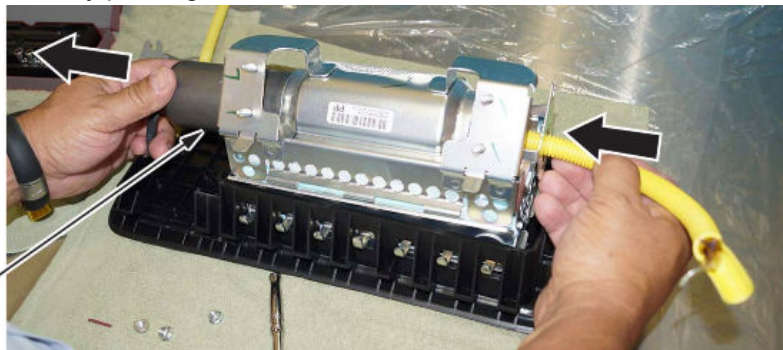
INFLATOR
Do not reuse.

12. Remove the inflator by pushing it out.

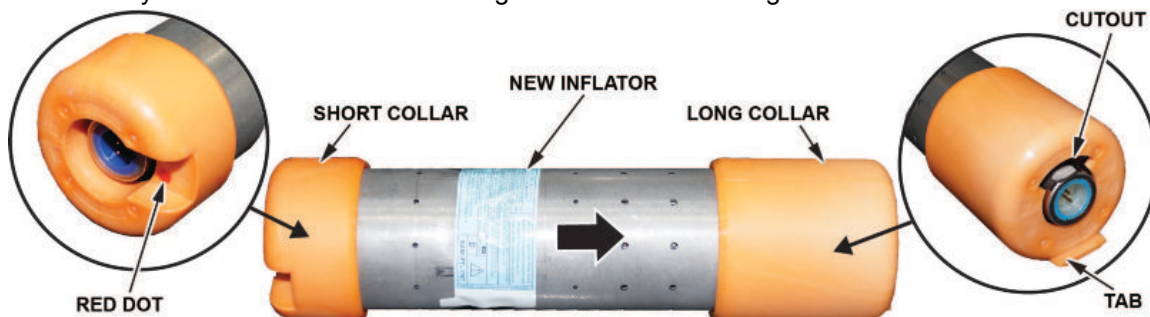
13.2. Collars on this inflator are orange, not white. One side of the inflator has a longer collar, a tab, a plastic cutout, and a small flat spot on the connector. The other side of the inflator has a shorter collar, no tab, and a red dot. Make sure you insert the end with the longer collar into the airbag first.

(Part numbers ending with 315, 316, 317, and 325 appears slightly different.)

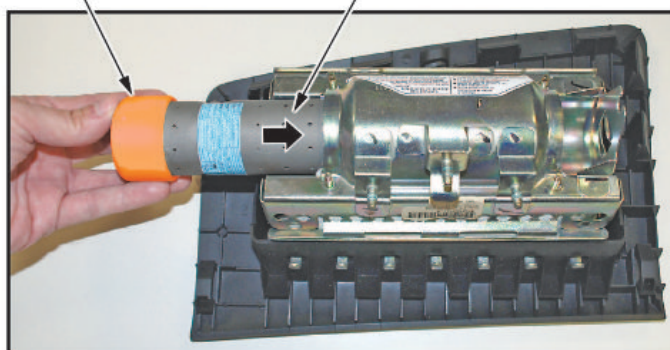
SHORT COLLAR The inflator installation is directional.

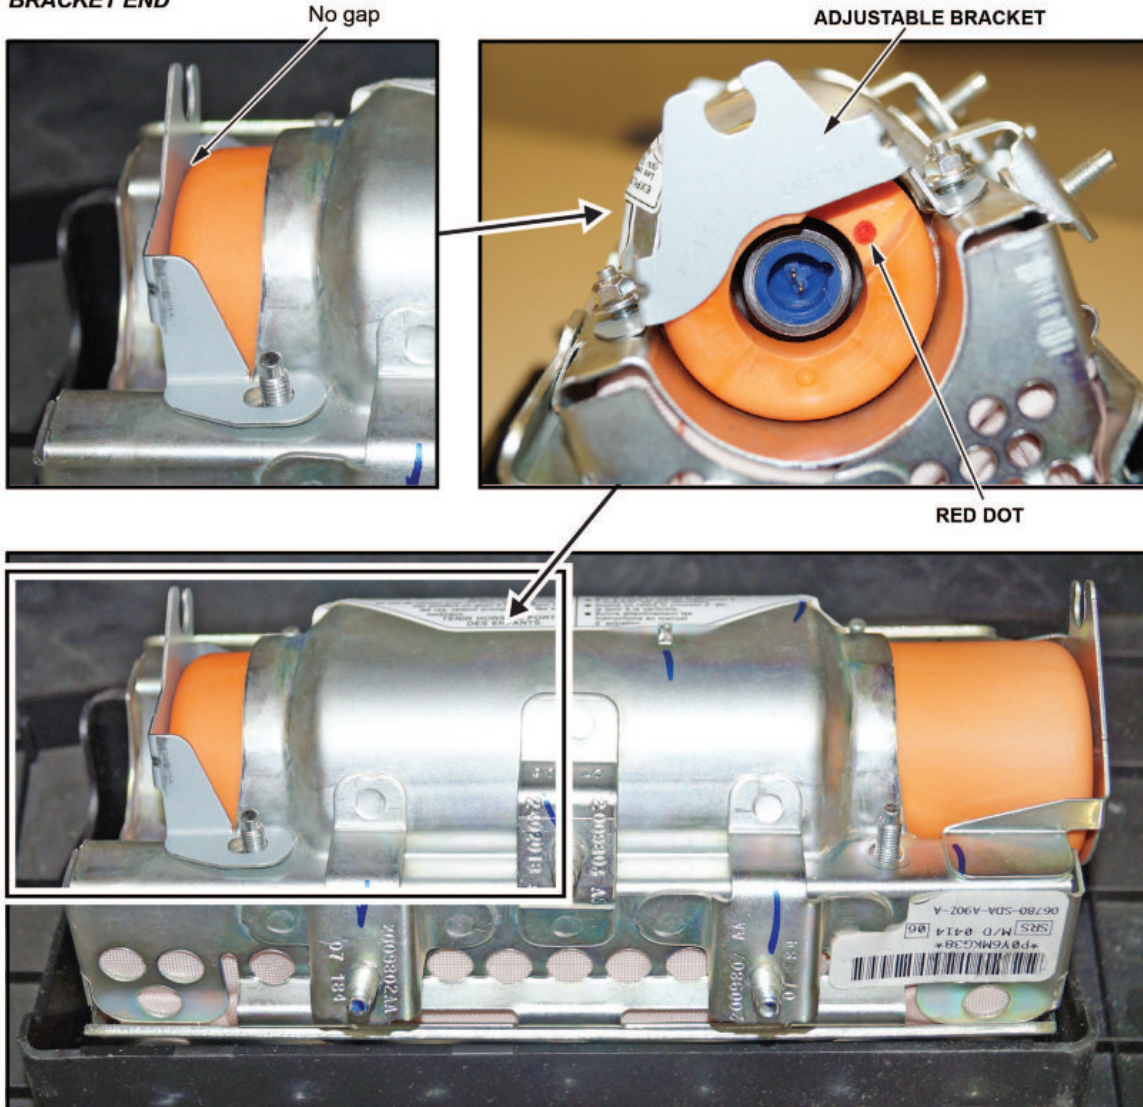
**ADJUSTABLE
BRACKET END**

13.4. Install the bracket included in the kit onto the airbag module. There should be a red dot visible on the end of the plastic connector. There should be no space or gap between the inflator and bracket.

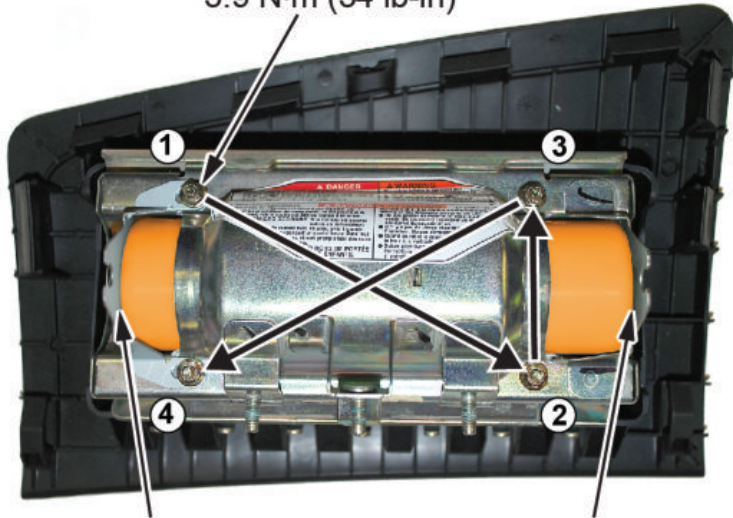
LOCK NUTS (4)
3.9 N•m (34 lb-in)

14. Install the new 5 mm locknuts and torque them in sequence to **3.9 N•m (34 lb-in)** .

Be sure there are no gaps between the inflator ends and the inflator brackets

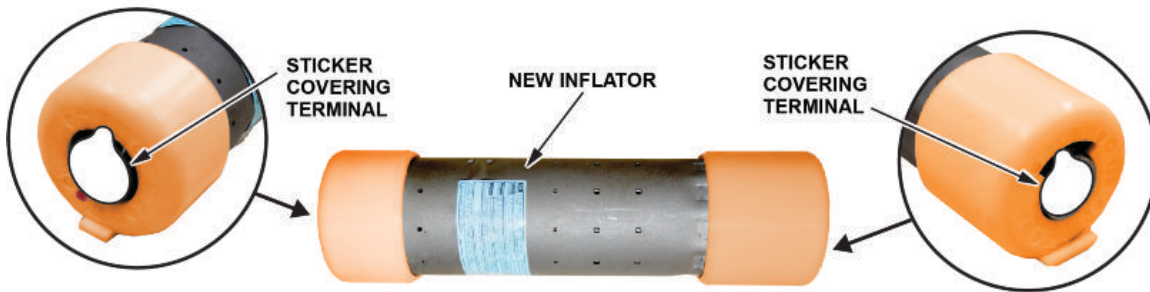
15. Remove the stickers covering the terminals on both sides of the new inflator.

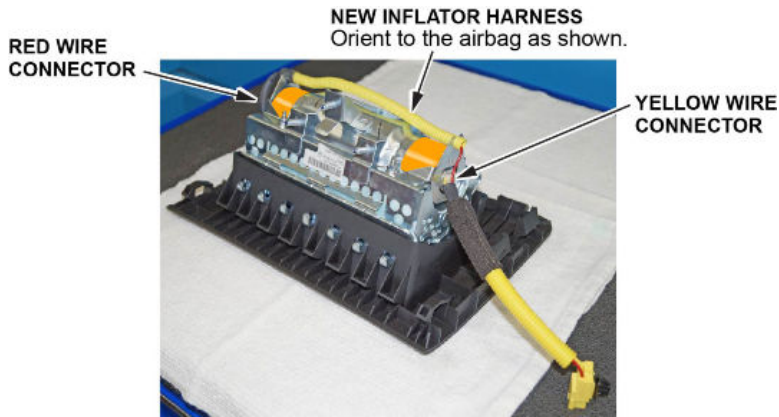
16.1. Make sure the airbag and harness are aligned as shown.

- **Make sure you have the orientation correct as shown below.** If you connect the harness incorrectly, the harness cannot be removed, and you will not be able to reinstall the airbag because the harness will be too short.
- Connect the red wire connector to the connector with the red dot.

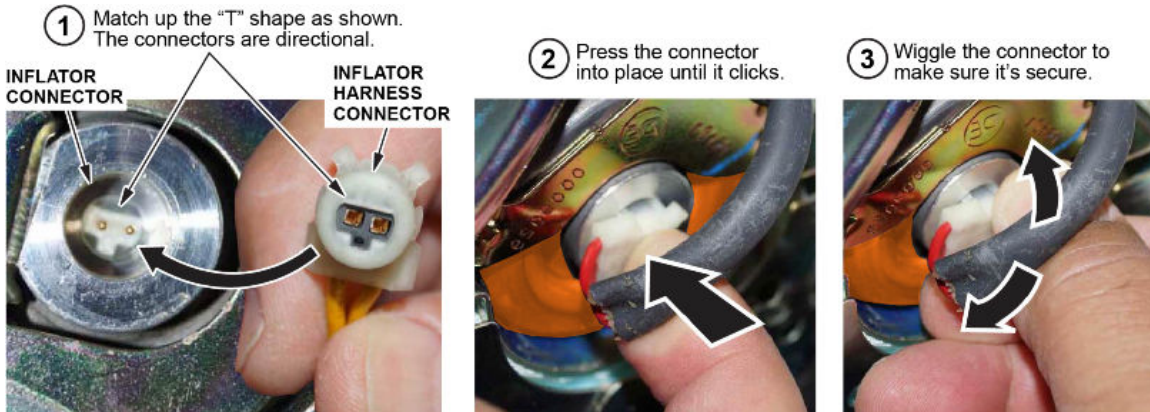
16.2. Connect the two connectors. Align the "T" shape in the inflator harness connector with the T-shaped inflator connector, then press the connector into place.

16.3. After you hear each connector click, wiggle it to make sure it is secure.

If the connector is not properly aligned, it will come out.

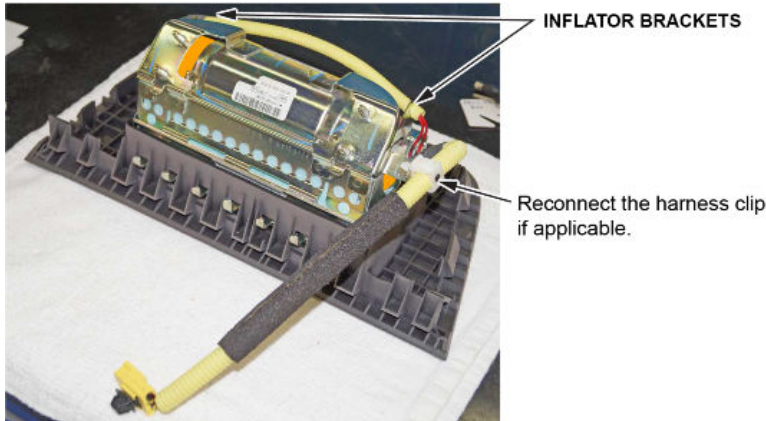
17.1. Insert the side without the shrink wrap tubing first. Insert the harness at the third “valley” in the corrugated tube.

17.2. Insert the side of the harness with the shrink wrap tubing into the inflator bracket. Make sure the harness is securely inserted and that it does not sag.

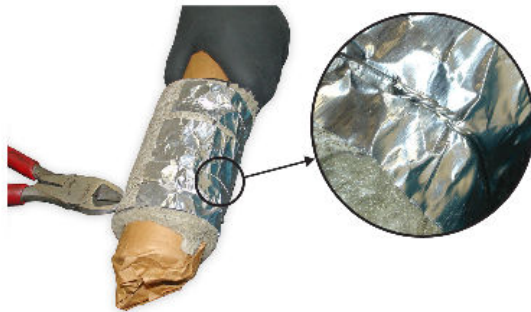
- Wear disposable gloves and protective glasses. The insulation is not toxic or dangerous, but some people may be sensitive to the insulation.
 - Dispose of the insulation and wrapping paper to avoid getting the insulation dust/fibers on you or the airbag assembly.
 - Do not reuse the insulation or wrapping paper. You do not need to wrap the inflator being removed from the vehicle when it is returned.
1. Cut the wires off from the opposite side from where they are tied (twisted) together.

Do not cut the insulation.

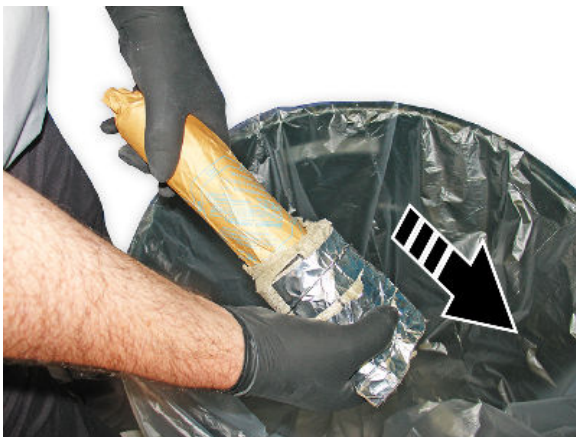
2. Hold the paper wrapping the inflator with one hand and slide the insulation off into the trash.

The insulation is securely wrapped around the inflator. You may have to use some force to slide the insulation off. Do not cut the insulation and be careful that you do not move the white or orange plastic ends.

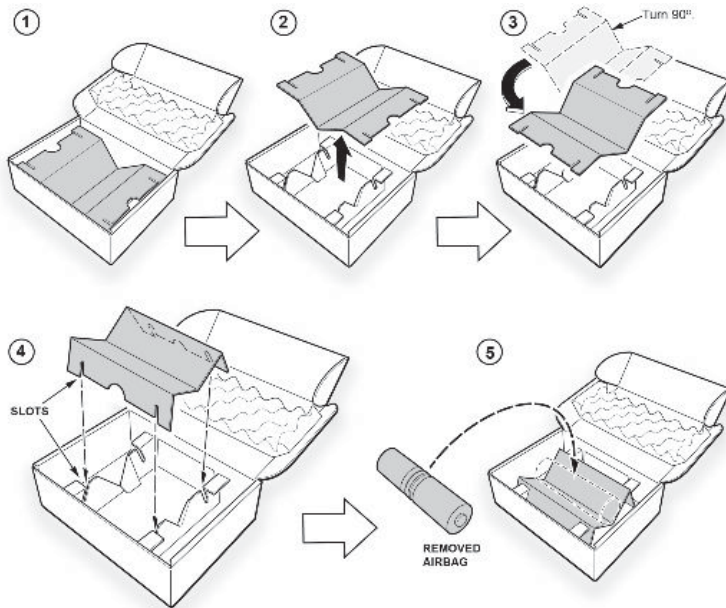
4. To return the original inflator, remove the cardboard insert and turn it 90 degrees. Then insert the cardboard into the slots as shown.

- **Do not reuse the shipping insulation.**
- The cardboard insert needs to be adjusted to send back the original inflator otherwise the original inflator removed from the vehicle will rattle around and may be rejected by the courier.

If the new inflator came with an insulated sleeve, make sure you change the orientation of the cardboard insert so that the original inflator doesn't rattle. See INSULATION REMOVAL for more information.
