September 4, 2019

Version 5

Safety Recall: Front Passenger's Airbag Inflator Can Be Over-Pressurized (Phase 1)

*Supersedes 16-028, dated December 7, 2018 to revise the information highlighted in **yellow**.*

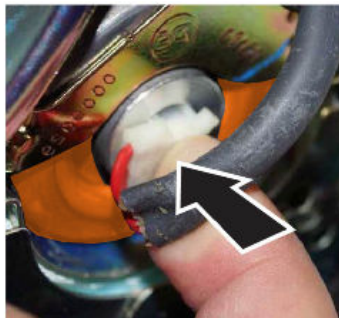
② Press the connector into place until it clicks.
