September 4, 2019

Version 8

## Safety Recall: Takata Front Passenger's Airbag Inflator (Phase 1)

Supersedes 16-029, dated December 7, 2018 to revise the information highlighted in **yellow**.

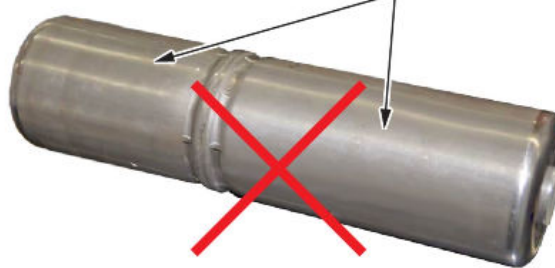
NO LABELS ON INFLATOR

- If there is nothing unusual about the airbag or the inflator, continue with the inflator replacement procedure.
- If there are any unusual markings, like an incorrect label or a model year written in marker, the airbag and inflator may not be the correct airbag and/or inflator for the vehicle or it may be a counterfeit part. For more information about counterfeit airbags, you can refer to [safercar.gov](http://safercar.gov), enter keywords **MANAGING COUNTERFEIT**, and select **Recommended Dealer Guidance for Managing Counterfeit Air Bags** from the list. **If you suspect that the airbag or inflator is counterfeit, do not continue this procedure.** Contact your DPSM for assistance

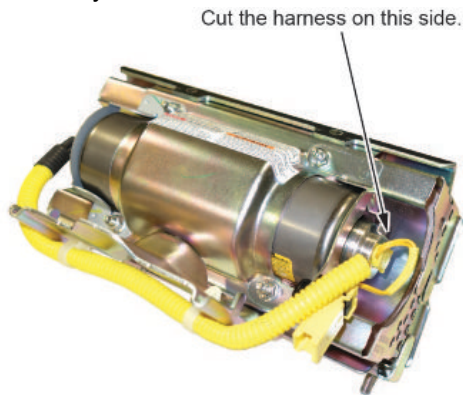
- **You must cut the yellow wires** for inflator removal and short the yellow wires on the inflator side as indicated to prevent accidental deployment.
- **Do not cut the red wires** because the airbag connector shorts these inflator wires.

- 8.1. Cut the yellow wires as shown.

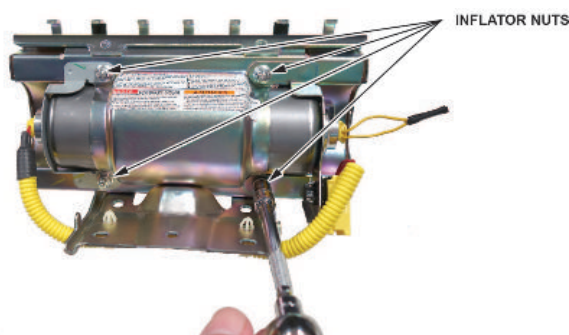
9. Remove the four inflator nuts.

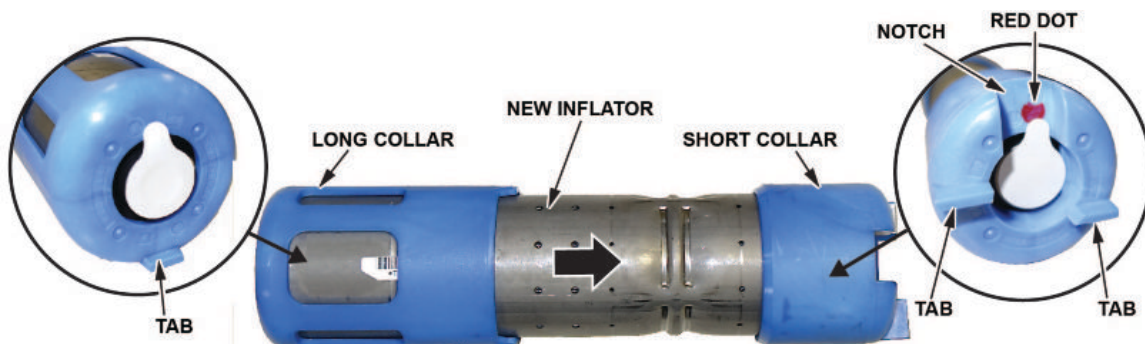
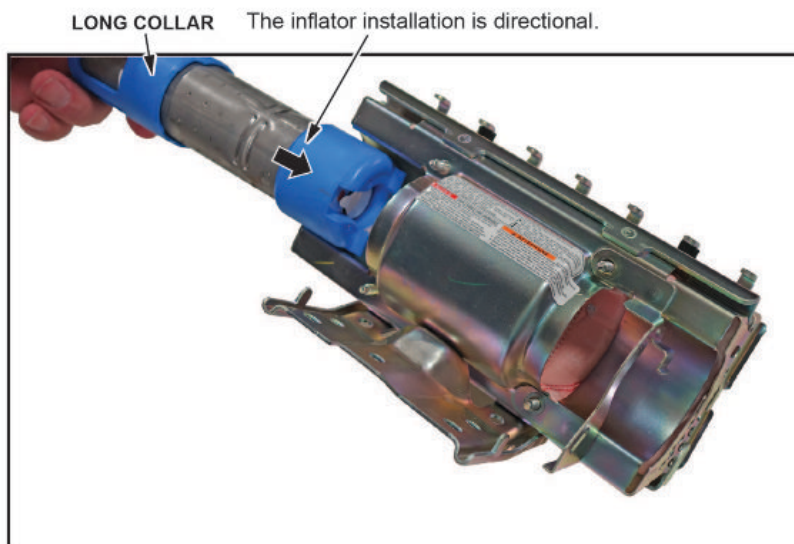
- The V-SMART tool can only validate inflators with slotted end caps. You may receive an inflator with solid end caps. This is the correct part to repair the vehicle, but the V-SMART will fail the validation. **The V-SMART validation must fail a total of three times** before you can have your supervisor override the validation using the **Supervisor Inspection Override**.
- Your supervisor can be a service manager, shop foreman, team leader, etc. **The supervisor must inspect your work** to make sure the replacement inflator was installed correctly. When a supervisor enters his or her information, **the supervisor is signing off that the technician's work was inspected and approved**.

- 12.2. Slide the inflator in until the plastic collar contacts the bracket. The two tabs should align with the side of the airbag module and the metal tab as shown. There should be no space or gap between the inflator and bracket.

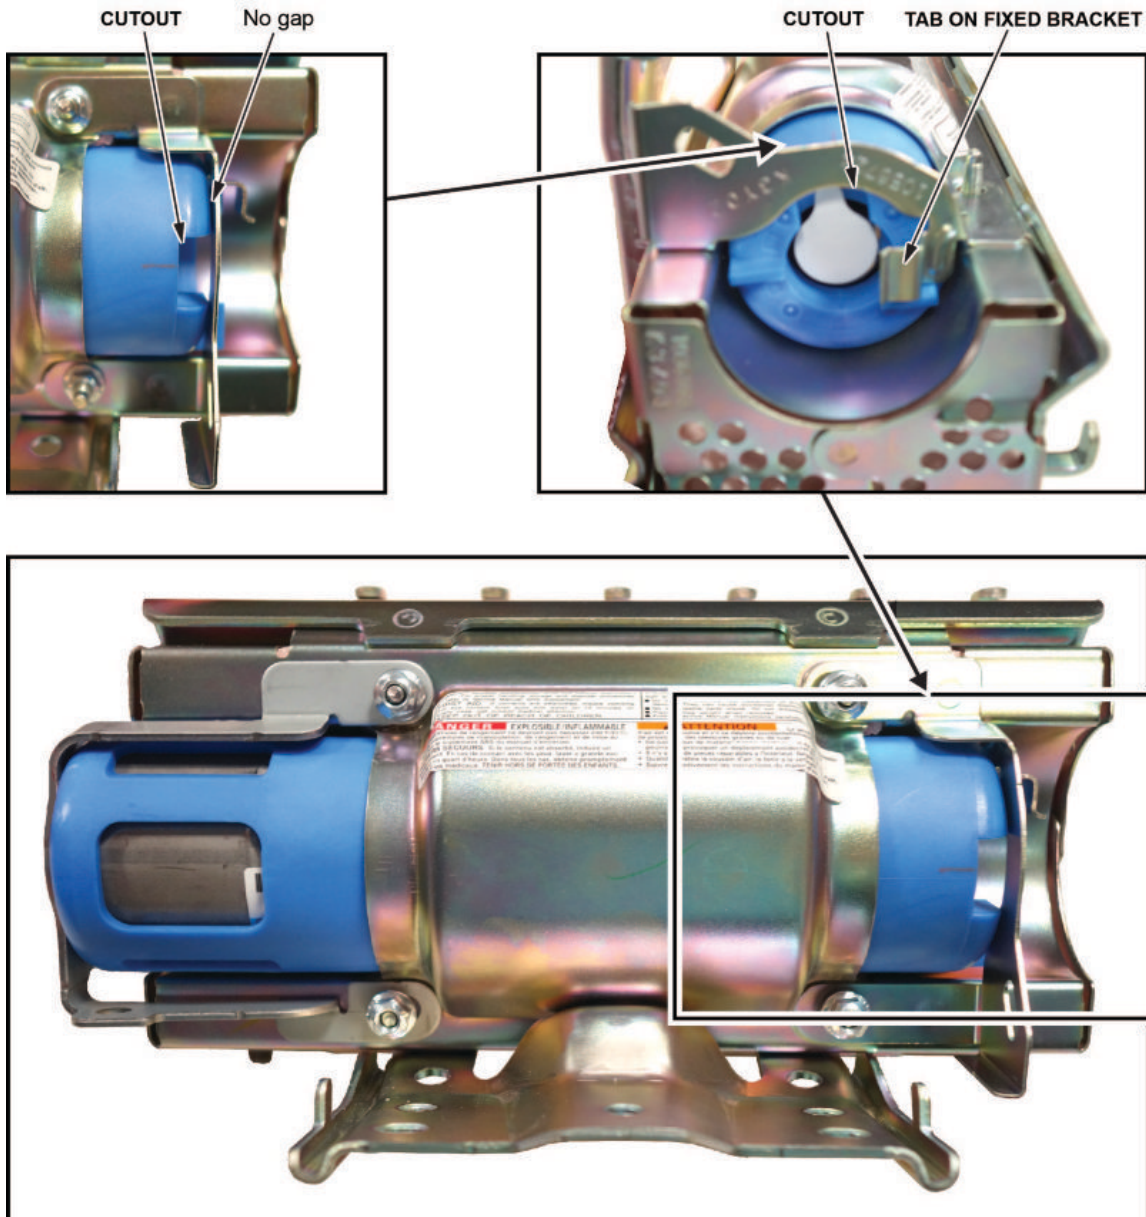
**FIXED BRACKET END**

- 12.3. Install the bracket included in the kit onto the airbag module. Check there is no space or gap between the inflator and bracket by pushing the bracket against the inflator.

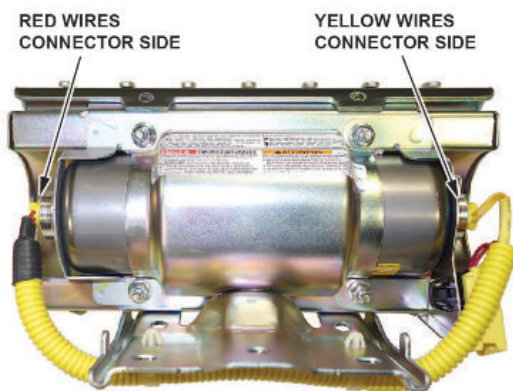
ORIGINAL INFLATOR HARNESS ROUTING

- **The replacement inflator harnesses have the wire colors in the opposite positions of the original harness.** If you connect the harness incorrectly, the harness cannot be removed and you will not be able to reinstall the airbag because the harness will be too short.
- Connect the red wire connector to the side of the inflator with the red dot.
- The red dot may be difficult to see because of the bracket.

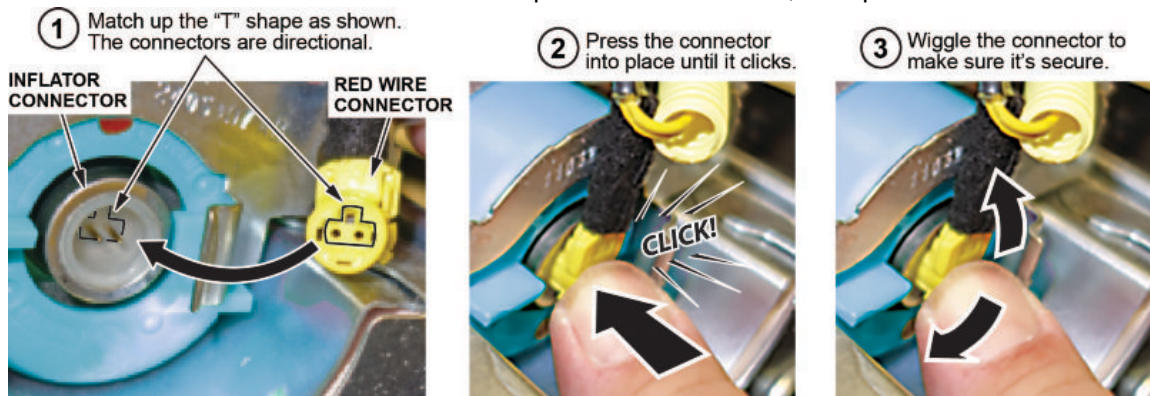
16.2. Connect the red wire connector to the connector on the side with the short plastic cap. Align the "T" shape in the inflator harness connector with the T-shaped inflator connector, then press the connector into place.

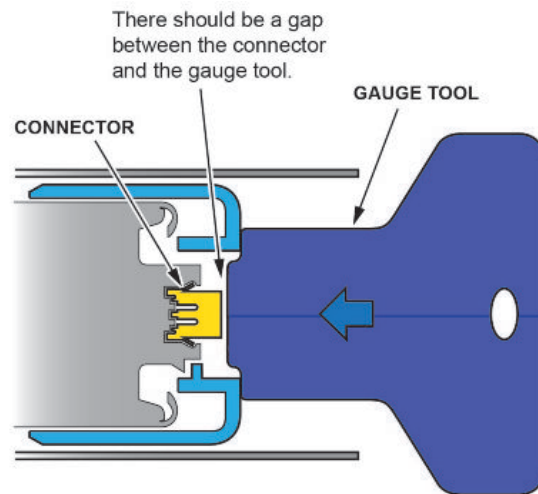
16.5. Make sure the connector is secure and in place by using the gauge tool. (PSPI6 Gauge Tool P/N: 070AJ-TA00A00 or 07AAJ-TA0AA00).

Be sure the connector is fully seated by checking it with the gauge tool.

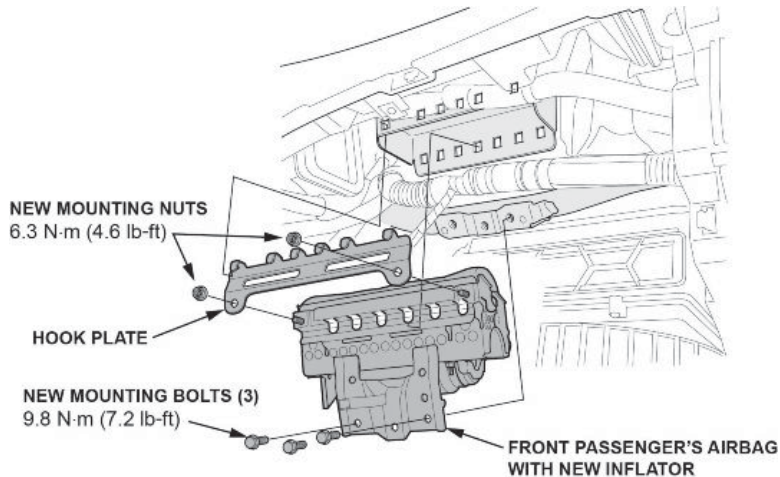
- 18.1. Place the front passenger's airbag into the dash panel. Install the hook plate and install the new mounting nuts and new mounting bolts finger tight.

Make sure the hooks are set properly.

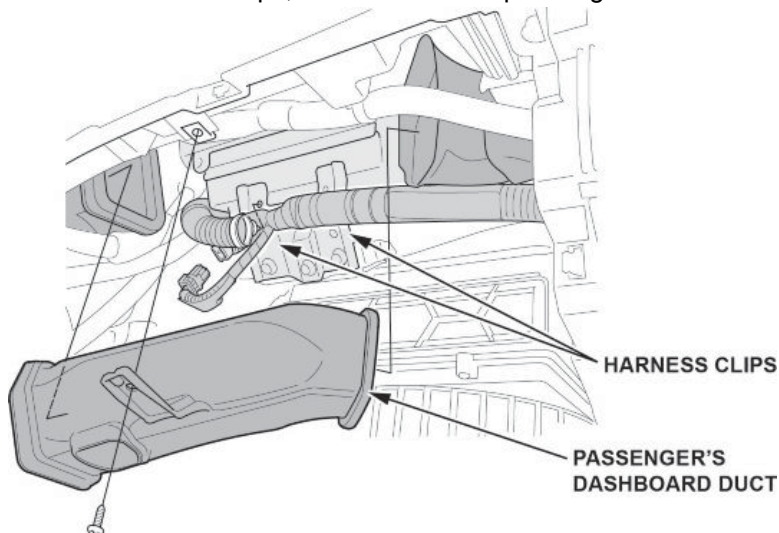
- 18.3. Install the harness clips, then reinstall the passenger's dashboard duct.

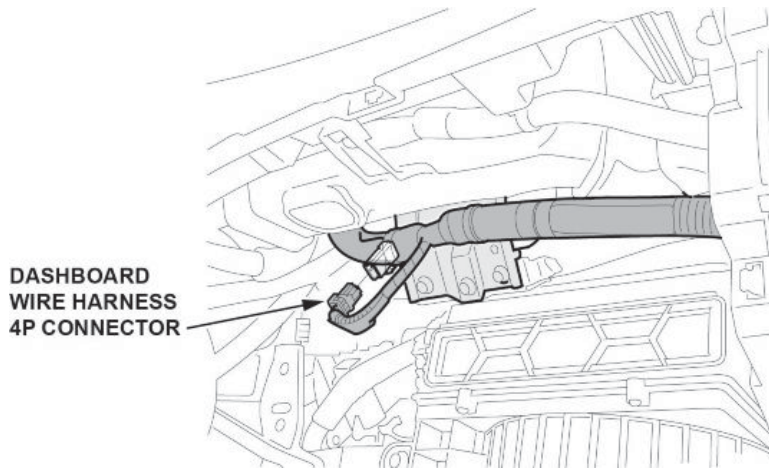
- 18.4. Connect the dashboard wire harness 4P connector to the front passenger's airbag, then reinstall the glove box.

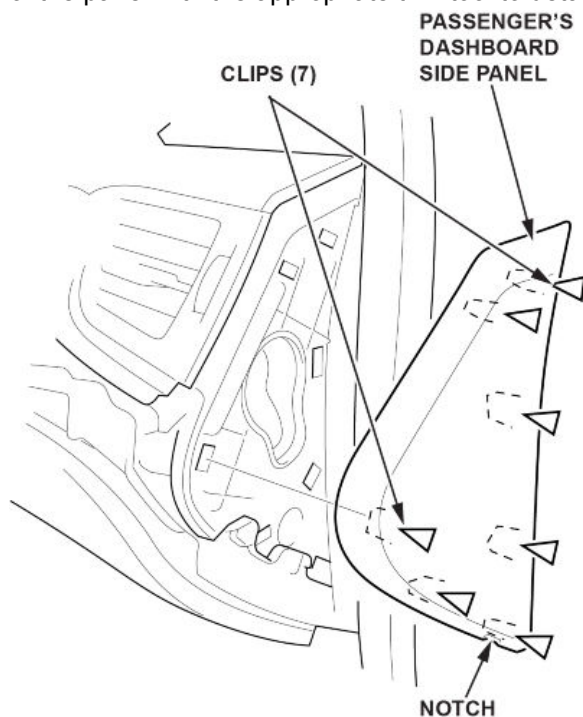
- 3.2.1. Remove the passenger's dashboard side panel by opening the door and then gently prying the notch of the panel with the appropriate trim tool to detach the clips.

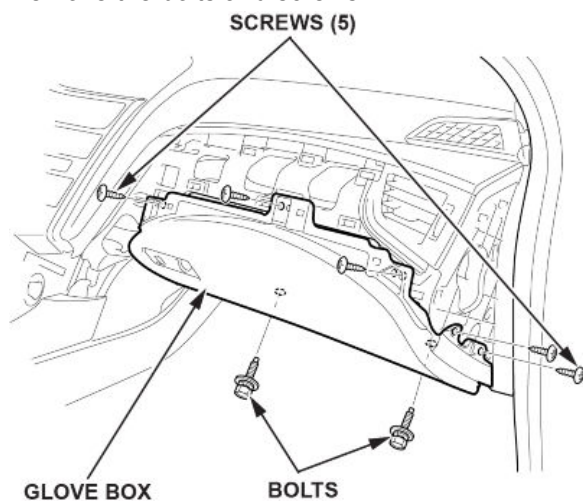
- 3.2.2. Remove the bolts and screws.

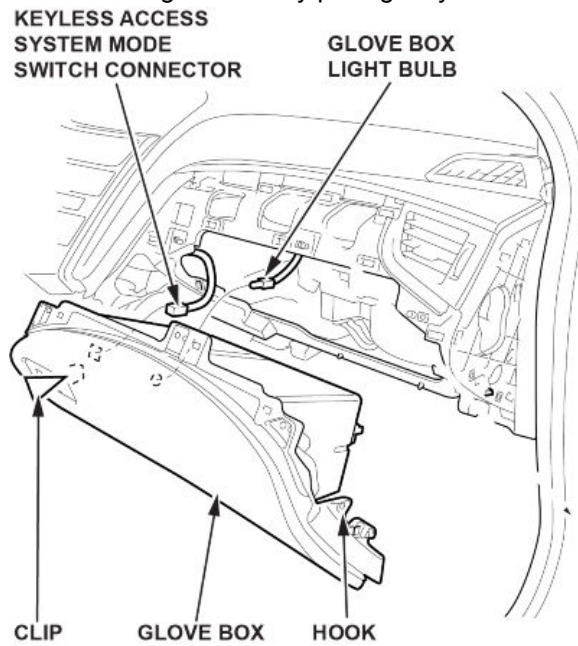
3.2.3. Remove the glove box by pulling it by hand to detach the clip.

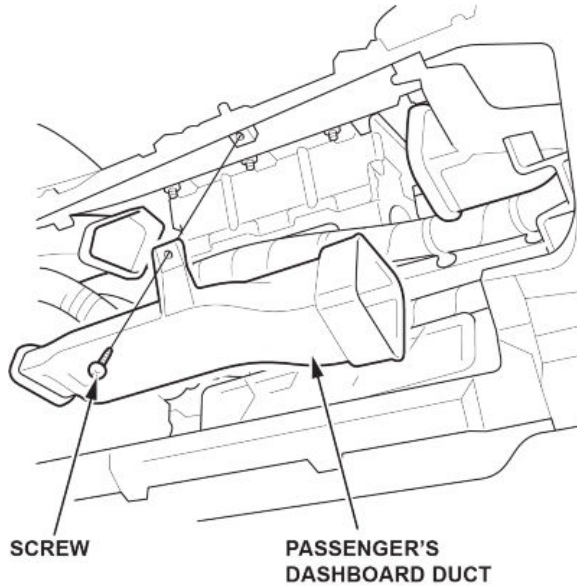
3.3. Remove the passenger's dashboard ducts by removing the screw.

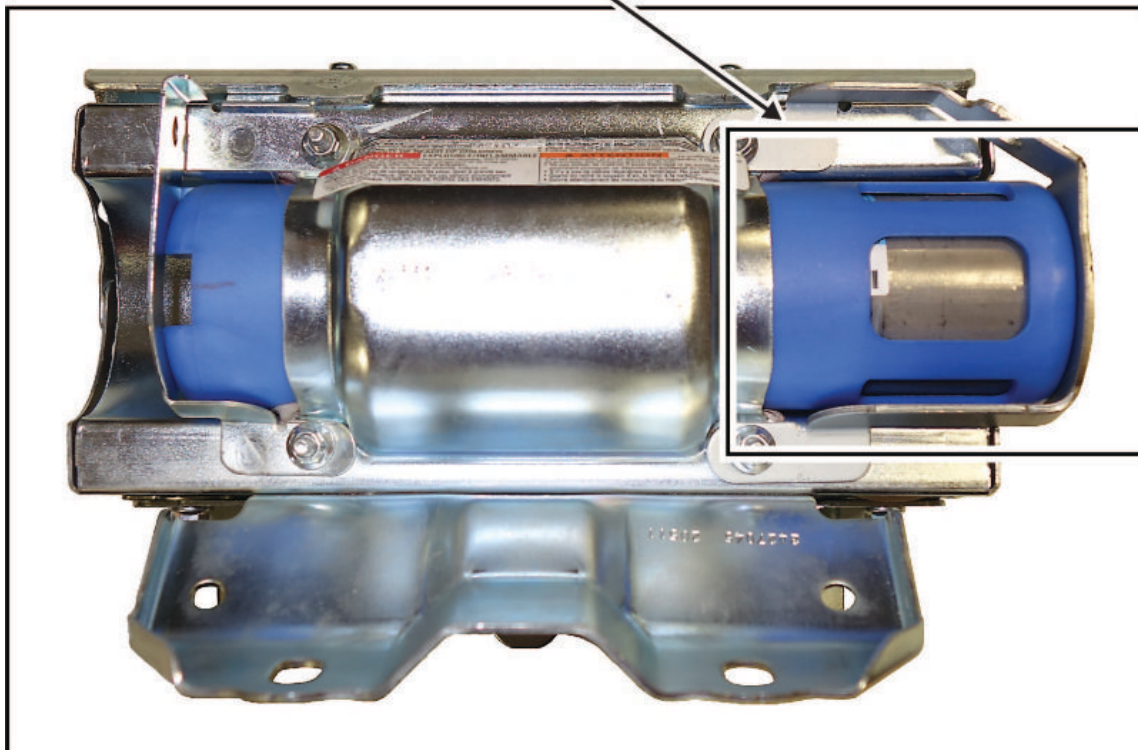
**FLAT SPOT ON PLUG SOCKET**

**TAB ON BRACKET**

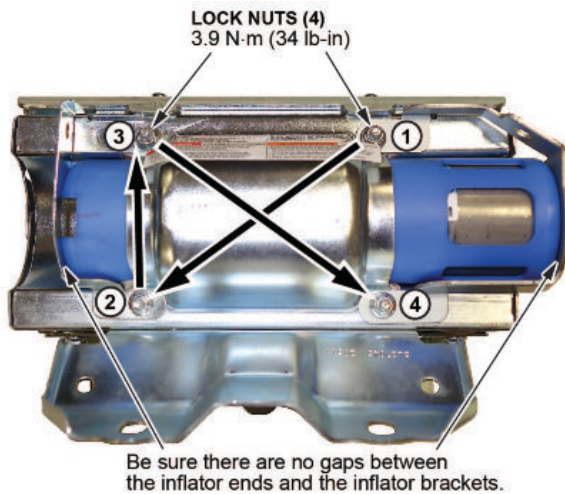
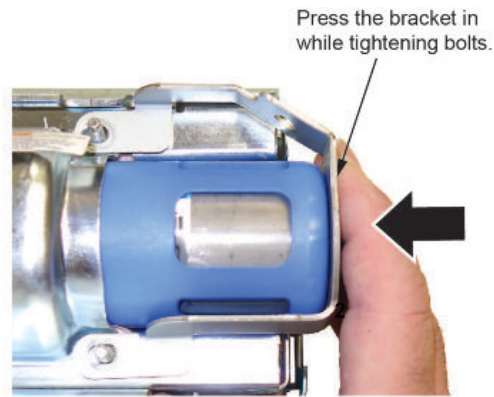
13. Hold the bracket against the inflator, then install the new 5 mm locknuts and torque them in sequence to **3.9 N•m (34 lb-in)** .

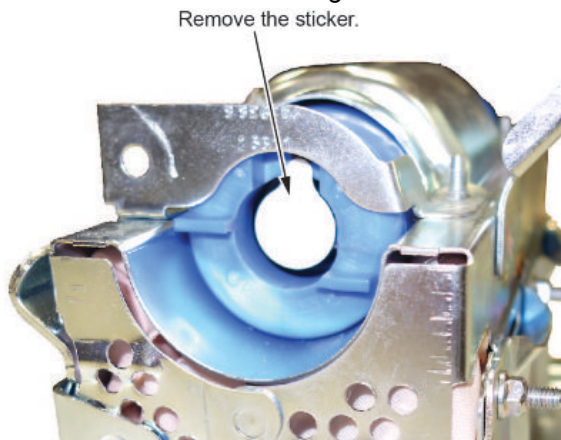
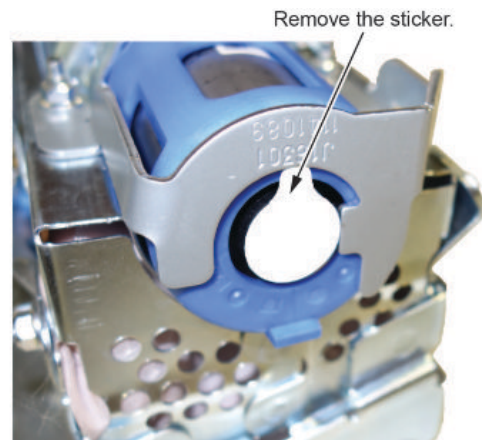
14. Remove the stickers covering the terminals on both sides of the new inflator.

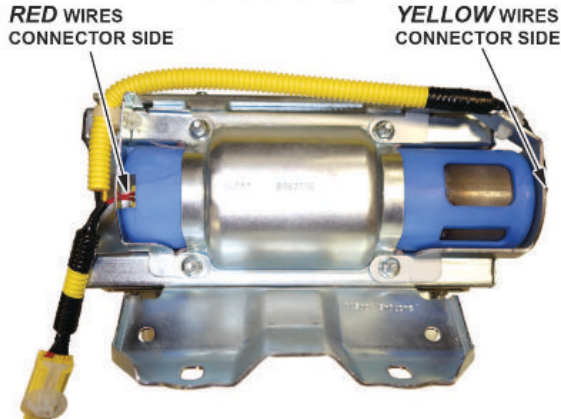
#### NEW INFLATOR HARNESS ROUTING

*The same as the original.*

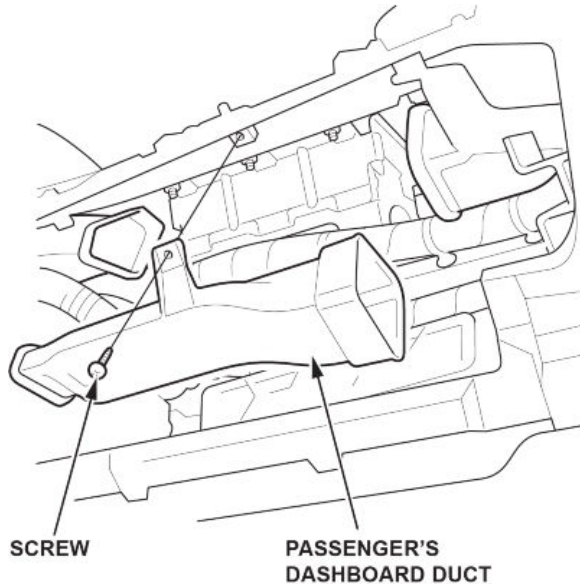
18.3. Install the passenger's dashboard duct.
