December 7, 2018

## Safety Recall: Takata Front Passenger's Airbag Inflator (Phase 1)

Supersedes 16-029, dated August 23, 2016 to revise the information highlighted in **yellow**.

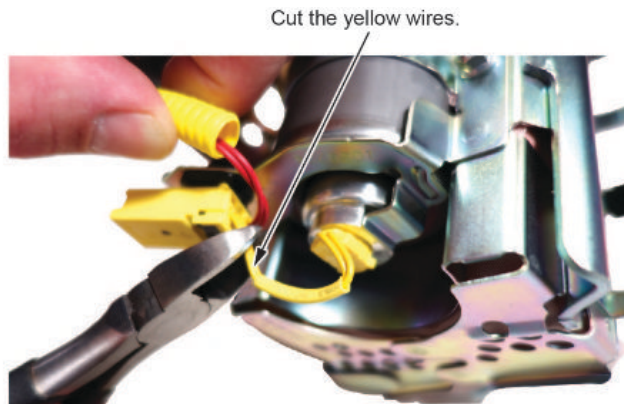
- **You must cut the yellow wires** for inflator removal and short the yellow wires on the inflator side as indicated to prevent accidental deployment.
- **Do not cut the red wires** because the airbag connector shorts these inflator wires.

- 8.1. Cut the yellow wires as shown.

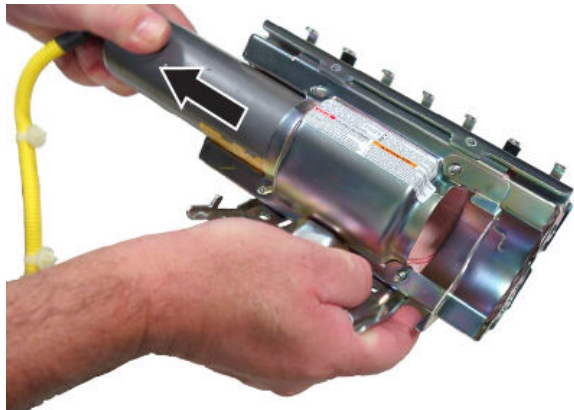
11. Remove the inflator by pulling it out.

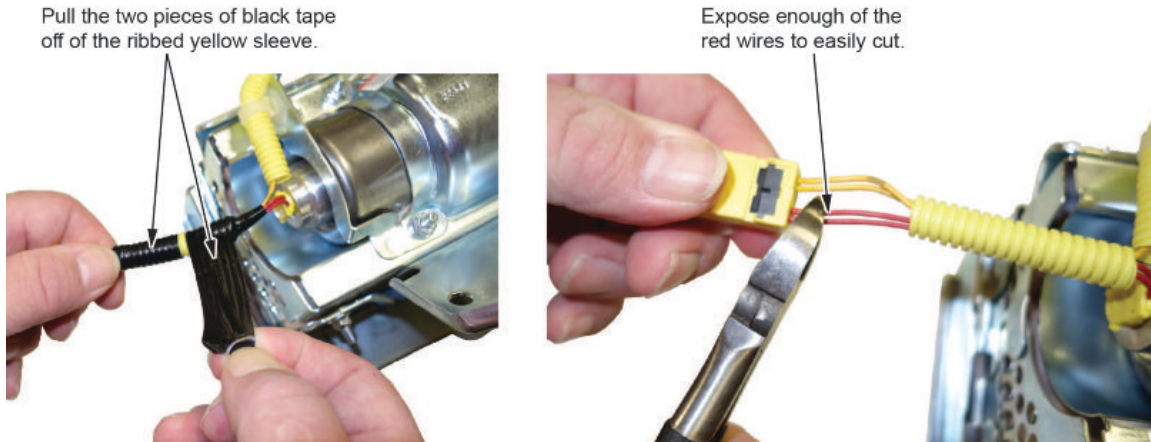
- **You must cut the red wires** for inflator removal and short the yellow wires on the inflator side as indicated to prevent accidental deployment.
- **Do not cut the yellow wires** because the airbag connector shorts these inflator wires.

8.1. Cut the red wires as shown.

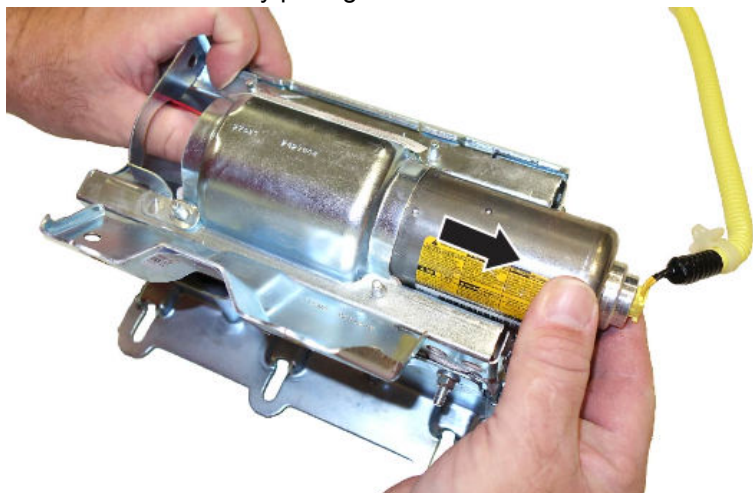
11. Remove the inflator by pulling it out.

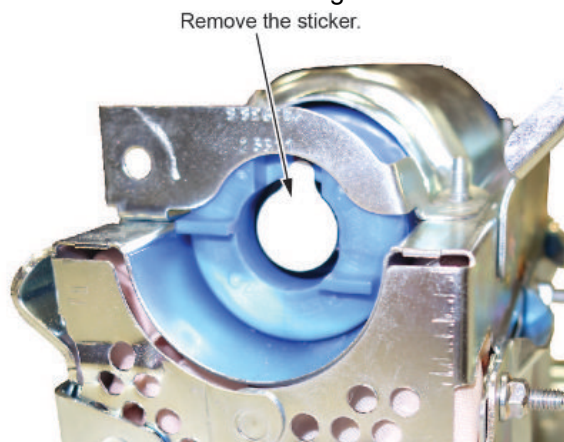
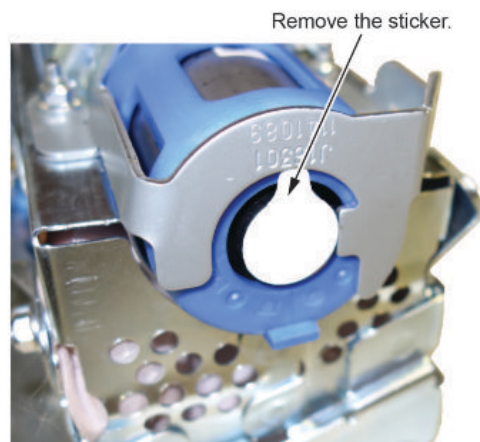
14. Remove the stickers covering the terminals on both sides of the new inflator.
