J069NAS2

TECHNICAL BULLETIN

501-20B: Supplemental Restraint System

SAFETY RECALL: Takata Passenger Airbag

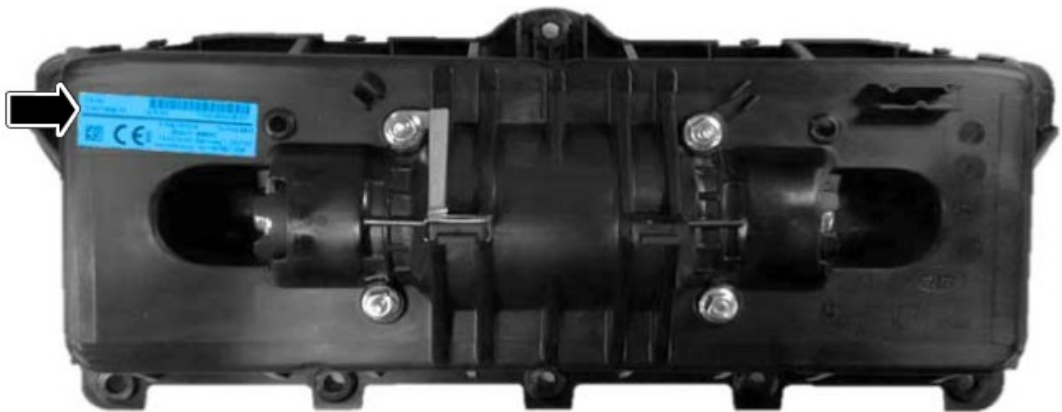
E207032

Locate the label on the **NEW** passenger airbag module.

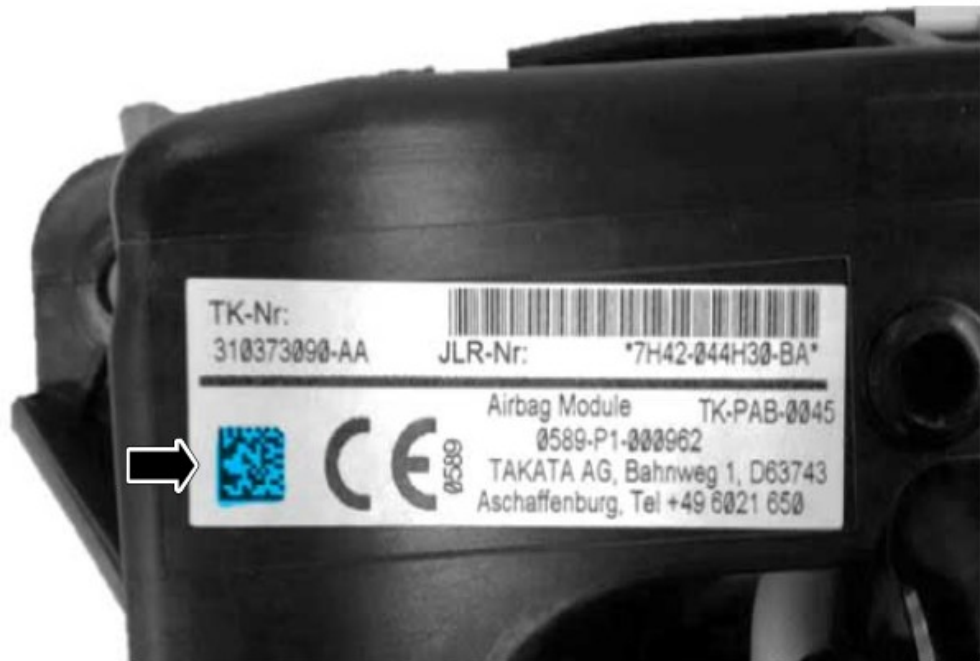
E207031

Locate the QR code on the NEW passenger airbag module label.
