SAFETY ADVISORY # 16-255 Kodiak 291 LED Countertop Lights

Models Included: 2016 - 2017 Dutchmen Kodiak 291RESL Travel Trailers

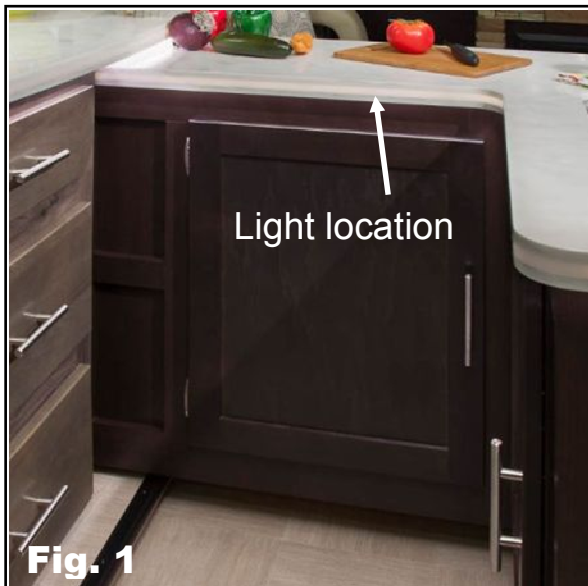
Keystone RV Company is conducting a voluntary **RECALL** notification campaign in accordance with the National Traffic and Motor Vehicle Safety Act. It has been decided the vehicles in this recall population may have been manufactured with 2 separate LED rope lights as back lighting for the countertop that can touch at the unprotected ends. If this condition exists it will lead to an increased risk of fire if an electrical short should occur.

Extend kitchen slide room to gain access to the kitchen sink base, Fig 1. Locate the 2 wire ends above the cabinet door in Fig. 2.
