Safety Recall

Code: 60C3

Subject	Sunroof Glass Adhesive
Release Date	August 4, 2016
Affected Vehicles	U.S.A.: 2007-2009 MY Audi A8/S8 CANADA: 2008-2009 MY Audi A8/S8 <i>Check Campaigns/Actions screen in Elsa on the day of repair to verify that a VIN qualifies for repair under this action. Elsa is the <u>only</u> valid campaign inquiry & verification source.</i> <ul style="list-style-type: none">✓ Campaign status must show "open."✓ If Elsa shows other open action(s), inform your customer so that the work can also be completed at the same time the vehicle is in the workshop for this campaign.
Problem Description	On certain vehicles, the glass panel of the sunroof may not have been properly bonded to the sunroof frame. This could allow the glass panel to separate from the vehicle while driving, creating a road hazard which could increase the risk of a crash causing injury and/or damage to property.
Corrective Action	Dealers will apply additional adhesive between the sunroof frame and glass panel.

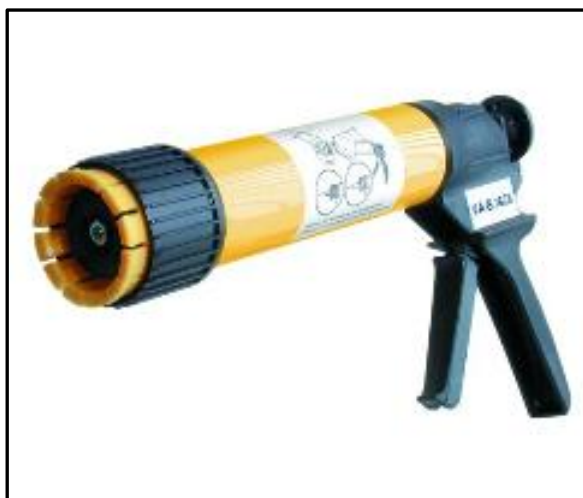
- Cartridge gun <VAG1628>

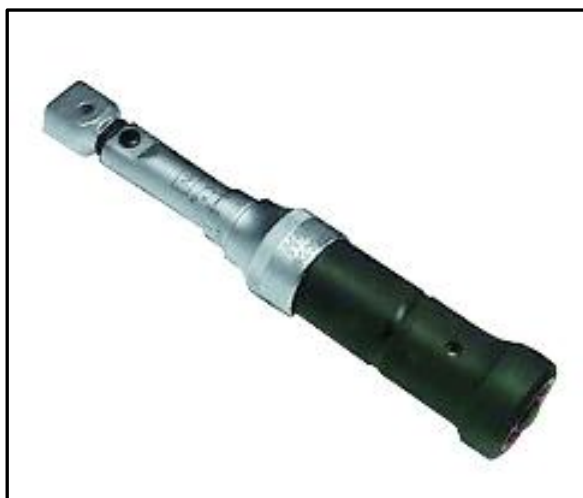
- Torque wrench <VAG1783> or equivalent
