August 23, 2016

Safety Recall: Takata Front Passenger's Airbag Inflator (Phase 1) Supersedes 16-029, dated July 29, 2016; See REVISION SUMMARY

Replacing the front passenger's airbag inflator

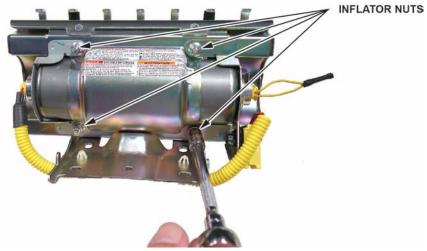
- Tape the twisted ends with electrical tape. •
- 9. Remove the four inflator nuts.

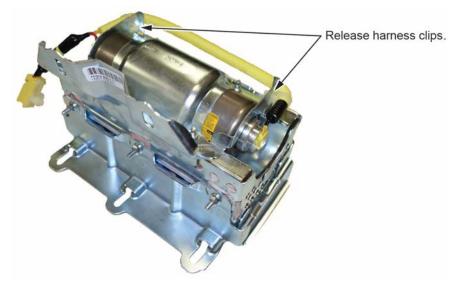
12. Remove the harness from the inflator bracket.

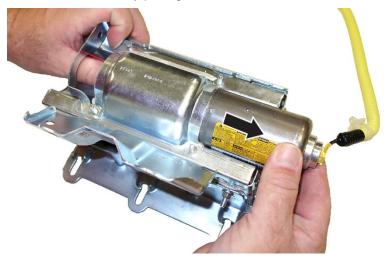
16. Remove the inflator by pulling it out.
