Service Bulletin

SAFETY RECALL

2015-2016 CBR300R/RA, CB300F CRANKSHAFT REPLACEMENT

Campaign #KB9 / Service Bulletin: CBR300R/CB300F#1

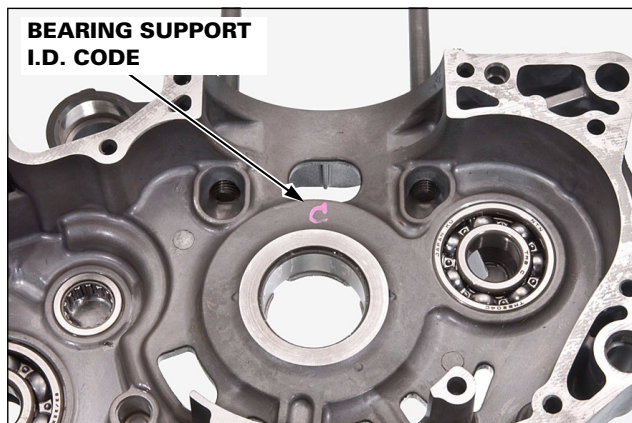
1. Record the bearing support I.D. code.

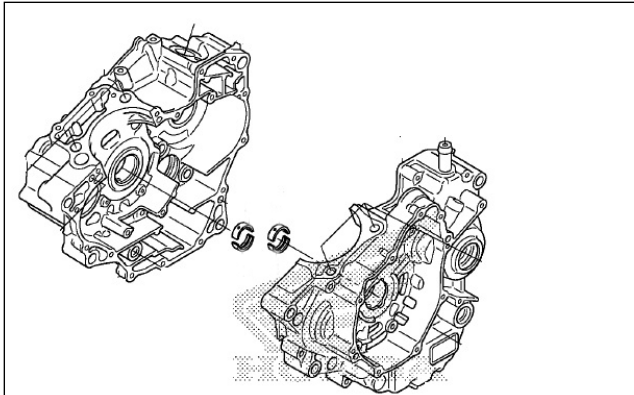
2. Select the correct main journal bearing from the chart as shown.

Bearing Support I.D. Code		Main Journal Bearing - Code (Color) / Part Number
A	➔	C (Brown) / 13314-K33-D01
B	➔	B (Black) / 13313-K33-D01
C	➔	A (Blue) / 13312-K33-D01

- Bearings are not included in the parts kit. These must be ordered separately.

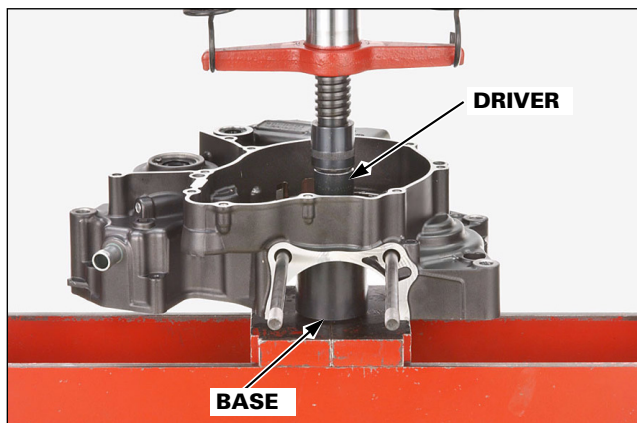
3. Assemble the special tools and crankcase onto a hydraulic press as shown.

Driver, 30 x 36 mm 07HMF-KR10101
Base, 42 mm 07GAF-SD40200

- Special tools are available through Honda parts channels, and may be available for loan. Call TechLine for loan availability.

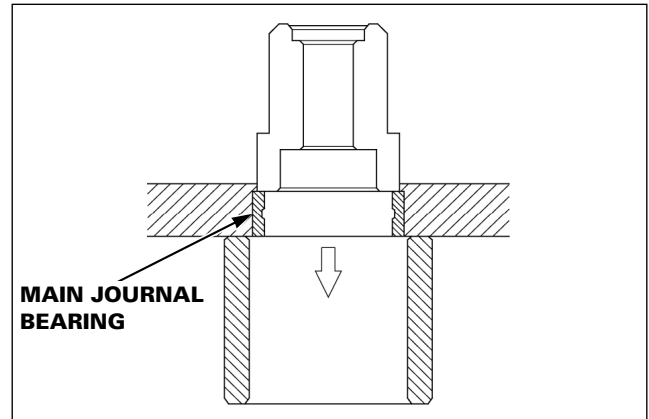
4. Press the main journal bearings toward the inside of the crankcase as shown.

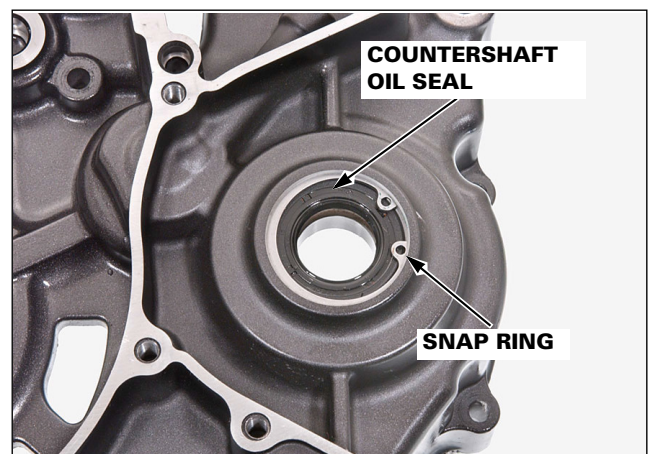
1. Remove the snap ring.
2. Remove the countershaft oil seal from the left crankcase.
3. Apply grease to the lips of a new countershaft oil seal.
4. Install the countershaft oil seal with its marked side facing up.
5. Install the snap ring securely in its groove.

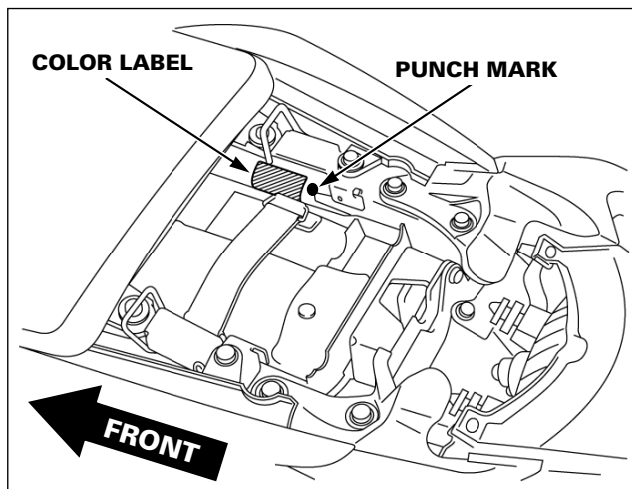
After the repair procedure is complete, apply a punch mark on the frame behind the color label located under the passenger seat, as shown.

Before you begin the Repair Procedure, check if the recall has been performed on the affected unit by looking for a punch mark on the frame as shown in the IDENTIFICATION section of this Service Bulletin.

- If there is a punch mark at the specified location:
 - No further action is necessary.
- If there is no punch mark:
 - You must proceed with the REPAIR PROCEDURE section of this Service Bulletin.
