DOC #	PROCESS NAME	PAGE	REVISION	STATION	BY	DATE
Recall 16V769	Engine May Start Without Warning	1 OF 6		SER	C.Ward	1/31/2017

The purpose of Recall 16V769 is on certain vehicles, the rear run safety switch (lockout) was not wired properly. This allows the vehicle to start with the possibility of a mechanic working on the engine. This could increase the risk of mechanic safety causing injury and/or death.

Complaint: Vehicle can possibly be started from driver compartment with mechanic in engine compartment

Cause: Electrical mis-wiring into the power distribution module (PDM)

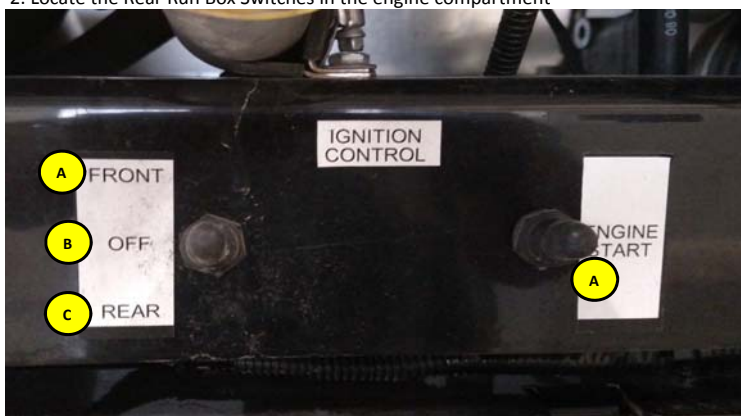
1. Open the rear engine compartment door
2. Locate the Rear Run Box Switches in the engine compartment

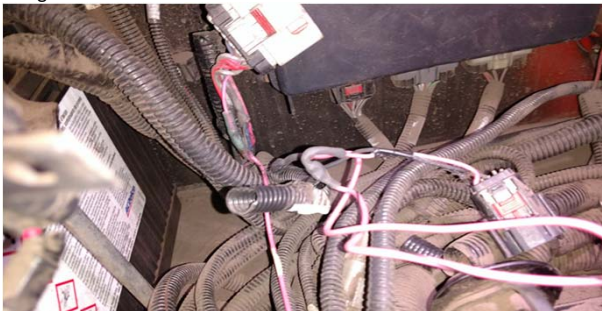
2b. FCCC PDM Connections

1. Follow wires from relays back to the black and grey connections on the FCCC PDM Module
2. Find butt splice connections in the pink wires - cut out the butt splice connections to allow the wires to lay back into factory configuration

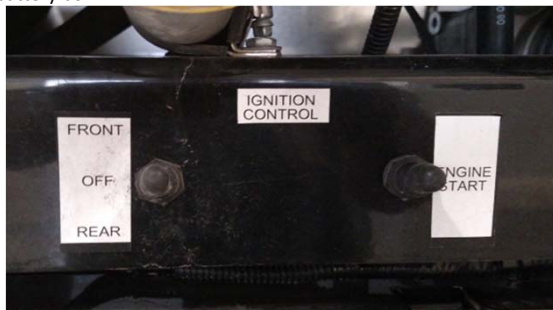
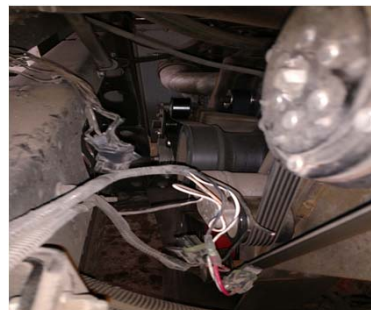
2c. Rear Engine Switches

1. Unscrew toggles and pull wire out for easy access
2. Unplug/cut off connections (**keep toggles to be re-used**)
3. At the right side of the battery box, pull harness from switch location (cutting wire ties as needed) through right side of battery box

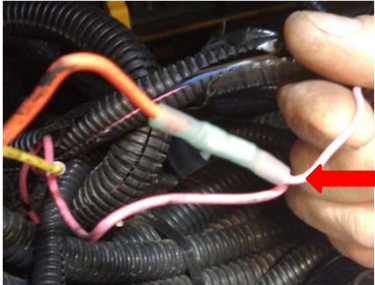
9. Connect the Orange wire in the Jumper Harness to the (2) Pink Wires that remain on the 'Plug' side with butt connector (crimp and heat shrink)

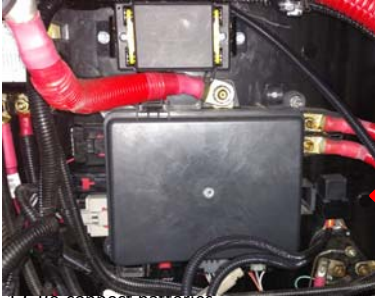
11a. Re-Mount Run Box Module

11. Mount relay on the back wall
