## Christianson Ladder Hinge Repair Kit Installation

It has been decided the vehicles in this recall population may have been manufactured with a Christianson Industries ladder that folds up against the unit. The mounting bracket on the ladder could separate from the hinge due to an incorrect weld. There are six hinges on each ladder; the likelihood of all six hinges failing at the same time is remote.

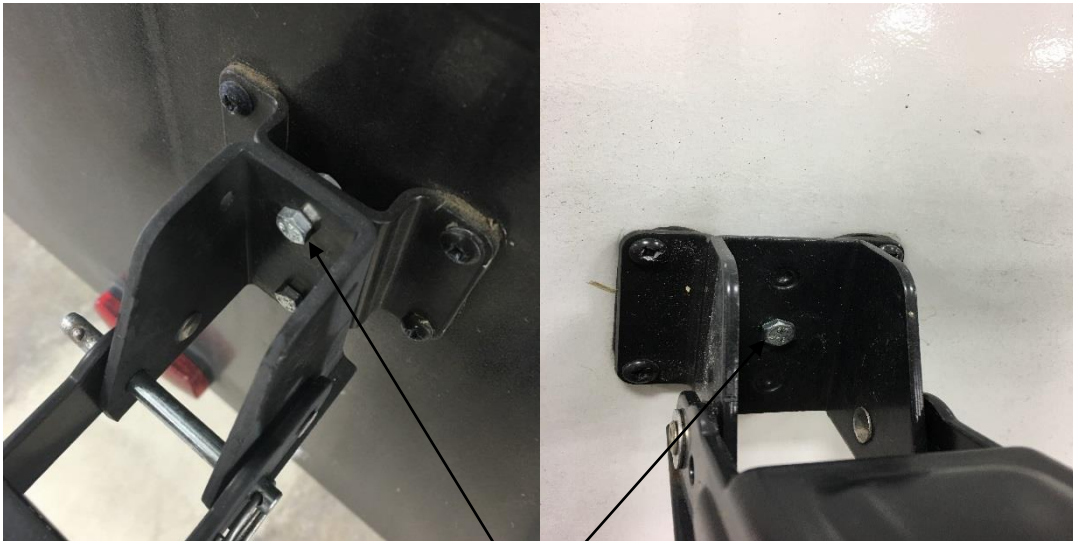
1. New style bracket – no repair required file claim for inspection only.

New style brackets are bolted together. No repair required.

File Recall Inspection warranty claim using warranty code 99.03.11.L, for 0.10 hours.

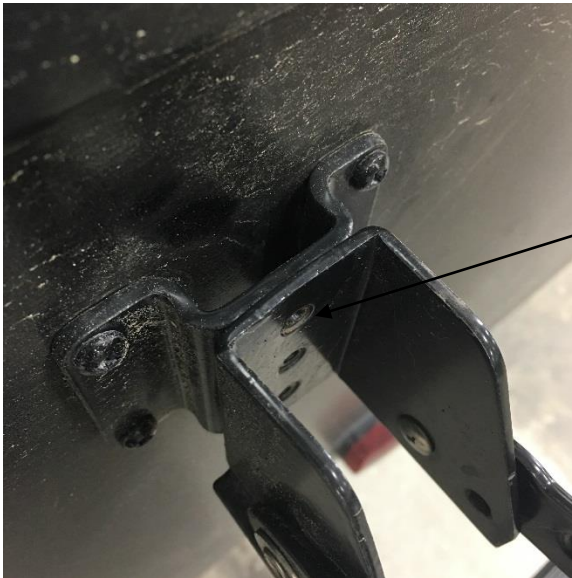
2. Old style bracket, is welded together and requires the addition of the kit.

Bracket is  
welded to  
hinge

3. Follow the Bracket installation instructions provided with the Bracket kit.

Ladder Bracket Kit Part # 0263469
