# Thor Motor Coach Recall Repair Instructions

Recall # 16V—834  
Description/Title: **Tuscany Keyless Entry Module Short**

Affected Product Line(s): **Certain Tuscany Motorhomes**

Service Campaign # : **RC000123** Released Date: **1.9.17**

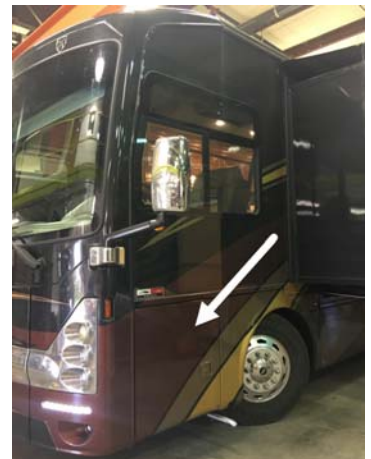
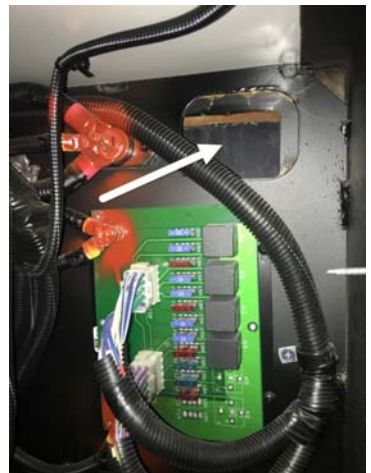
1. From the outside of the motorhome open the electronics' bay compartment door. This will be the first compartment door on the driver's side of the motor home.
2. Locate the opening at the top right hand corner of the rearmost compartment wall.
3. Clean the area surrounding the opening to remove any moisture, oil, or debris.

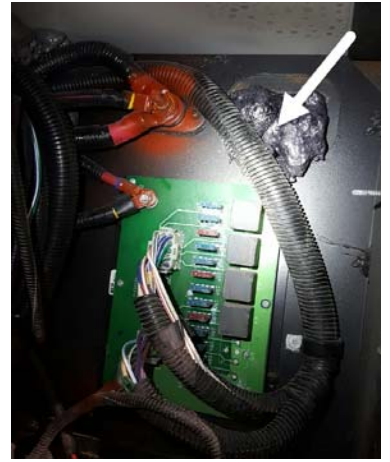
4. Fill the opening with expanding spray foam.
5. Clean the area of any drips or other areas of stray spray foam.
