# Safety Recall

## Code: 45F2

<b>Subject</b>	<b>ABS Control Module Software</b>
<b>Release Date</b>	March 17, 2017
<b>Revision Summary</b>	<b>Work procedure and claiming instructions updated.</b>
<b>Affected Vehicles</b>	<b>Certain 2009-2010 MY Volkswagen Vehicles</b> <i>Check Campaigns/Actions screen in Elsa on the day of repair to verify that a VIN qualifies for repair under this action. Elsa is the <u>only</u> valid campaign inquiry &amp; verification source.</i> <ul style="list-style-type: none"><li>✓ Campaign status must show "open."</li><li>✓ If Elsa shows other open action(s), inform your customer so that the work can also be completed at the same time the vehicle is in the workshop for this campaign.</li></ul>
<b>Problem Description</b>	On certain vehicles, a fault within the antilock brake system (ABS) may cause the module to fail during ABS and/or electronic stability control (ESC) activation. This will cause warning lights for ABS, brake and the ESC systems to illuminate. If this happens, the brake system related vehicle stabilizing functions (ABS/ESC) may not be available, increasing the risk of a loss of vehicle control and could lead to a crash causing injury and/or

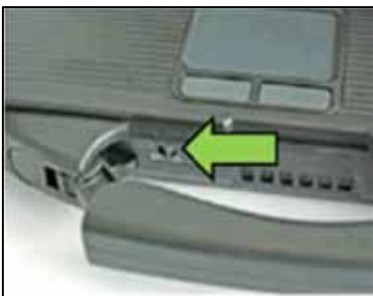
**VAS 6150 & VAS 6150A**  
(Front panel behind handle)

- Performing a software update using a Bluetooth connection increases the risk of losing connection during the update, which could result in damage to the control module. It also greatly increases the time required to perform the update. Requests for additional time or parts will be denied if the GFF log shows the update was performed using Bluetooth.
- ✓ **The Bluetooth function of the scan tool is physically switched off <see pictures below>.**

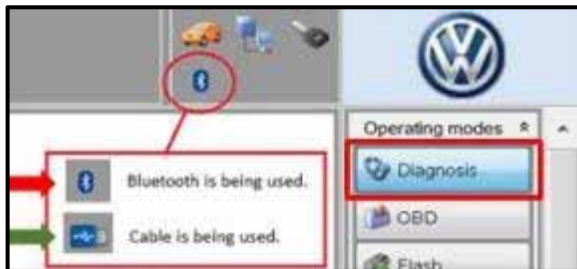
- Open the hood.
- Open the battery cover.
- Attach the GRX3000VAS Tester/Charger (or equivalent) to the vehicle battery.
- Switch the ignition on.
- Apply the parking brake.
- Turn off all consumers; headlights heated seats, etc.
- Connect the VAS6150D Diagnostic Tester (or equivalent) to the vehicle.
- Start the ODIS program.
- Confirm that scan tool is communicating with the diagnostic head by USB <Green Arrow>.
- If the Bluetooth symbol is shown <Red Arrow> then disconnect the diagnostic head from the vehicle and reconnect the USB cable to the diagnostic head and then reattach to the vehicle.
- Upon ODIS startup, verify the "Diagnosis" operating mode is selected <as shown>.
- Select "Starting Diagnosis" and perform a GFF scan of the vehicle.

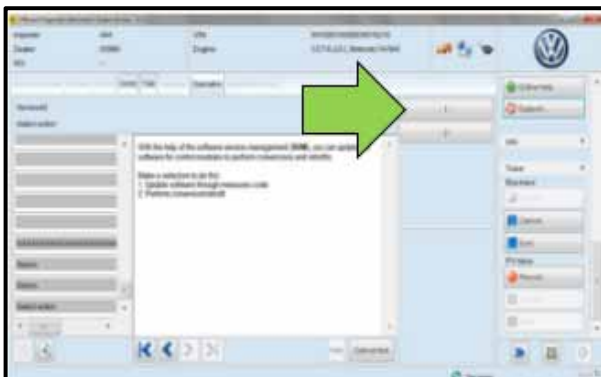
- Select the appropriate option to update “**through measures code**” <arrow>.

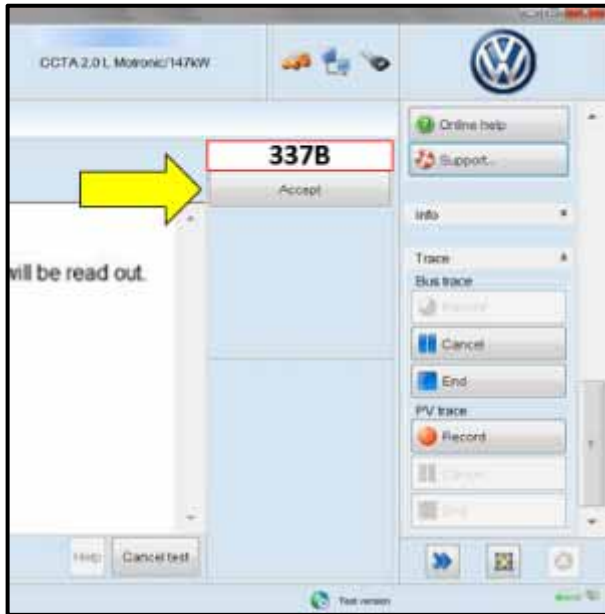
- Enter “337B” <as shown>.
- Select “Accept” <arrow> and follow on screen instructions.

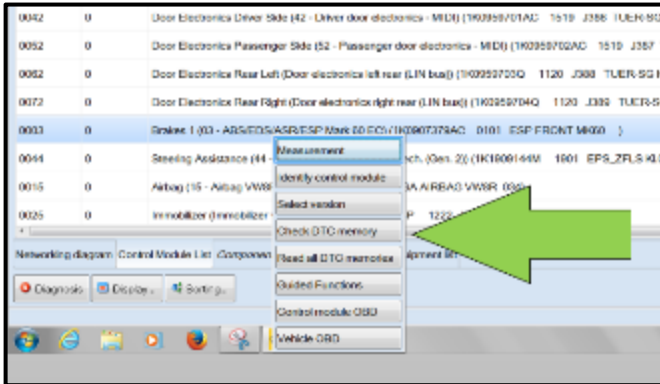
- After the short road test, turn off the ignition and cycle ignition back on.
- Select the “Control Module” tab.
- Scroll down and right click on Address Word 0003/ABS Control Module.
- Select Check DTC Memory <arrow>.

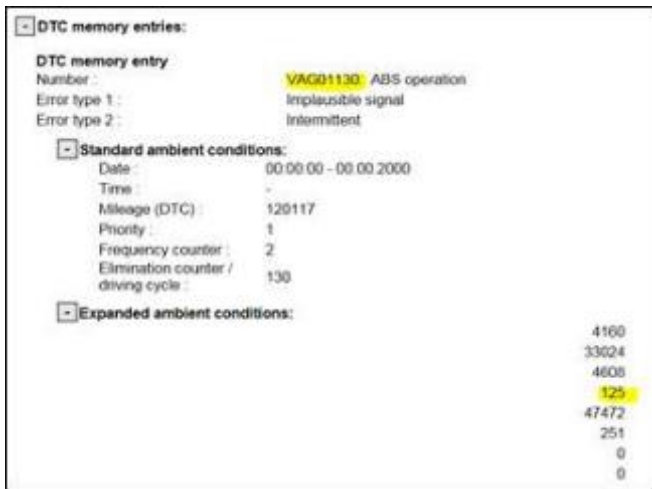
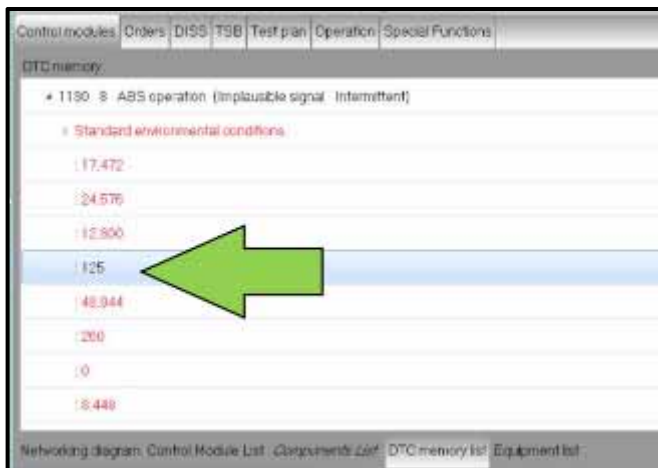
- If faults **01130: ABS Operation – Implausible Signal** with 125 shown in the 4th line of the Expanded ambient conditions and/or **16352: Control Module Faulty** with 96 shown in the 4th line of the Expanded ambient conditions are stored in the ABS Control Module (address word 0003), the ABS module will require replacement. **Continue to Section D**

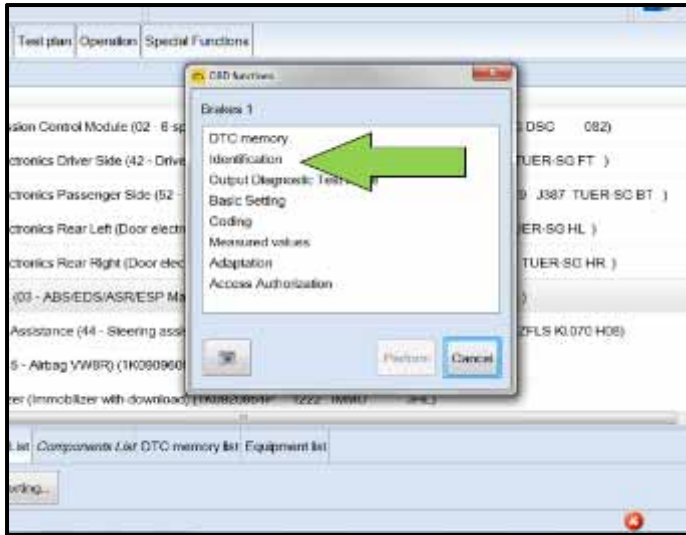
- Right click on Address 0003 (ABS Control Module), select “Control Module OBD” and then select “Identification” <arrow>.

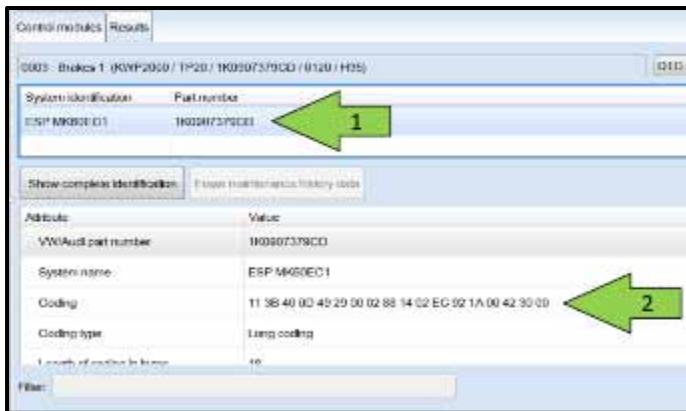
- Record the ABS Control Module part # <arrow 1> and the coding of the ABS Control Module <arrow 2> on the repair order. ABS Control Module coding may need to be entered manually after the ABS Control Module is replaced.
- Exit ODIS, send the Diagnostic Protocol online to GFF paperless.

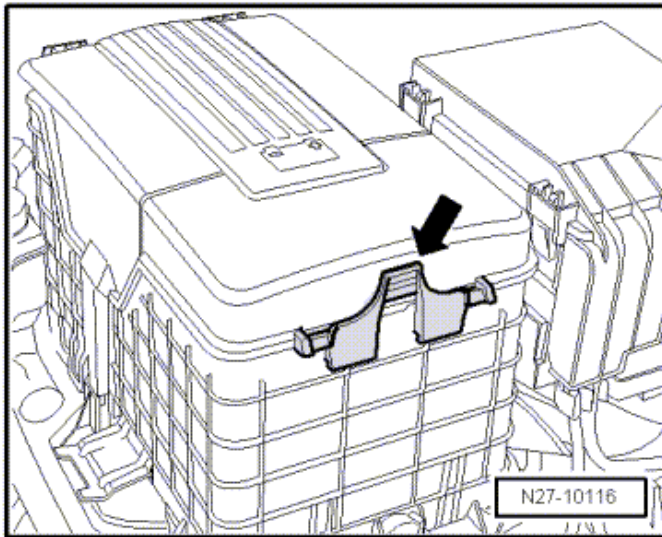
- Switch off ignition and remove ignition key.
- Open the locking mechanism <arrow> and remove the battery housing cover.

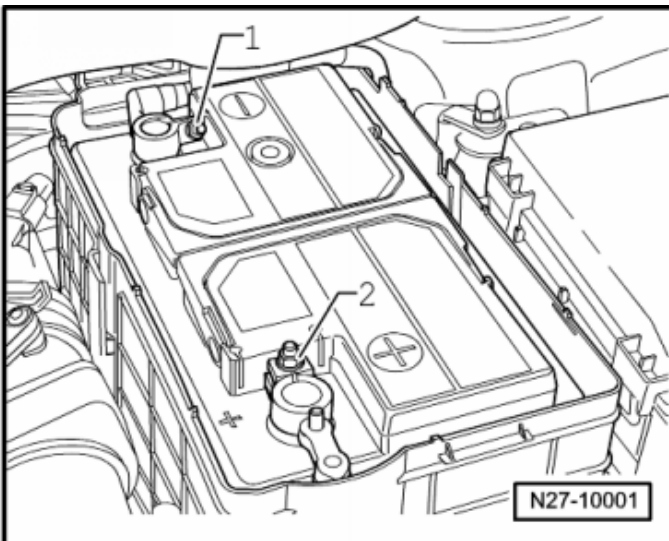
- Loosen the nut <1>.
- Remove and isolate the battery ground cable terminal from the battery terminal.

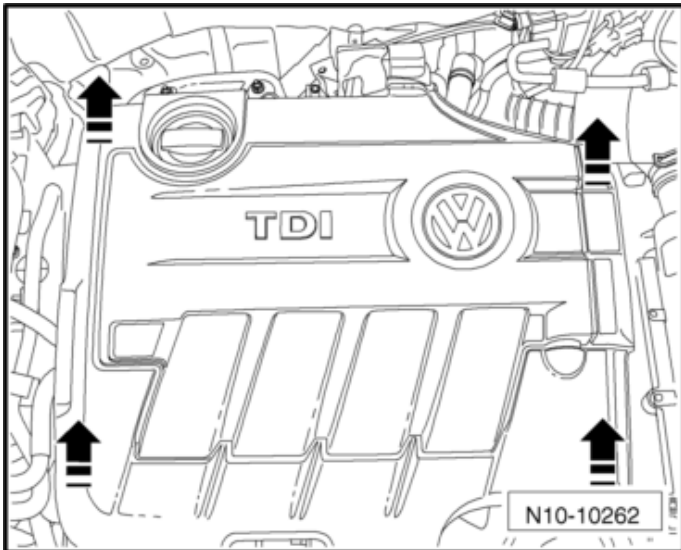
- Pull the engine cover at the corners in direction of <arrows> upward out of the mounts.

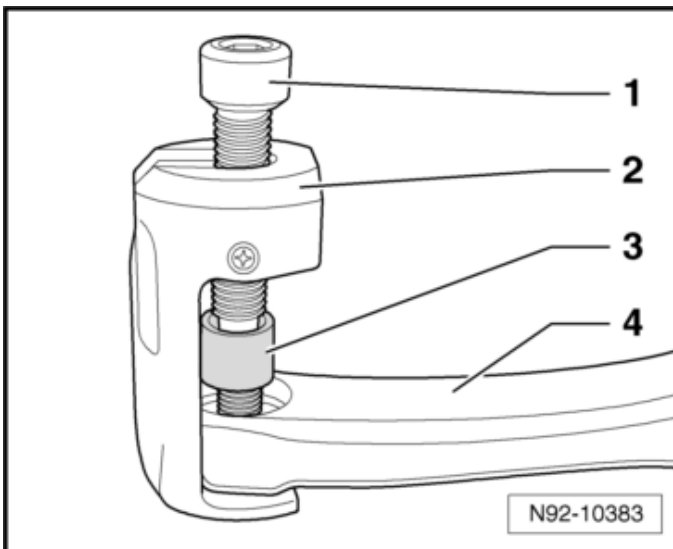
- Slide the Puller - Wiper Arm Kit - Puller 1 - T10369/1 <2> arm under the wiper arm <4>.

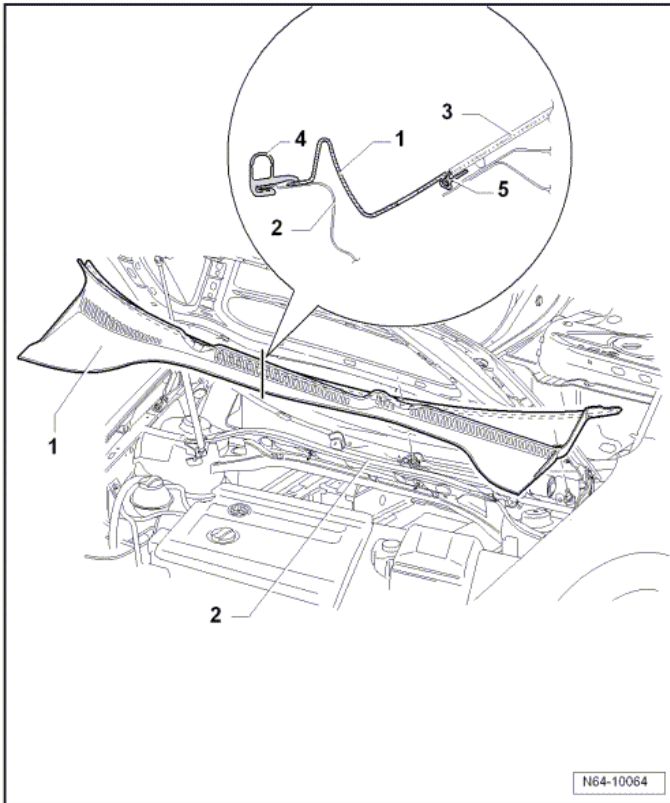
- Pull off plenum chamber seal <4> from the entire length of facing wall <2> of plenum chamber.
- Pull out plenum chamber cover <1> starting at right carefully upward from binding profile <5>.

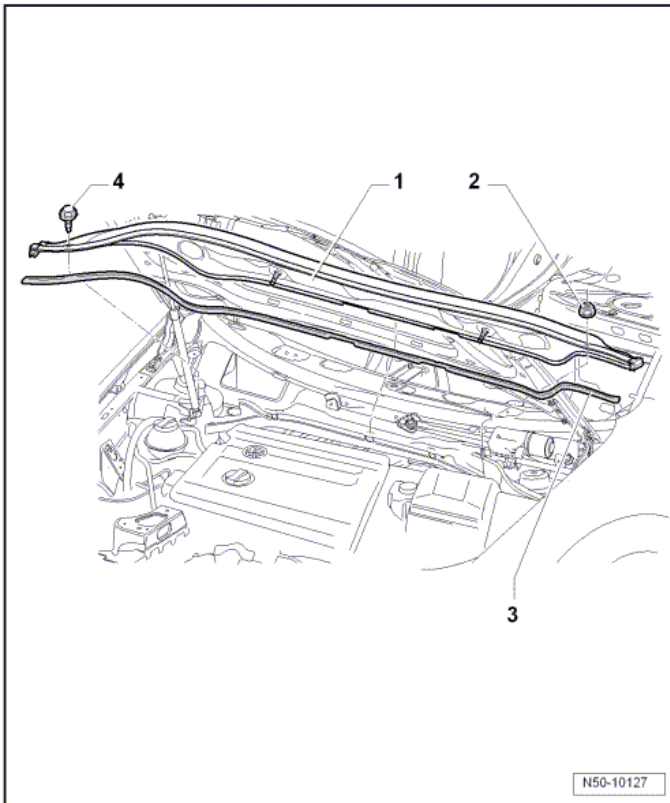
- Remove bolt <4> and nut <2>.
- Pull plenum chamber bulkhead upward and remove from the vehicle.

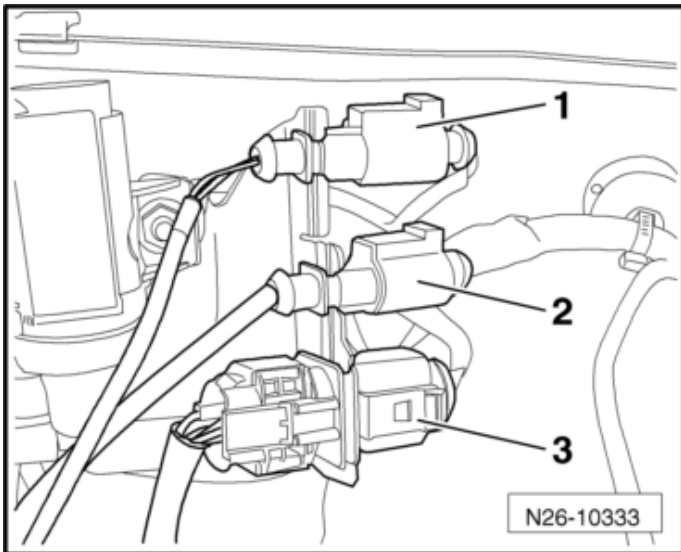
- Disconnect the connector for the Exhaust Gas Temperature Sensor 4 -G648- <2> and Heated Oxygen Sensor -G39- <3>.
- Unclip the Exhaust Gas Temperature Sensor 4 -G648- and Heated Oxygen Sensor -G39- cables from the brackets on the plenum chamber and engine.

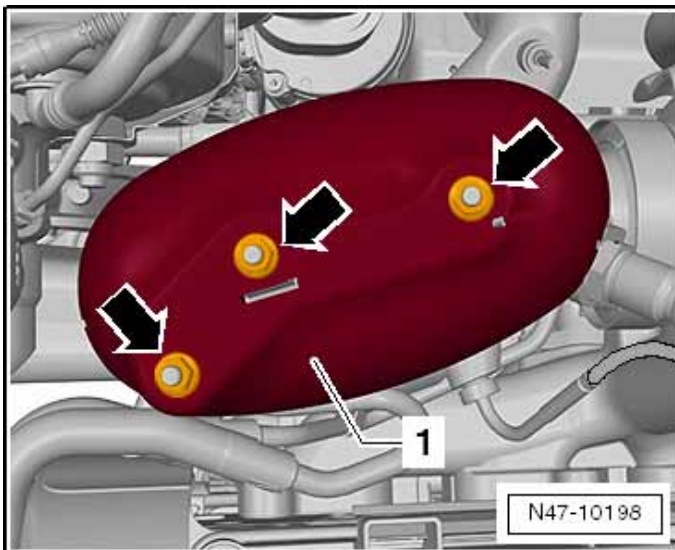
- Remove the nuts <arrows> and then remove the heat shield <1> from the diesel particulate filter.

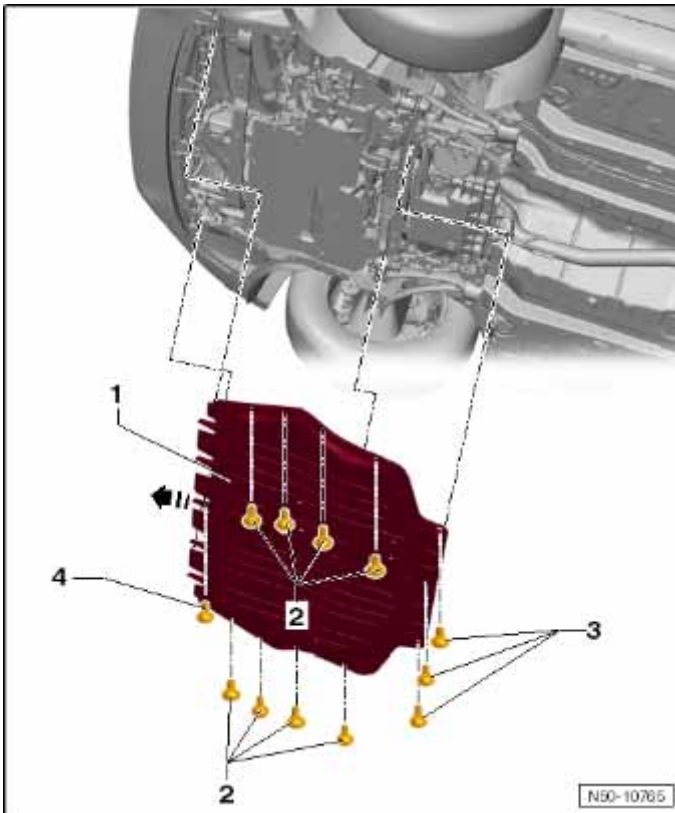
- Remove bolts <2> and <3>.
- Pull noise insulation <1> back, out of front bumper cover.

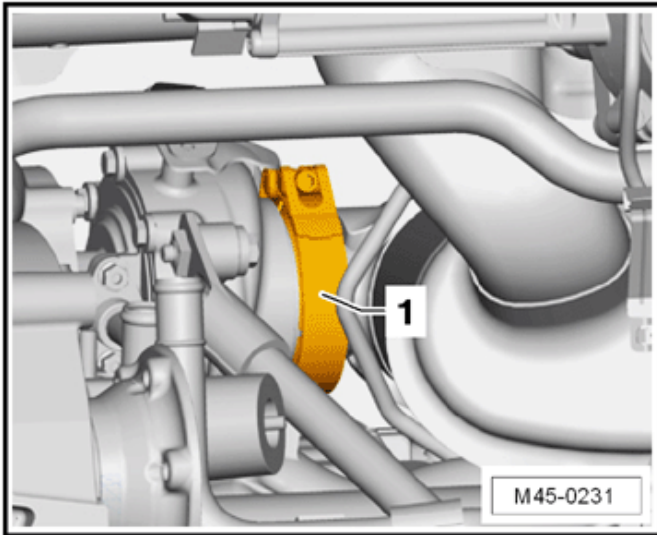
- Loosen and remove the turbocharger/particulate filter clamp <1>.

Position of clamp <1> may vary. If necessary, use 5 mm bit with ball head (e.g. T10058).

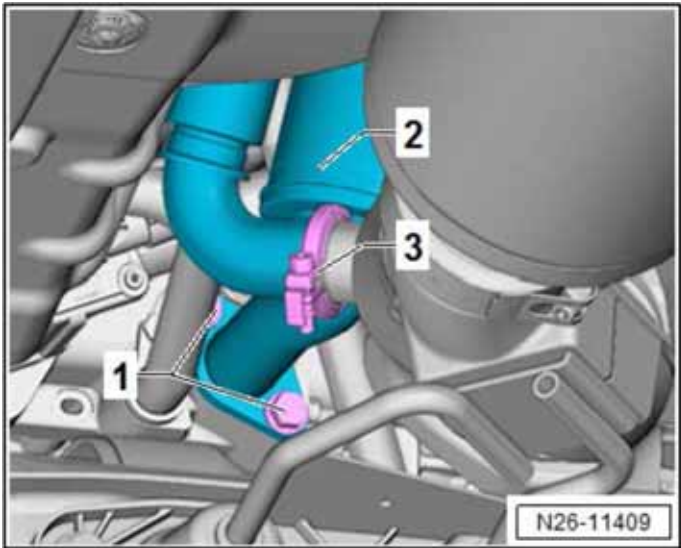
- Remove clamp <3> between EGR filter and Particulate filter.

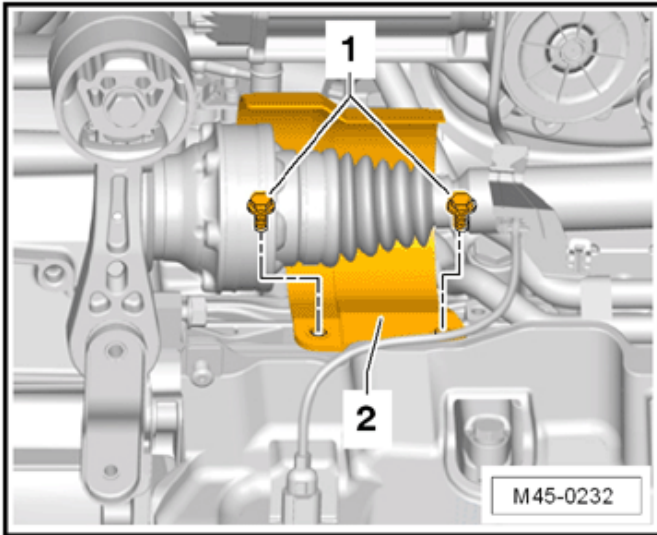
- Remove the bolts <1> and remove the drive axle cover <2>.
- Loosen the double clamp on the exhaust pipe and push it toward the rear (if required).

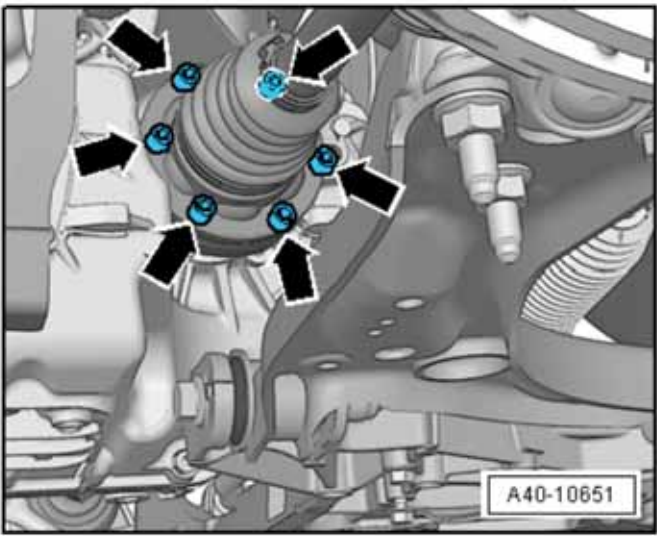
- Remove and discard bolts <arrows> and remove right drive axle from transmission.
- Rest drive axle on front subframe.

The drive axle does not need to be removed from the vehicle or unbolted from the wheel hub.

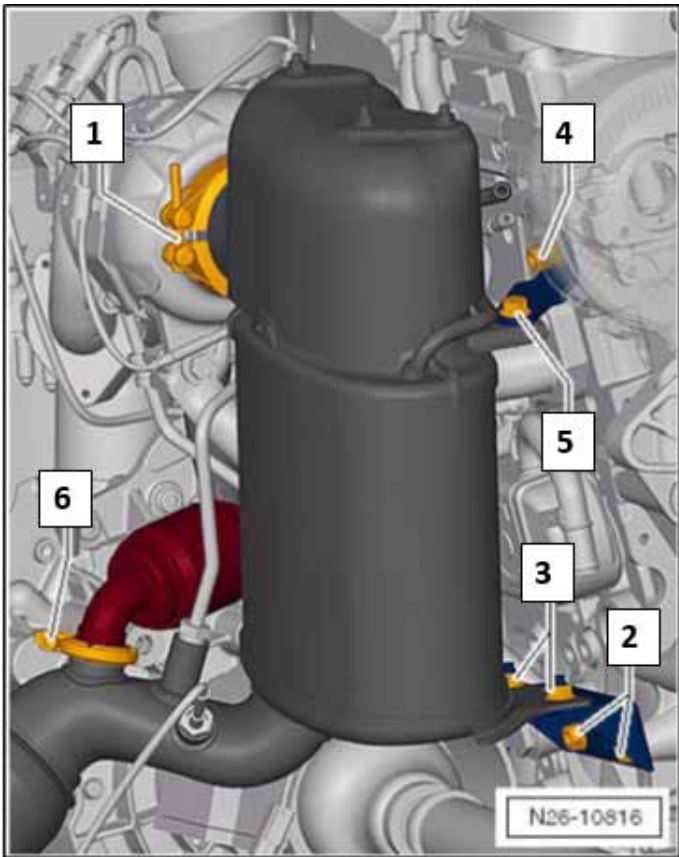
- Loosen bolt <4>, but do not remove.

Use a commercially available 13 mm combination wrench with a 15° offset and a total length of 140 mm to loosen nut <4>.

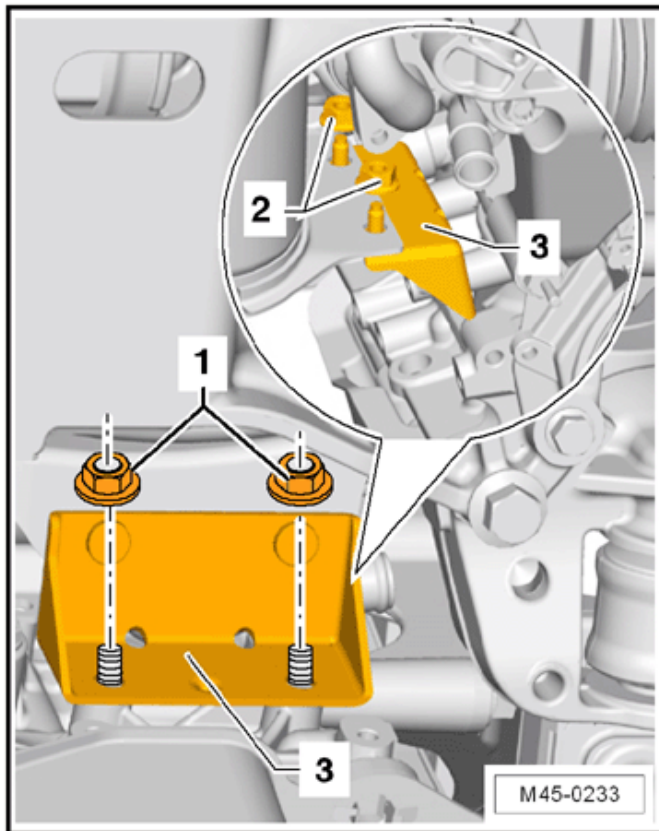
- Remove the nuts <1> and lower the particulate filter.
- Remove the nuts <2> and remove the particulate filter bracket <3>.
- Lower the particulate filter just enough so that it touches the steering gear.

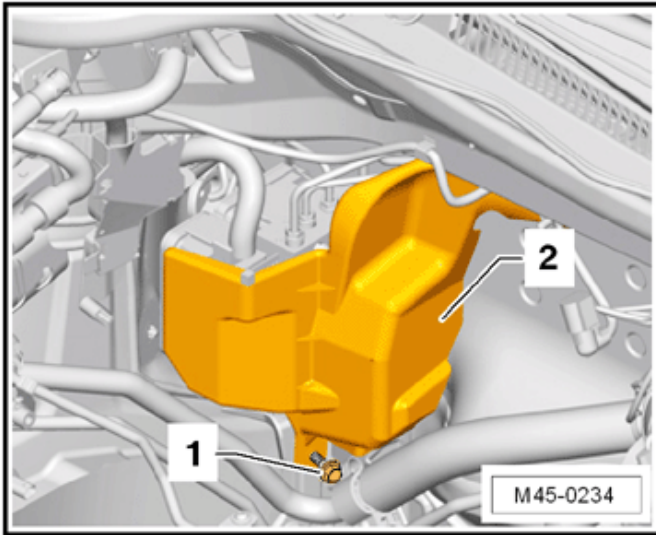
- Remove the nut <1> and remove the heat shield <2> (if equipped).

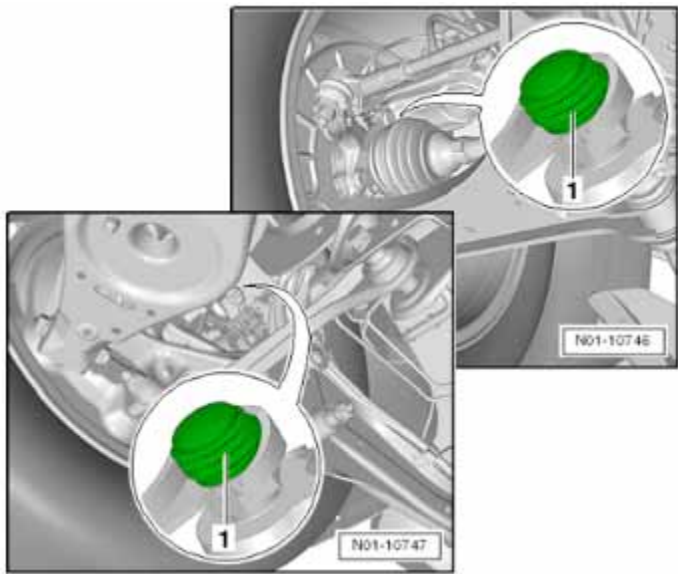
- Remove bleeder valve caps <1> from the left front and left rear brake bleeder valves.

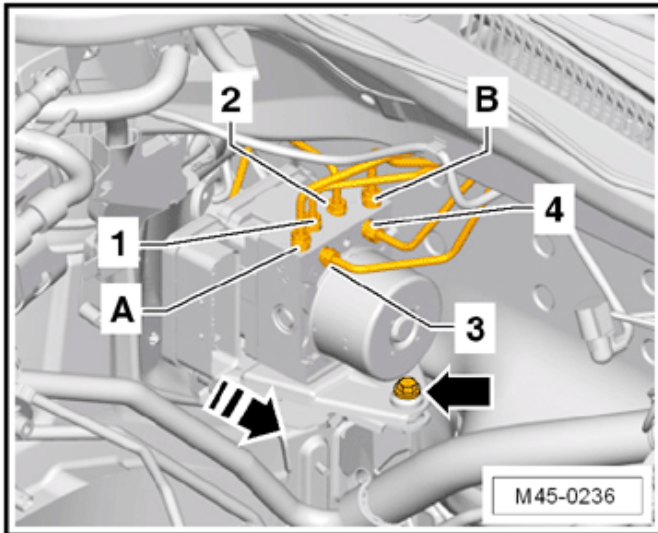
- To protect against escaping brake fluid, place a lint-free rag in the area under the control module and hydraulic unit.
- First, mark the installed position of both brake lines from master cylinder <A and B> and remove from the hydraulic unit.
- Seal threaded holes in the hydraulic unit with black sealing plugs (provided with new ABS module) and cover exposed brake lines using a clean plastic bag to prevent leaking brake fluid.
- Mark the installed position of brake lines (brake calipers) <1 through 4> and remove.
- Seal threaded holes in the hydraulic unit with clear sealing plugs (provided with new ABS module) and cover exposed brake lines using a clean plastic bag to prevent leaking brake fluid.
- Remove bolt <arrow> from the bracket.
- Remove the hydraulic unit, the control module and the side retainer in <direction of arrow> from the bracket rubber insulation.

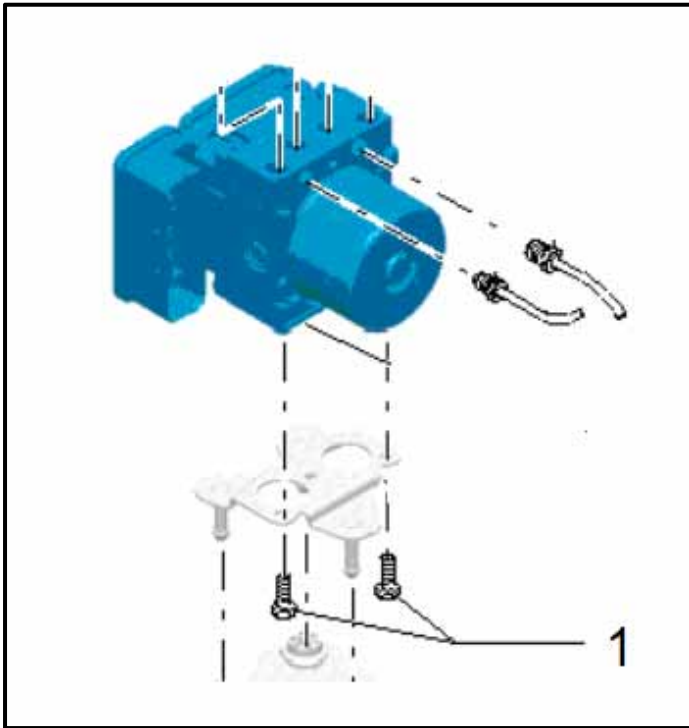
- Remove bolts <1> and separate the hydraulic unit from the bracket.

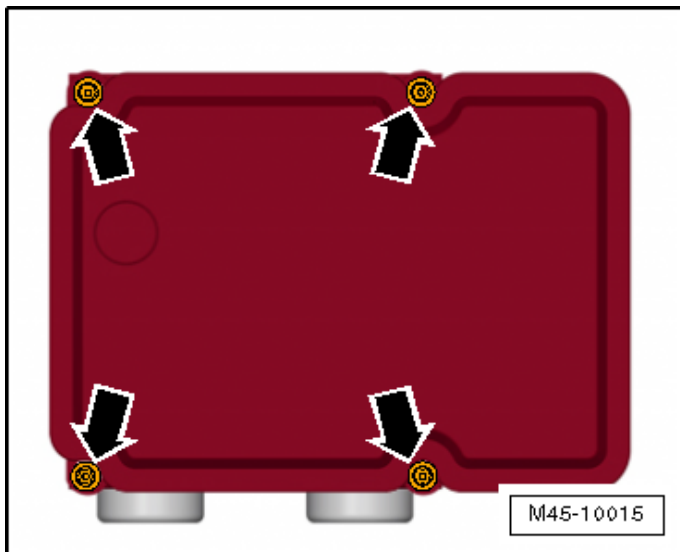
- Remove and discard bolts <arrows>.

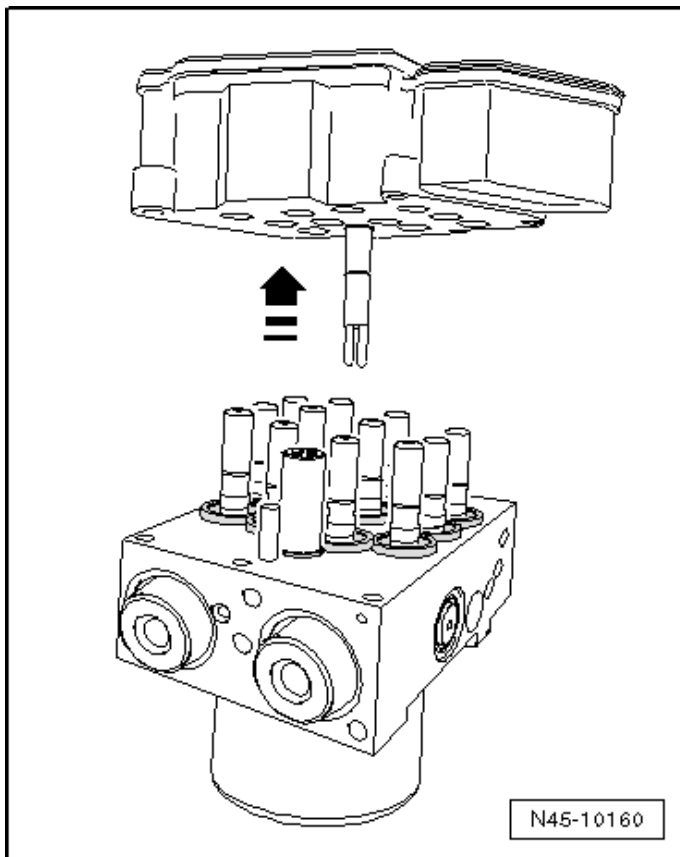
- Remove the ABS Control Module -J104- from the ABS Hydraulic Unit -N55- in the direction of <arrow> without tilting it.
- Carefully remove and discard all the seals from the valve domes on the ABS Hydraulic Unit - N55-.

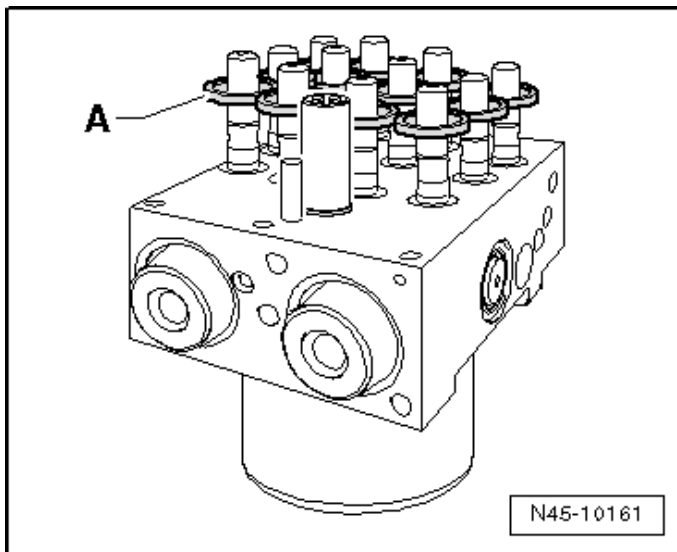
- Install new sealing rings <A> slightly over the valve domes as shown.

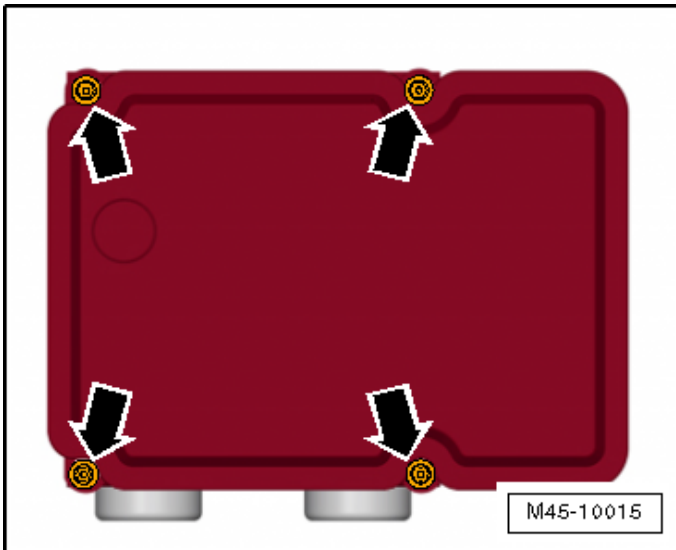
- Install and torque new bolts <arrows> in a cross pattern to  $2 \text{ Nm} \pm 0.8 \text{ Nm}$ .

New bolts are included with the new ABS Control Module.

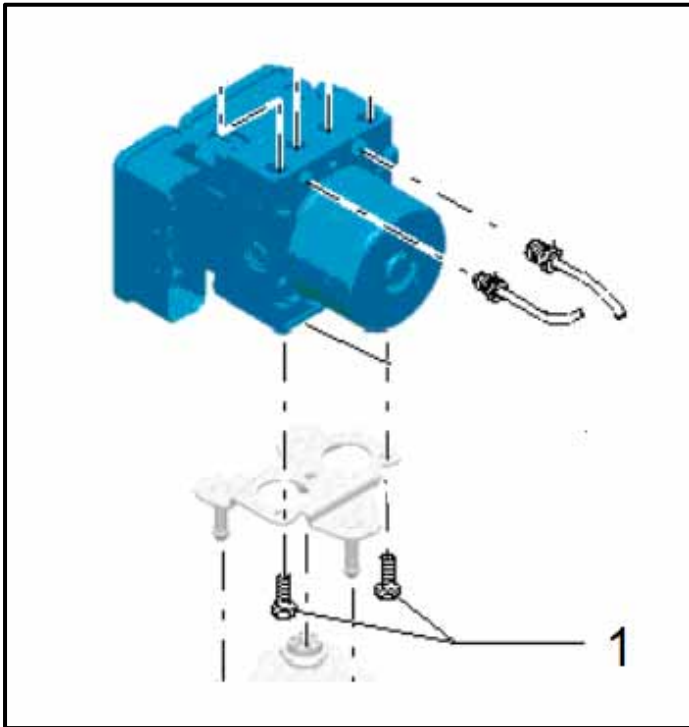
- Working inside the engine compartment, install the bracket to the ABS Hydraulic Unit -N55- and torque the bolts <1> to 8 Nm.

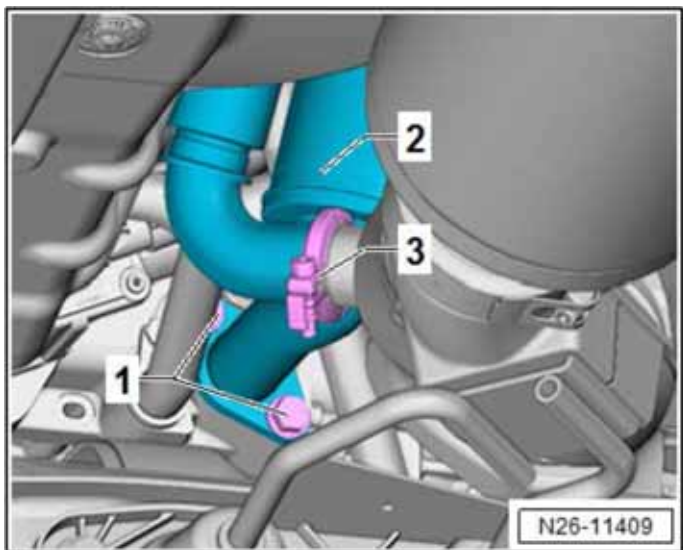
- Install new clamp and gasket between EGR filter and Particulate filter.

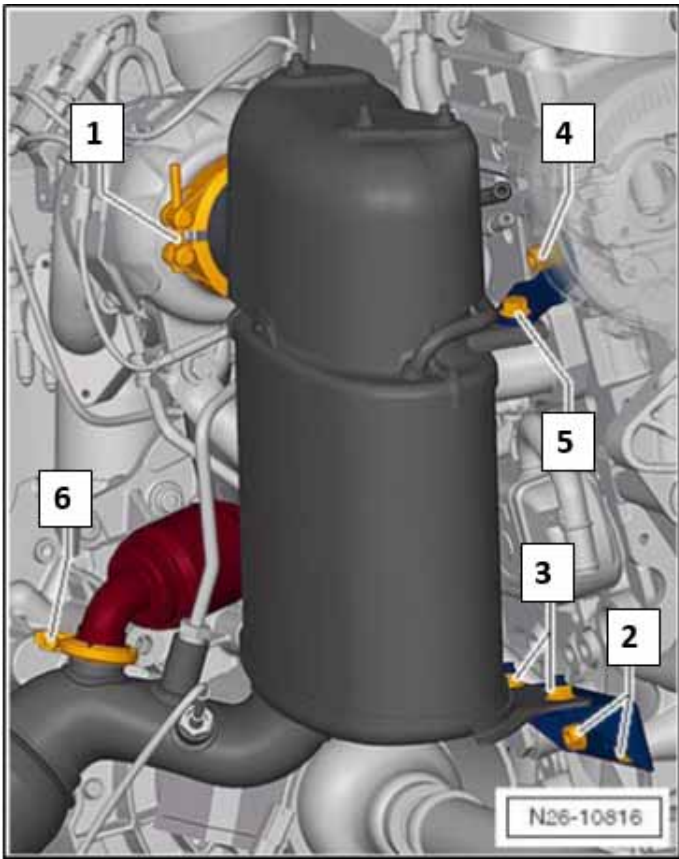
- Install bolt <5> loosely by hand.
- Particulate filter and bracket must be able to move.
- Tighten fasteners in the following order:

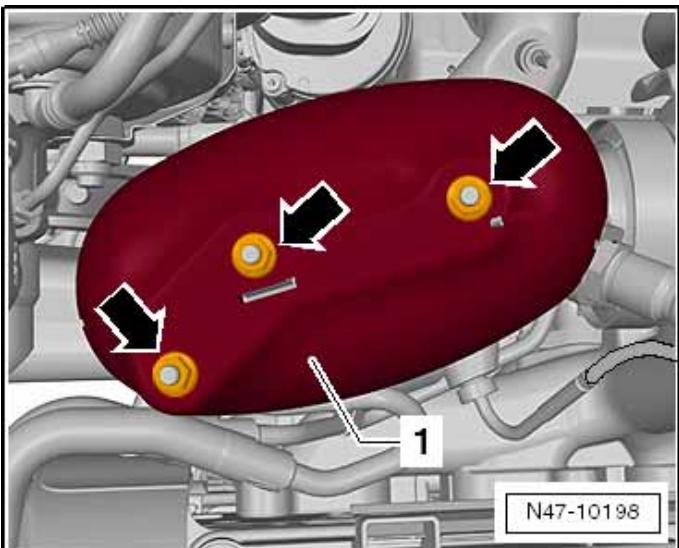
- Install heat shield <1> and torque nuts to 10 Nm.

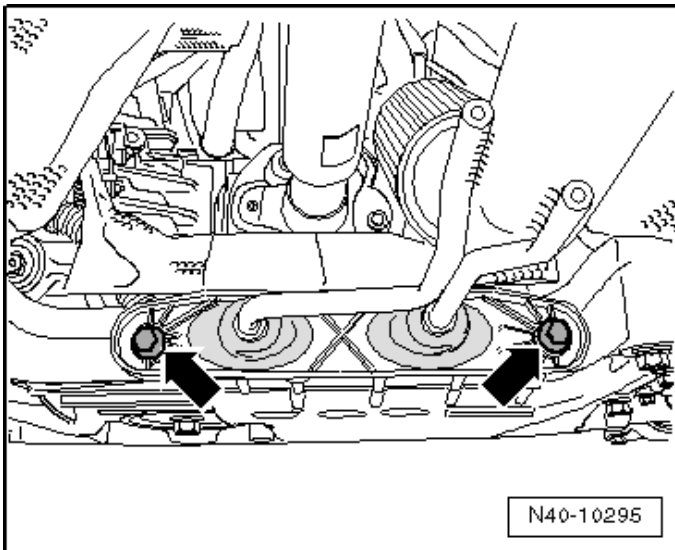
- Install exhaust system bracket and torque bolts <arrows> to 25 Nm.

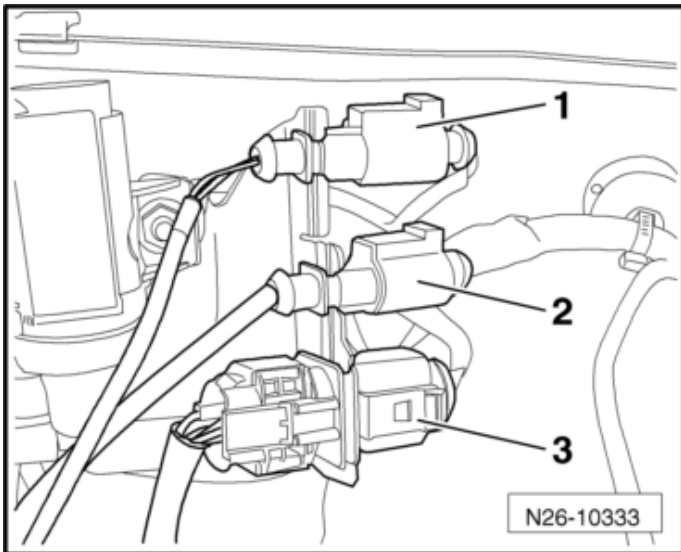
- Install the Exhaust Gas Temperature Sensor 4 -G648- and Heated Oxygen Sensor -G39- into the brackets on the plenum chamber and engine.
- Connect the connector for the Exhaust Gas Temperature Sensor 4 -G648- <2> and Heated Oxygen Sensor -G39- <3>.

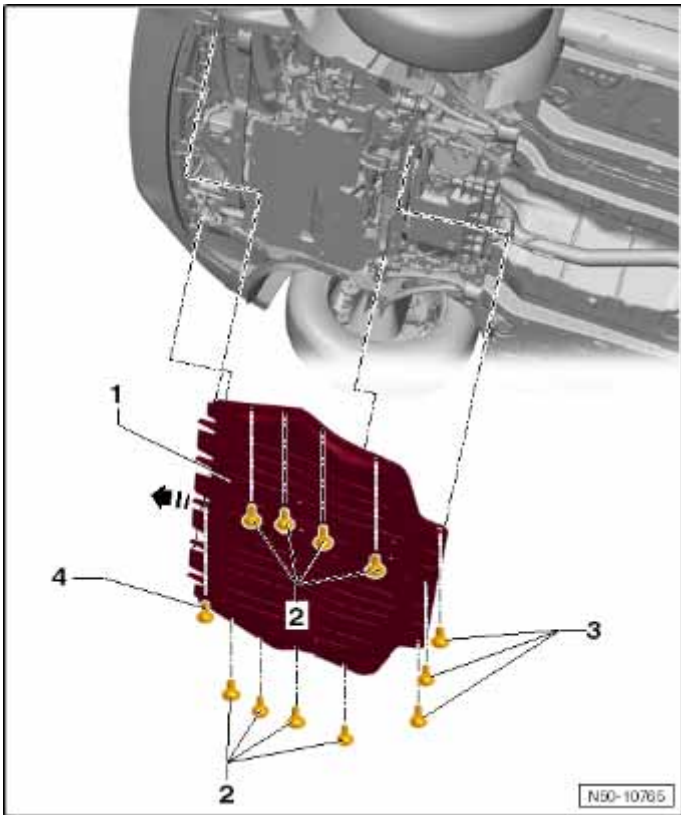
- Install noise insulation <1>. Torque bolts <2> to 2 Nm and bolts <3> to 6 Nm.

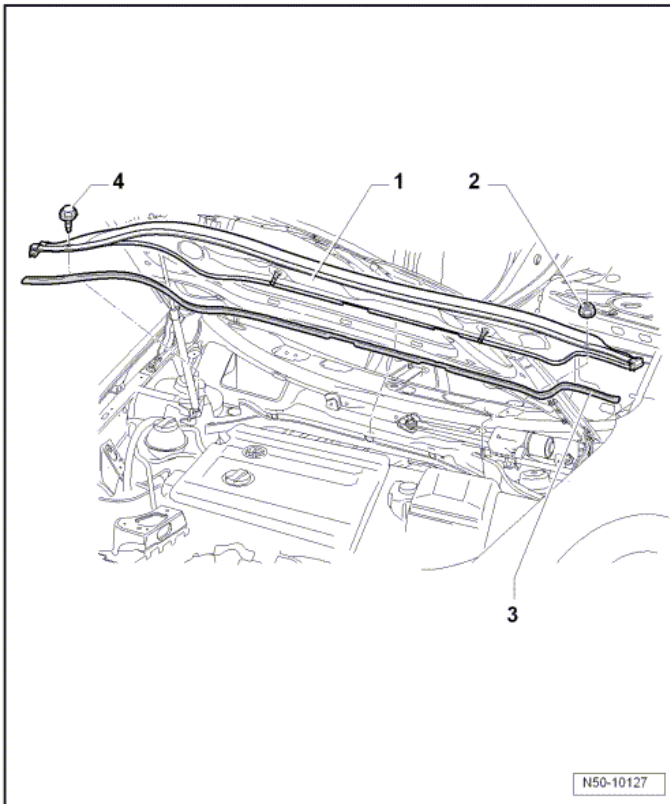
- Install plenum chamber bulkhead. When installing bulkhead, make sure seal <3> is seated correctly.
- Install bolt <4> and nut <2> and torque to 8 Nm.

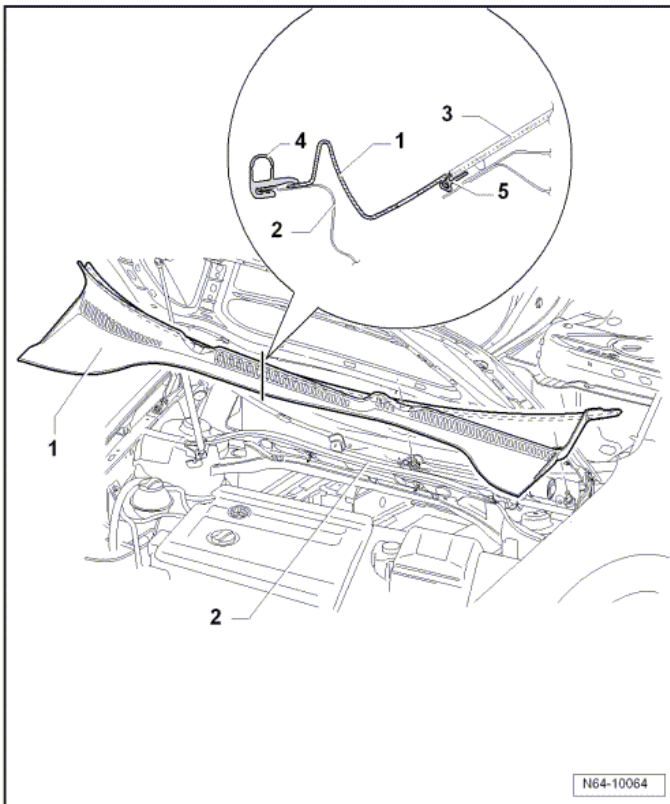
- Spray binding profile <5> with soap solution so that plenum chamber cover <1> can be pressed in more easily.
- Place plenum chamber cover <1> onto binding profile <1> and engage it with binding profile <5> starting from center using light pressure.
- Install plenum chamber seal <4>.

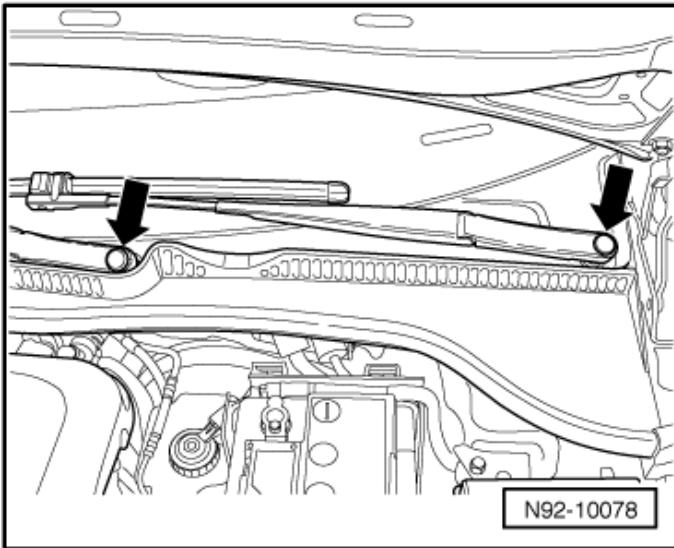
- Turn on the ignition and then switch the windshield wipers on and off so that the Windshield Wiper Motor -V- goes into its park position.
- Mount both wiper arms on the wiper arm shafts and install the nuts <arrows> hand-tight.

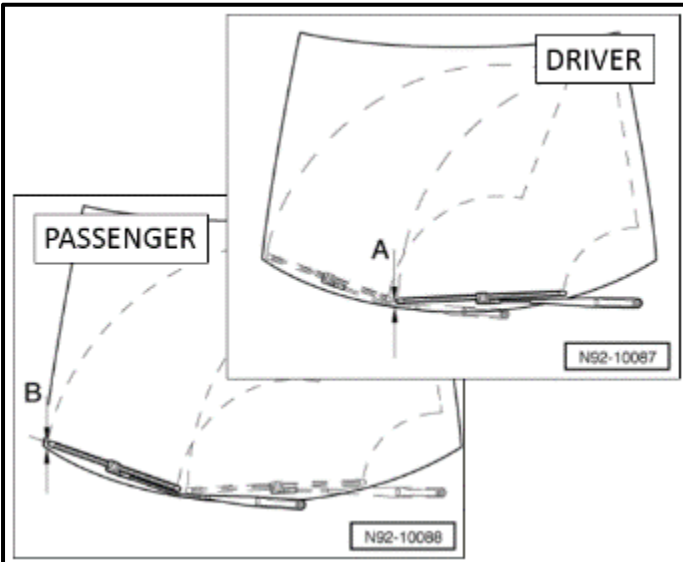
- Adjust the wiper blade park position.
  - For the driver side: distance <A> between tips of wiper lips and upper edge of plenum chamber cover must be 10 mm.
  - For the passenger side: distance <B> between tips of wiper lips and upper edge of plenum chamber cover must be 10 mm.
- Torque wiper arm nuts to 20 Nm and install protective caps.

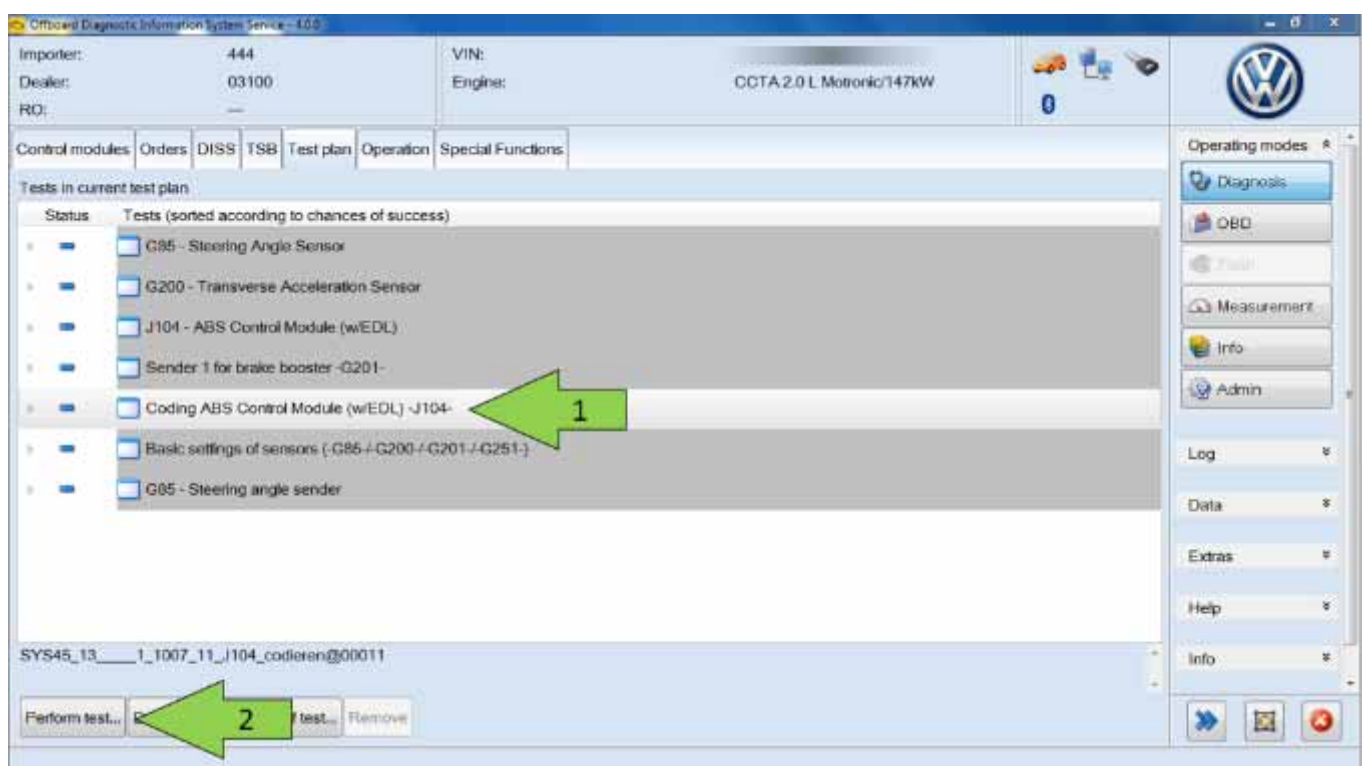
- Select "Coding ABS Control Module -J104-" <arrow 1>.
- Select "Perform test.." <arrow 2> and follow the on screen directions.

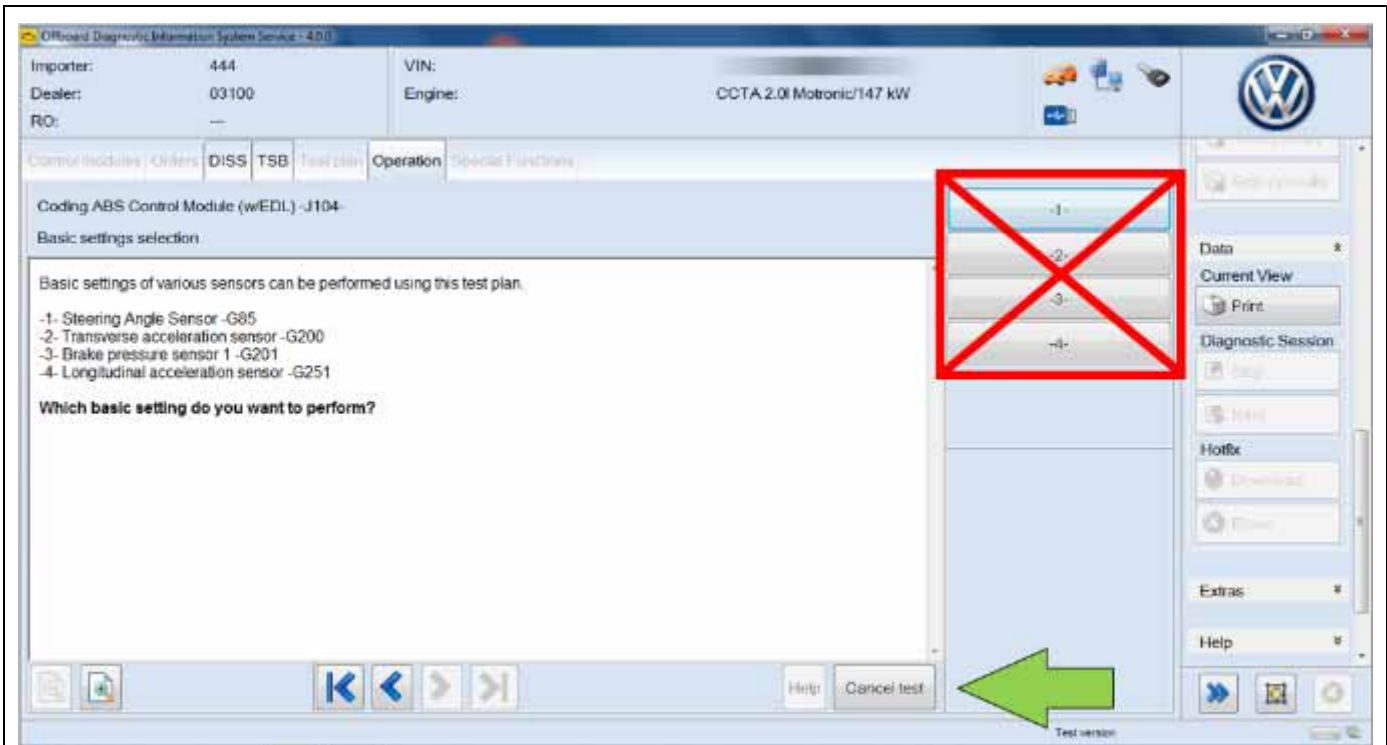
- After coding is completed, this screen may be displayed. DO NOT move forward in this test plan.
- Select “Cancel test” <arrow>.
- Remove the battery charger, close the hood.

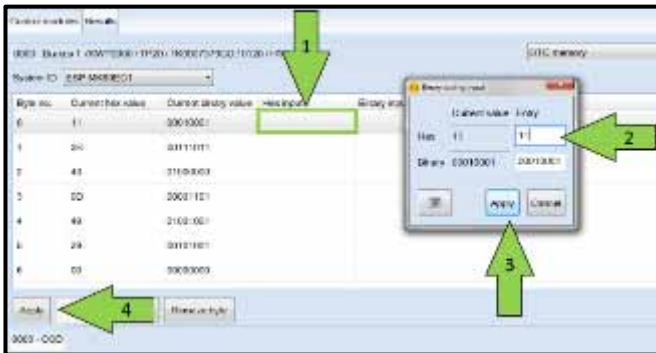
- Right click on Address 0003 (ABS Control Module), select "Control Module OBD" and then select "Coding".

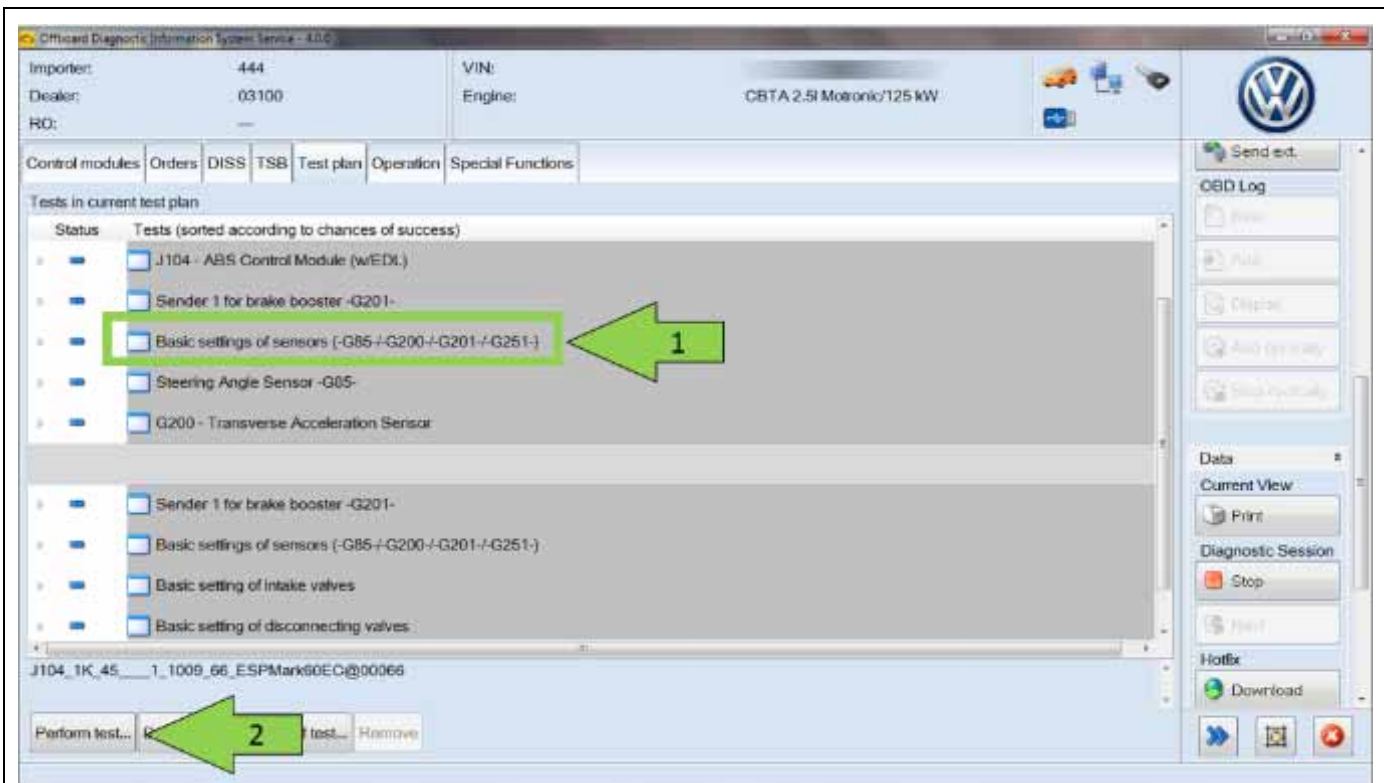
- Select “Basic settings of sensors (-G85-/G200-/G201-/G251-)” <arrow 1>.
