# Safety Recall

## Code: 45F2

<b>Subject</b>	<b>ABS Control Module Software</b>
<b>Release Date</b>	March 17, 2017
<b>Revision Summary</b>	<b>Work procedure and claiming instructions updated.</b>
<b>Affected Vehicles</b>	<b>Certain 2009-2010 MY Volkswagen Vehicles</b> <i>Check Campaigns/Actions screen in Elsa on the day of repair to verify that a VIN qualifies for repair under this action. Elsa is the <u>only</u> valid campaign inquiry &amp; verification source.</i> <ul style="list-style-type: none"><li>✓ Campaign status must show "open."</li><li>✓ If Elsa shows other open action(s), inform your customer so that the work can also be completed at the same time the vehicle is in the workshop for this campaign.</li></ul>
<b>Problem Description</b>	On certain vehicles, a fault within the antilock brake system (ABS) may cause the module to fail during ABS and/or electronic stability control (ESC) activation. This will cause warning lights for ABS, brake and the ESC systems to illuminate. If this happens, the brake system related vehicle stabilizing functions (ABS/ESC) may not be available, increasing the risk of a loss of vehicle control and could lead to a crash causing injury and/or

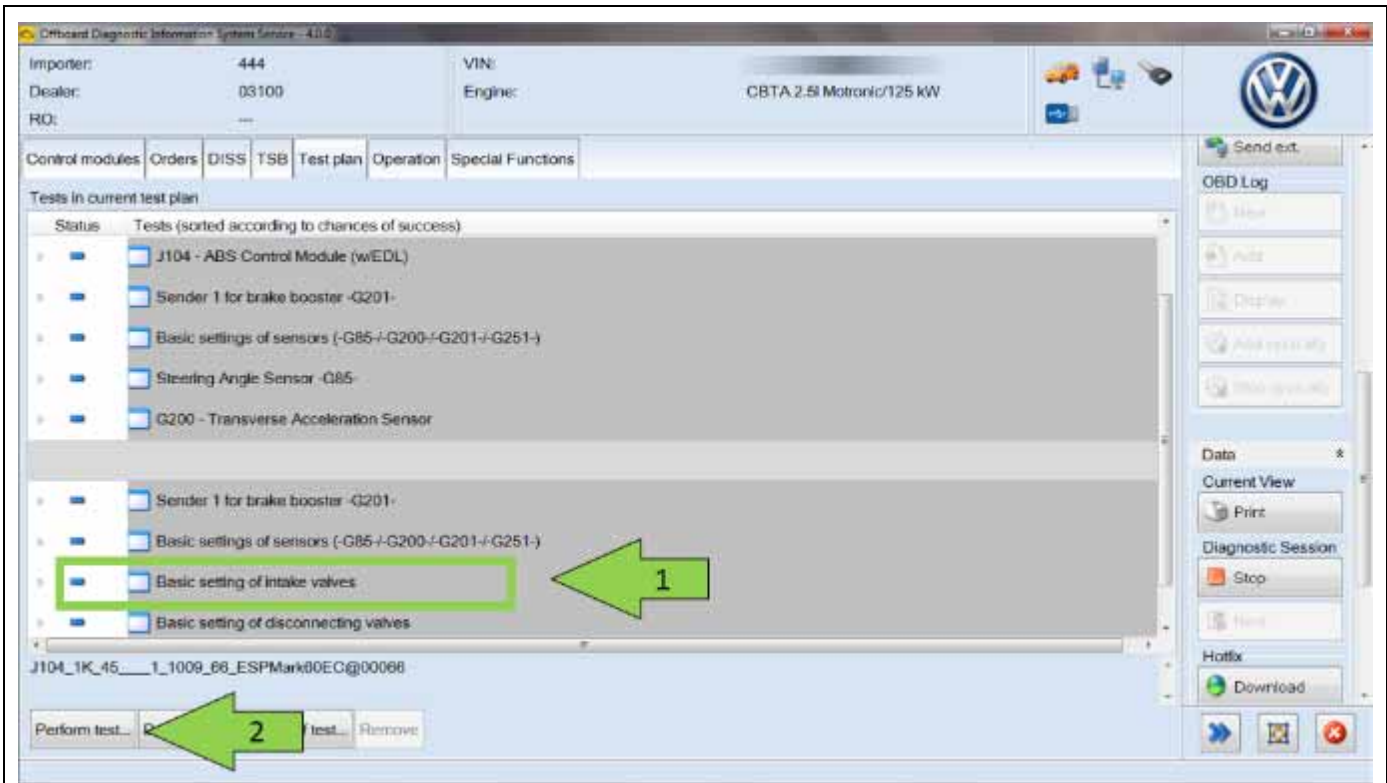
- Once the -G85-/-G200-/-G201-/-G251- faults are cleared, select “Basic setting of intake valves” <arrow 1>.
- Open the hood.
- Select “Perform test..” <arrow 2> and follow on screen instructions.

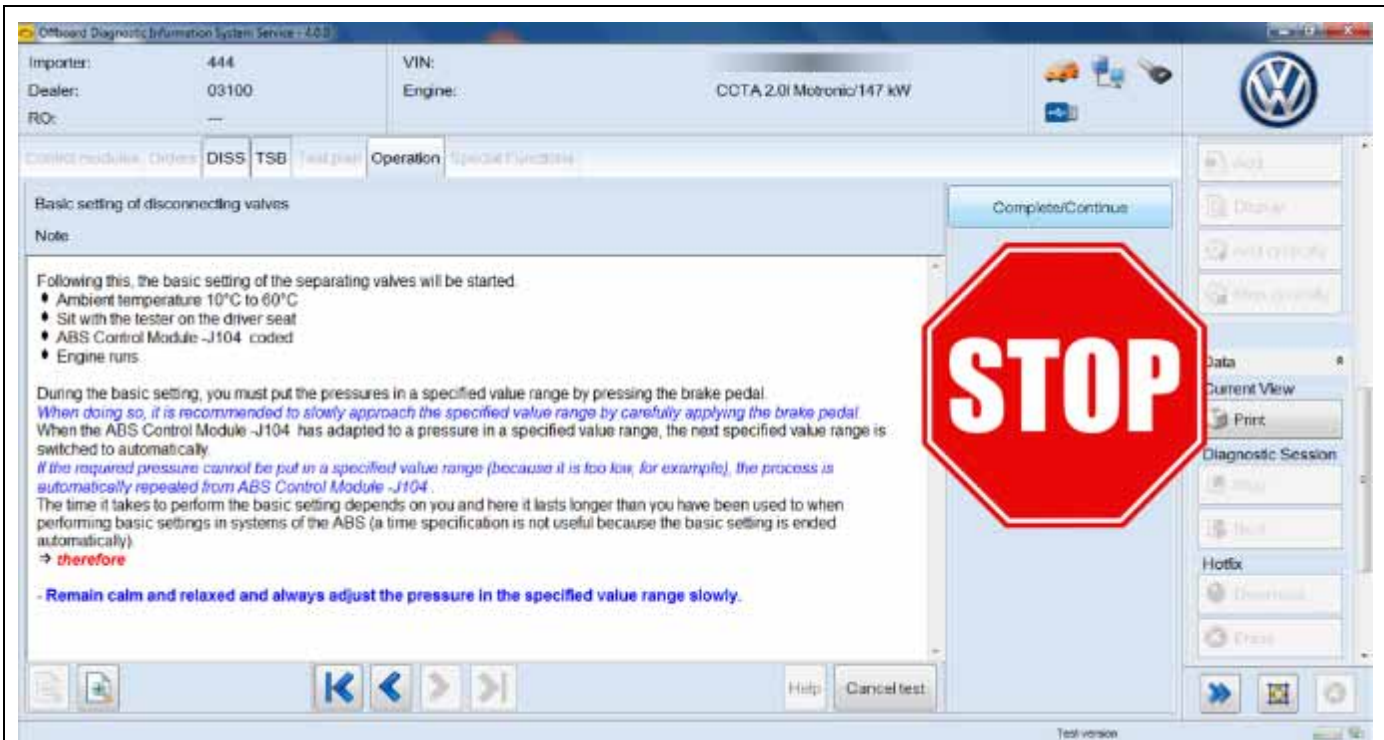
- When this message is displayed, **STOP!**
- Cycle the ignition off for 30 seconds.
- Turn the ignition back on and now press Complete/Continue.
- The test plan for setting the intake valves should now start.

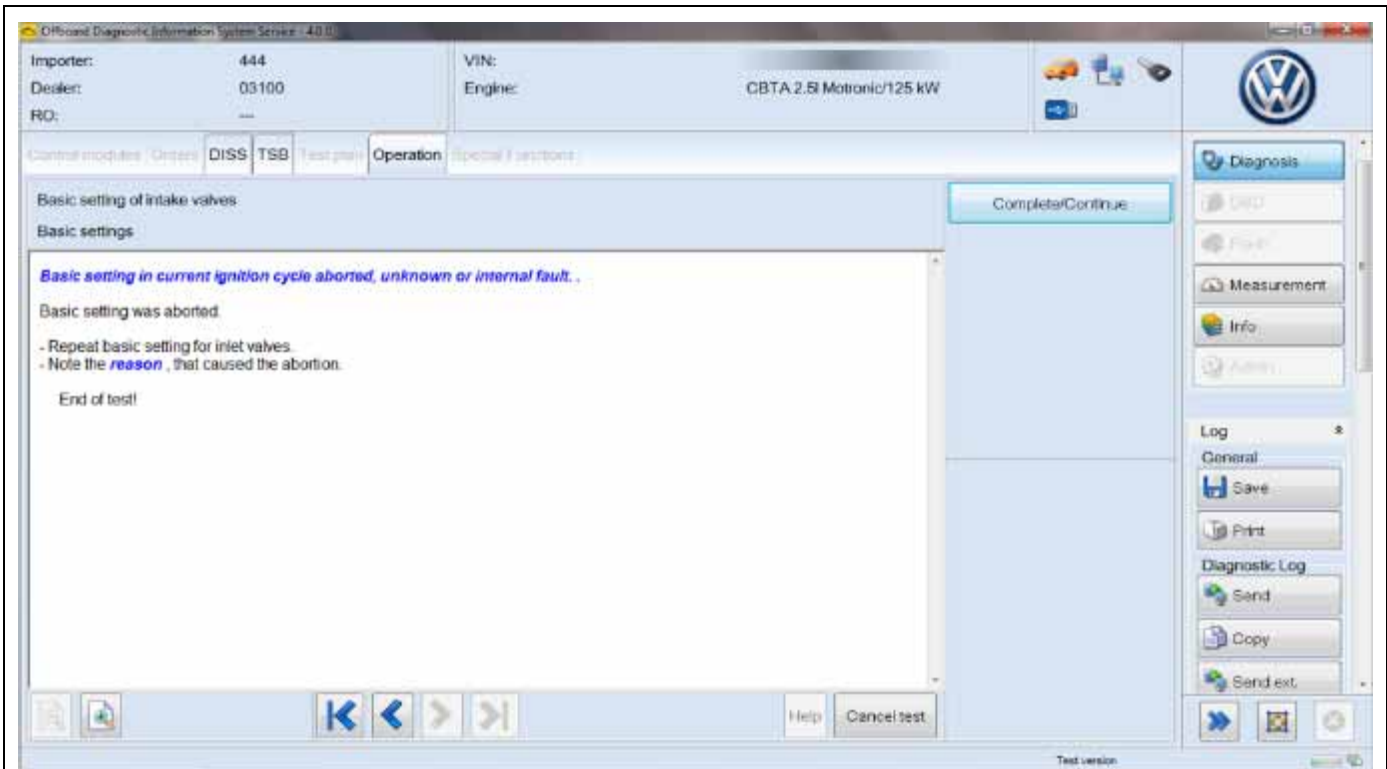
- It is possible that this screen is displayed after starting the “Basic setting of intake valves” test plan. The following have been found to get the test plan to start:
  - Clearing all vehicle system faults using Control Module OBD, cycling the ignition and repeating the test plan.
  - Exiting ODIS, rescanning the vehicle and repeating the test plan.
  - Shutting the engine off and leaving the ignition turned on for 30 minutes.

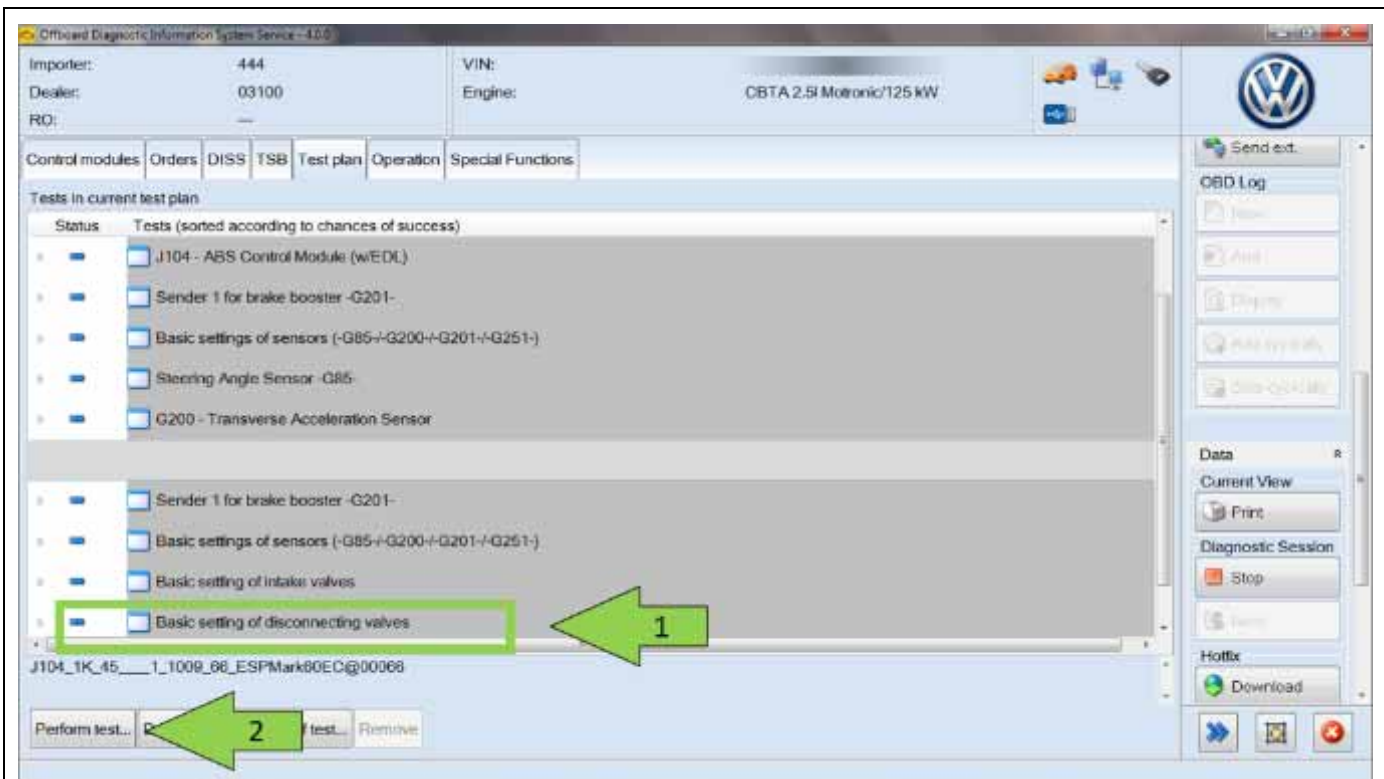
- Once the Basic setting of intake valves is complete, select “Basic setting of disconnecting valves” <arrow 1>.
- Select “Perform test..” <arrow 2>.
- An ignition cycle should not have to be performed.

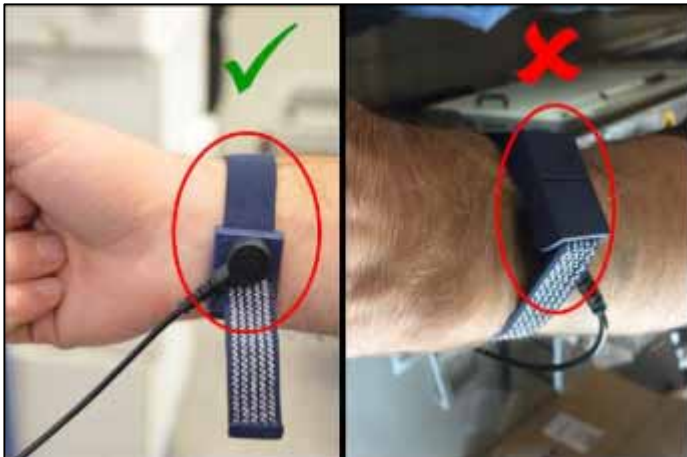
- Prior to beginning work, all parts and tools are to be placed on the ESD table mat.
- Assemble ESD workplace according to the instructions included with the ESD Workplace.
- The wall socket or extension cord used must have a sufficient ground.

The white dots on the wrist strap must be against the skin.
