J081NAS1

TECHNICAL BULLETIN

SAFETY RECALL: Autoliv Seatbelt Operation

MODEL:	MODEL YEAR:	VIN:	ASSEMBLY PLANT:
F-TYPE (X152)	2017	K41657-K46354	Castle Bromwich
XE (X760)	2017	960928-971795	Halewood

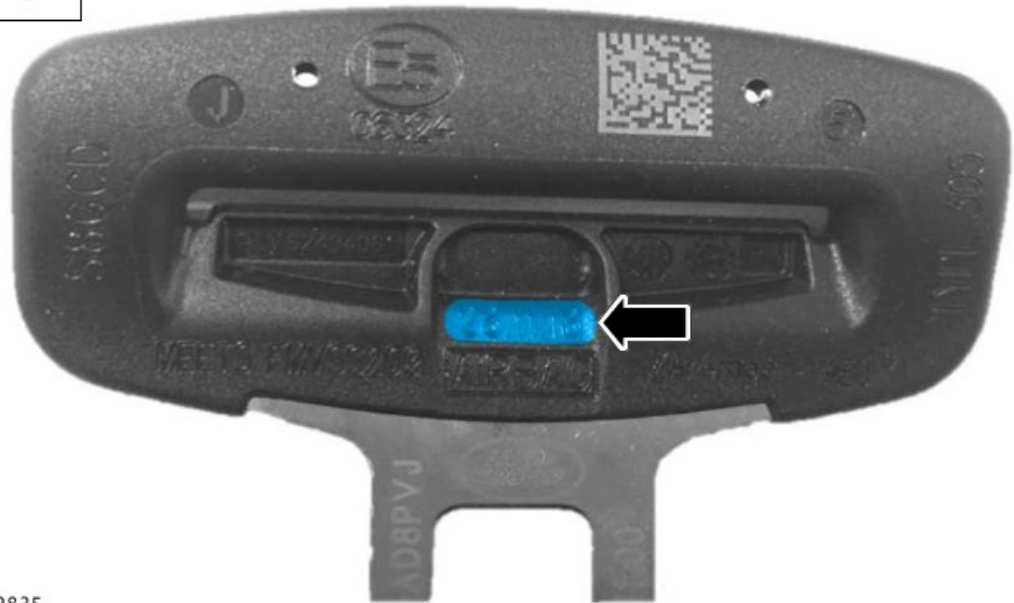
E202835

Record the seatbelt anchor date on the repair order.

4 Repeat steps 1-3 on front row seating right seatbelt anchor.

5 Check the left and right seatbelt dates for one of the following:

If both seatbelts do not have one of the listed date codes, release the vehicle.

If either seatbelt has any of listed date codes, **HOLD** the vehicle.
