P095NAS2

TECHNICAL BULLETIN

501-20A

SAFETY RECALL: Autoliv Seatbelt Operation

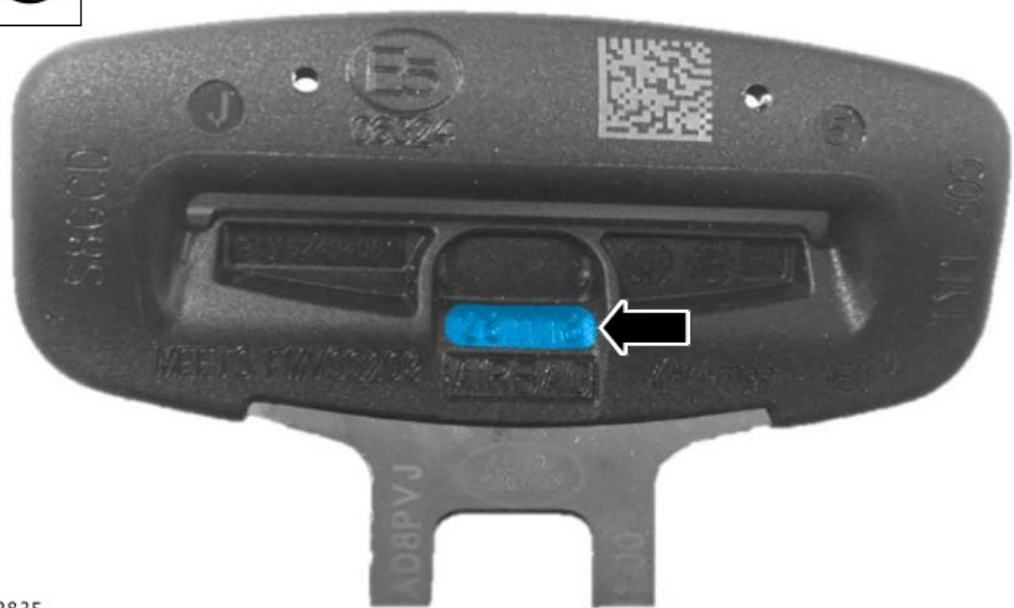
E202835

Record the left seatbelt production date **AND** production part number on the repair order.

5 Check the left and right seatbelt production date **AND** corresponding production part numbers against the table above:

If both seatbelts do not have one of the listed seatbelt production dates **AND** corresponding production part number, release the vehicle.

If either seatbelt has any of listed date codes **AND** corresponding production part number, **HOLD** the vehicle.

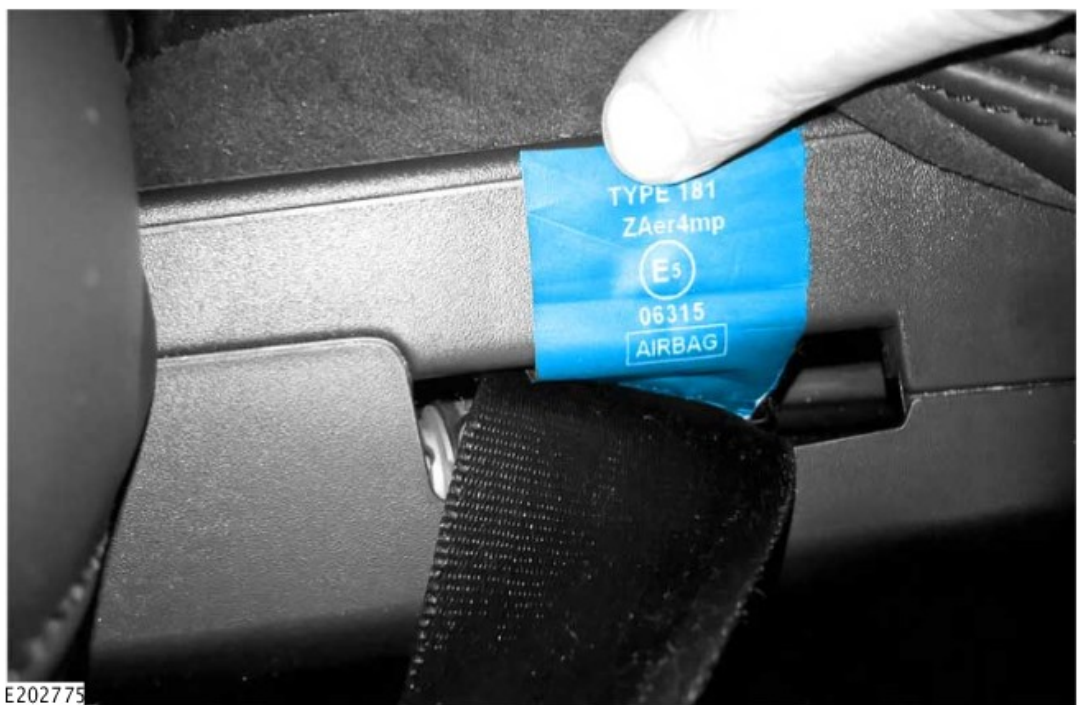
2

Locate the label on the front row seating right seatbelt.

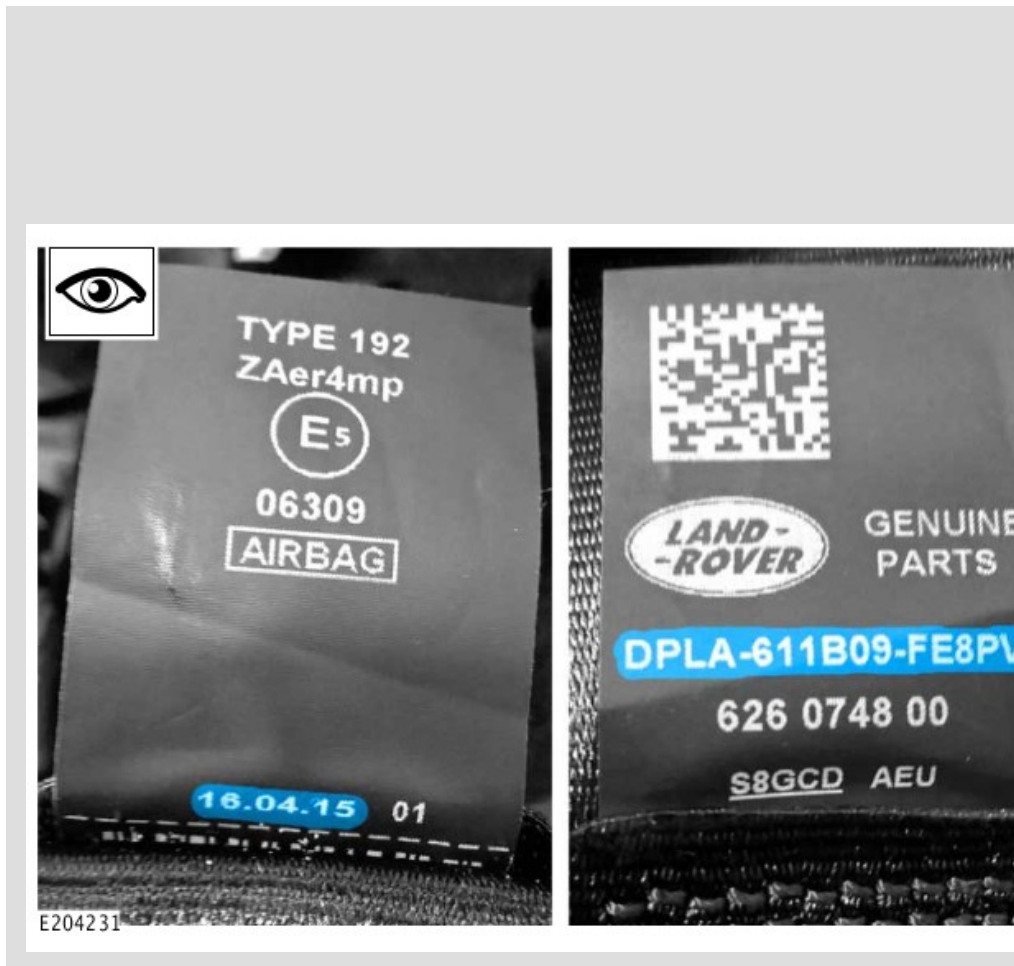
3

The label may need to be folded back away from the seatbelt to read the printed information.

Record the left seatbelt production date **AND** production part number on the repair order.

- 4 Repeat steps 1-3 on the front row seating left seatbelt.
- 5 Check the left and right seatbelt production date **AND** corresponding production part numbers against the table above:

If both seatbelts do not have one of the listed seatbelt production dates **AND** corresponding production part number, release the vehicle.

If either seatbelt has any of listed date codes **AND** corresponding production part number, **HOLD** the vehicle.
