DATE: FEBRUARY 8, 2017
TO: BLUE BIRD OWNERS
SUBJECT: RECALL R16YK, TRANSPEC STOP ARM
Non-Compliance FMVSS 131 – School Bus Pedestrian Safety Devices

NHTSA Recall Number: 16V-006 School Bus

**Subject: RECALL R16YK, Transpec Stop Arm
Non-Compliance FMVSS 131 – School Bus Pedestrian Safety Devices**

Transpec Stop Arm Blade Assembly Replacement

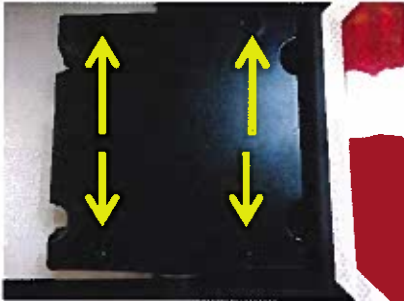
1. Disconnect power from stop arm (i.e. remove fuse)
2. Unfasten (4) screws and remove Stop Arm cover.

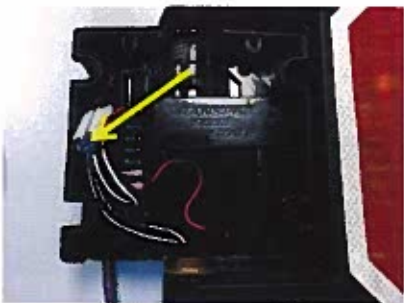
3. Disconnect Wiring Harness.

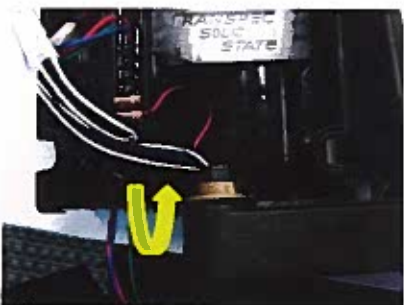
4. Separate the bottom end of the blade from the base.

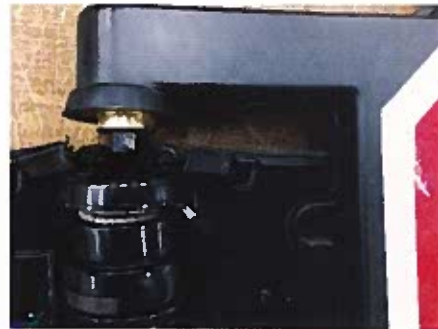
5. Separate the upper end of the blade from the clutch/motor shaft.

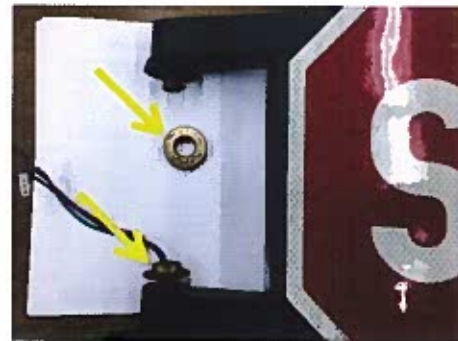
6. Remove brass bushings and reinstall on new blade.

7. Reinstall new blade inserting the top end of the assembly first.
8. Reconnect wiring harness
9. Check the placement of the gasket then, reinstall cover.
10. Test operation.
