**DATE:** JULY 6, 2016  
**TO:** BLUE BIRD OWNERS  
**SUBJECT:** RECALL R16YK  
Transpec Stop Arm

## IMPORTANT SAFETY RECALL NOTICE

**Subject: RECALL R16YK, Transpec Stop Arm  
Non-Compliance FMVSS 131 – School Bus Pedestrian Safety Devices**

### Transpec Stop Arm Blade Assembly Replacement

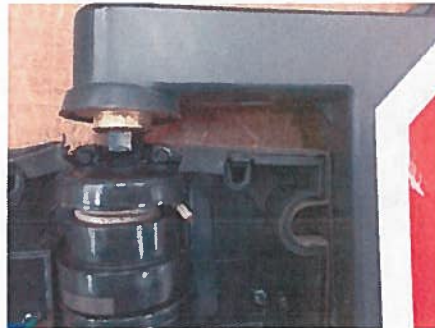
5. Separate the upper end of the blade from the clutch/motor shaft.
