# SAFETY RECALL NOTICE

## IMPORTANT SAFETY RECALL RVXX1601 NHTSA RECALL # 16V-095 – 2ND

# Inspection and Replacement Criteria for Drag Links

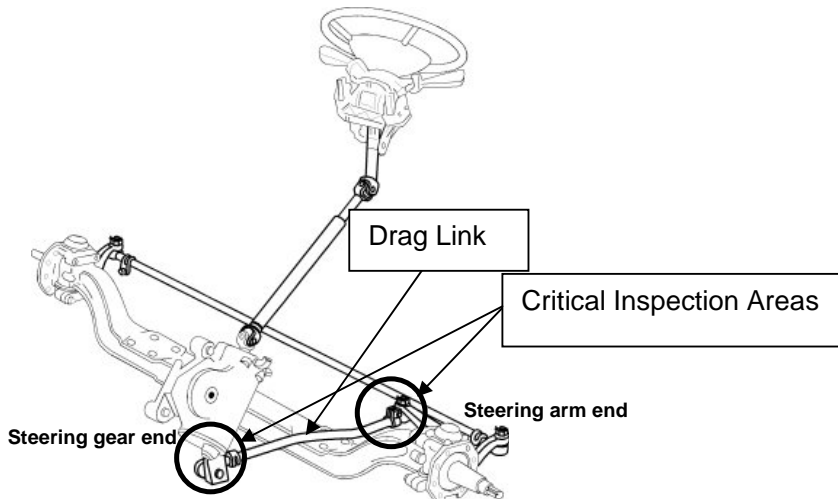
Figure 1

The image above shows the draglink and critical inspection areas. These areas **must be visually inspected daily** for damaged components; missing bolts, nuts, cotter pins; and for damaged sealing boots. Any problems found should be recorded on the daily inspection report.

The drag link ball sockets also require inspection for wear on a quarterly basis or at 25,000 miles (40,234 kilometers), whichever comes first. This is done by pushing and pulling on the drag link by hand to see if there is any movement in the ball socket.

**DANGER! Any movement, other than rotational, measured with hand pressure (i.e., 50 lbs of pressure), requires placing the vehicle out of service for immediate drag link or socket replacement. Complete loss of steering may occur!**

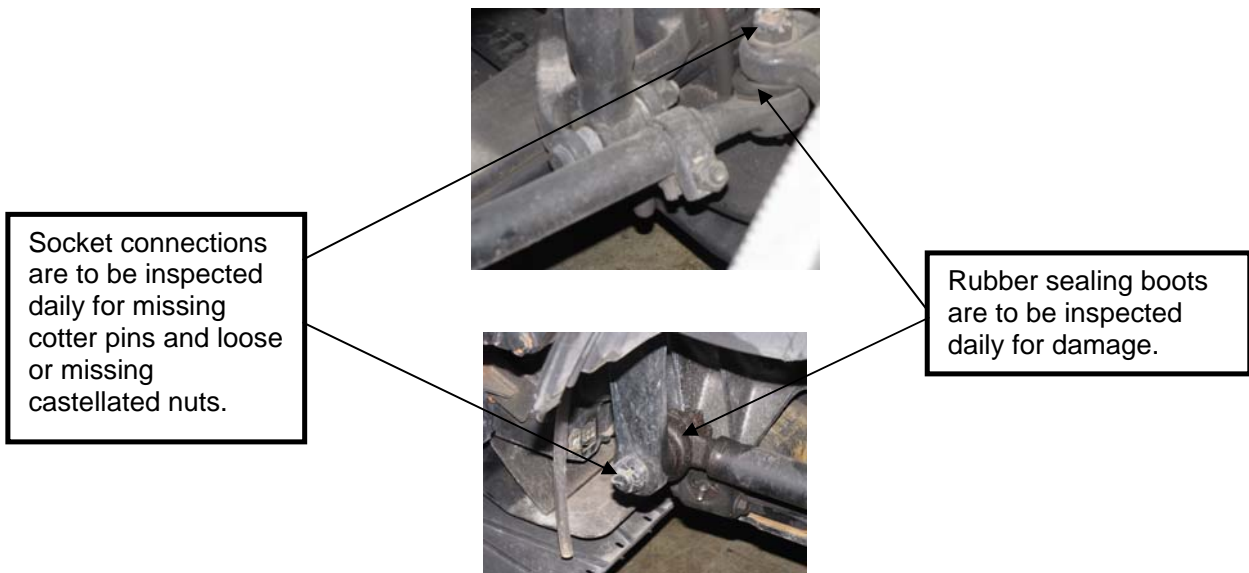
### **Step 1: Inspect for damaged or torn sealing boots and loose or missing attachment nuts and cotter pins.**

Any form of tear in the rubber sealing boot requires drag link or ball socket replacement.

Missing cotter pins and loose or missing castellated nuts are to be repaired before driving the vehicle.

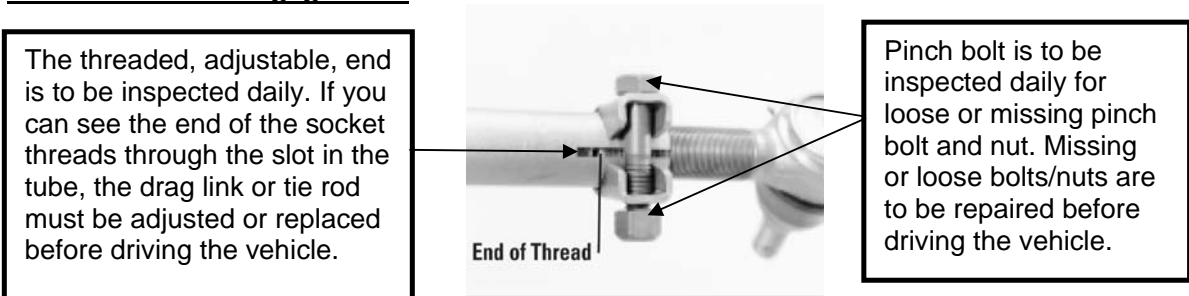
### **Step 2: Inspect the adjustable end of drag link for loose or missing pinch bolt and for socket thread engagement.**

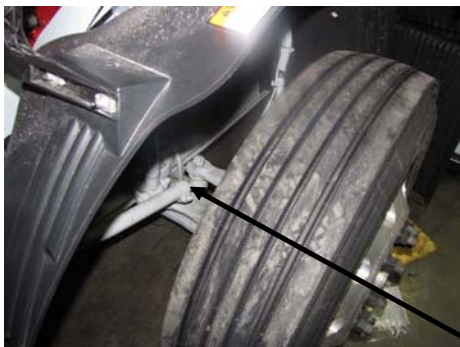
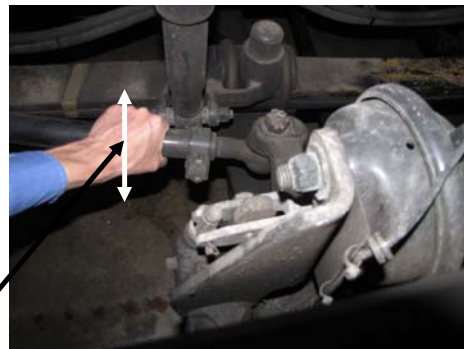
At the steering arm end (i.e., the adjustable end), **push down and pull up** on the drag link in a direction toward the ground by reaching over the driver's side front tire. **Any movement requires placing the vehicle out of service for immediate replacement of the ball socket.**

The adjustable end is the rearmost end and is to be checked by pushing down and pulling up on the drag link.

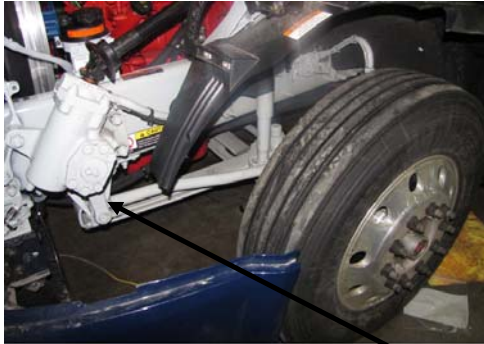
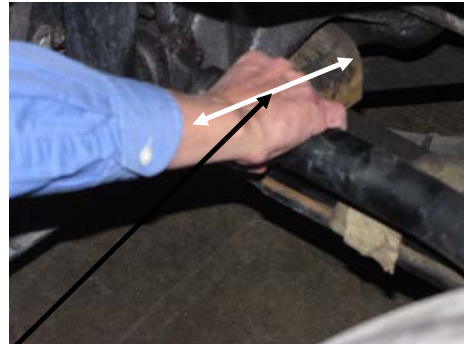
At steering gear end (i.e., the fixed end), **push in and pull out** on the drag link in a direction toward the engine. **Any movement, other than rotational, requires placing the vehicle out of service for immediate replacement of the drag link.** Rotational movement is normal and is explained on the bottom of this page.

At steering gear end (i.e., the fixed end), push in toward the engine and then pull back out.

If no movement is detected by hand, the socket is operable.

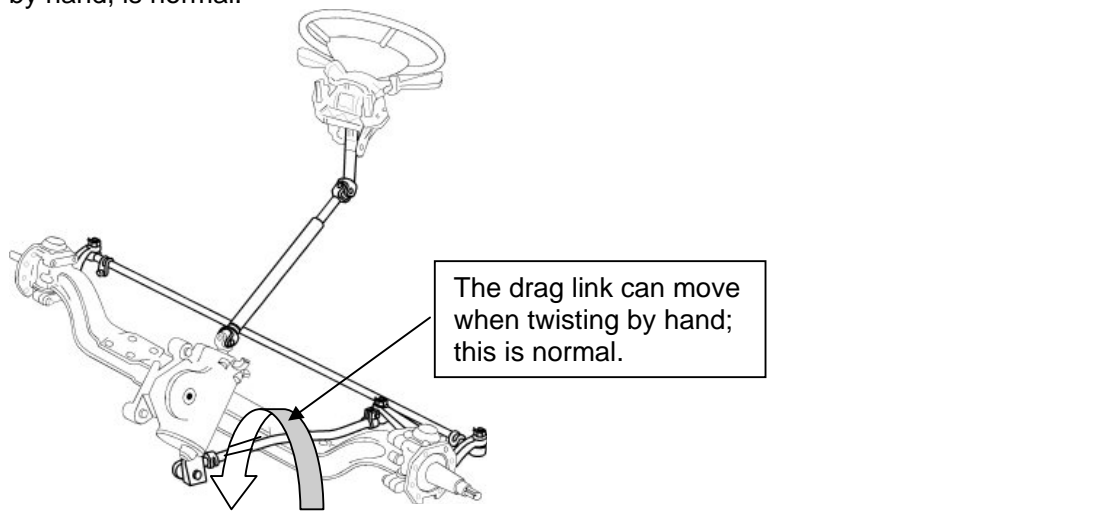
**Important Note:** Rotational Movement, movement when twisting or rotating the drag link by hand, is normal.
