BLUE BIRD

DATE: JANUARY 30, 2017
TO: BLUE BIRD OWNERS
SUBJECT: RECALL R16YT: PROPANE FUEL LINE ROUTING

Subject: RECALL R16YT, Propane Fuel Line Routing

Propane Fuel Line Routing

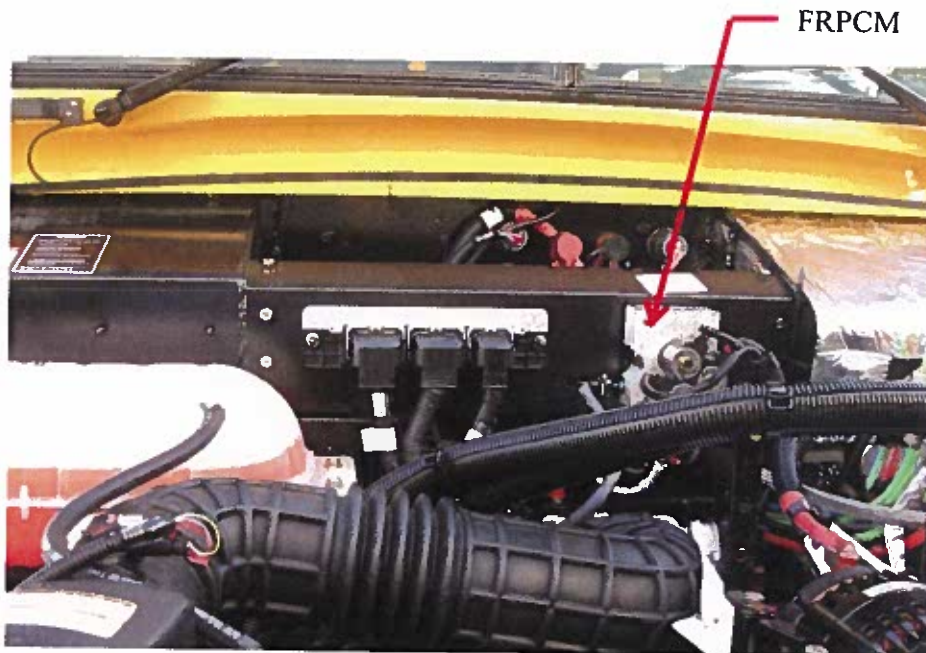
1. Park bus on level surface, apply parking brake, turn off ignition, remove key, and chock wheels.
2. Disconnect batteries.
3. Open hood and locate propane fuel lines from Fuel Rail Pressure Control Module (FRPCM) to the rear of the engine.

INSPECT FUEL LINE ROUTING BELOW FRPCM

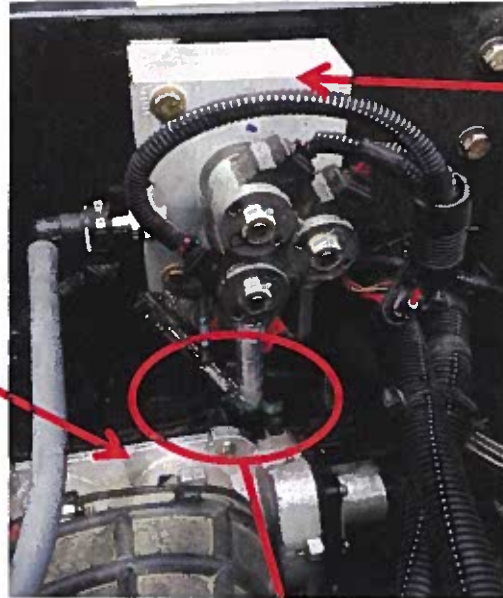
FRPCM

Throttle body and air intake tube

Fuel line damaged from contact with air intake tube

4. Inspect for clearance between the fuel lines and the air intake tube.
5. If the fuel lines are contacting the air intake tube, inspect for damage to the fuel lines and follow reroute instructions.

6. See Page 6 for help in identifying a good or damaged fuel line. If any fuel lines are damaged, follow replacement instructions.

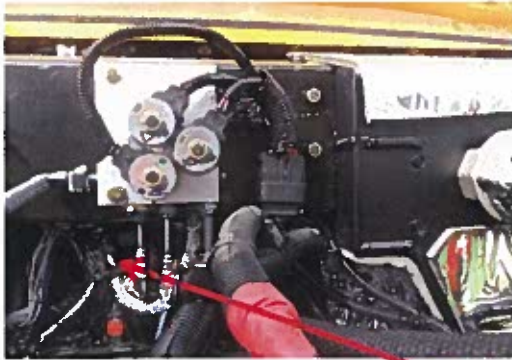
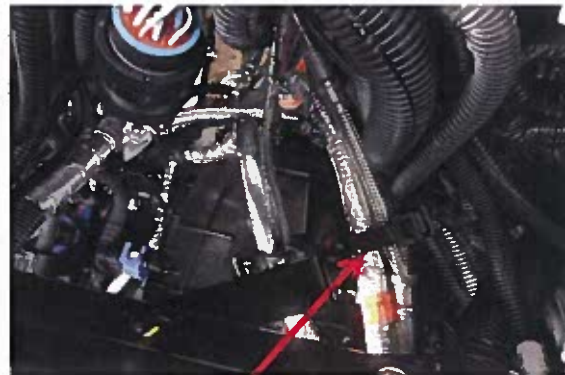
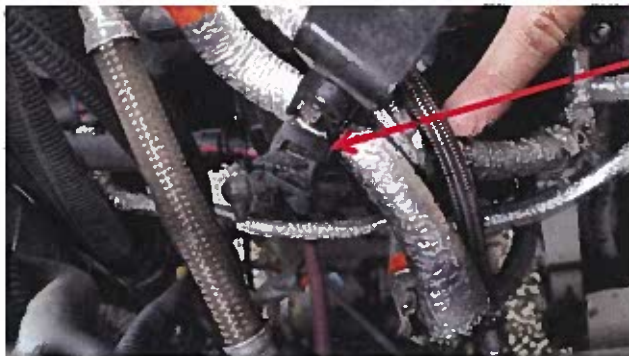
INSPECT FOR CROSSED AND RUBBING FUEL LINES

Cable tie and heavy duty cable mounts

These are examples of fuel lines routing where the fuel lines may be crossed and/or rubbing. These lines must be rerouted, per instructions on Page 4. Remove existing cable ties from both heavy duty cable mounts.

7. Fuel lines may have been installed where they contact each other. If the lines are rubbing or crossed, then the fuel lines may become damaged. Remove the cable ties from both heavy duty cable mounts and inspect the fuel lines for any damage. If the fuel line has been damaged, follow fuel line replacement instructions.

Do not remove heavy duty cable mounts just the cable ties.

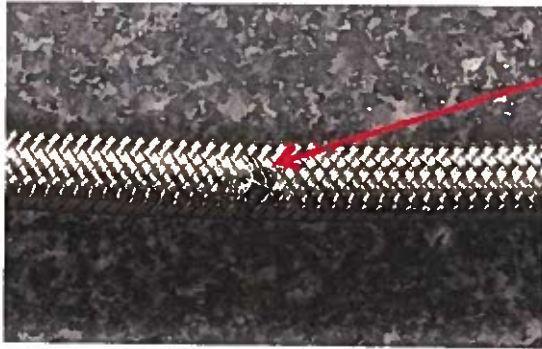
Steel braid has been damaged, fuel line **MUST** be replaced.

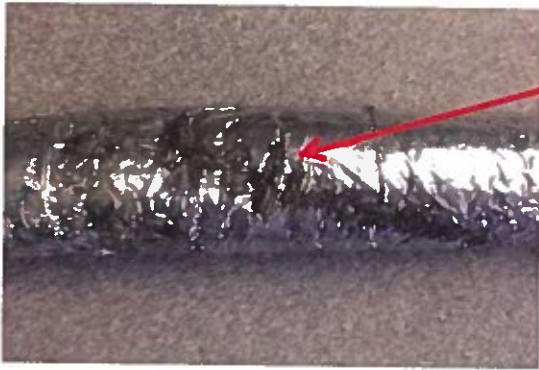
Witness mark only, Do Not Replace.

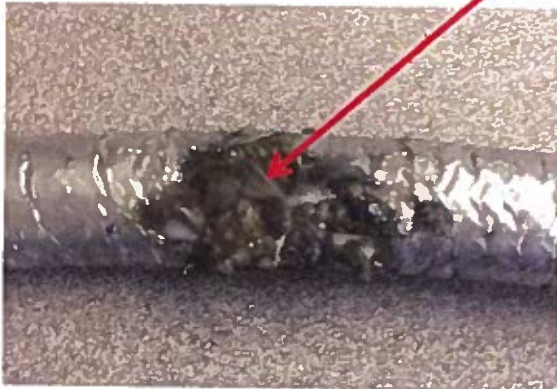
Visible fiberglass damage shown on Roush Fuel Line. If the heat sleeve is worn through to the point that the fiberglass is visible like shown, then it is recommended that it be replaced. As long as the line underneath shows no damage to the braid then a replacement sleeve can be installed over the line. Please contact **ROUSH CLEANTECH** at Phone Number: **800.59.ROUSH** or e-mail ROUSHcleantech.com with any questions regarding Roush's procedures.

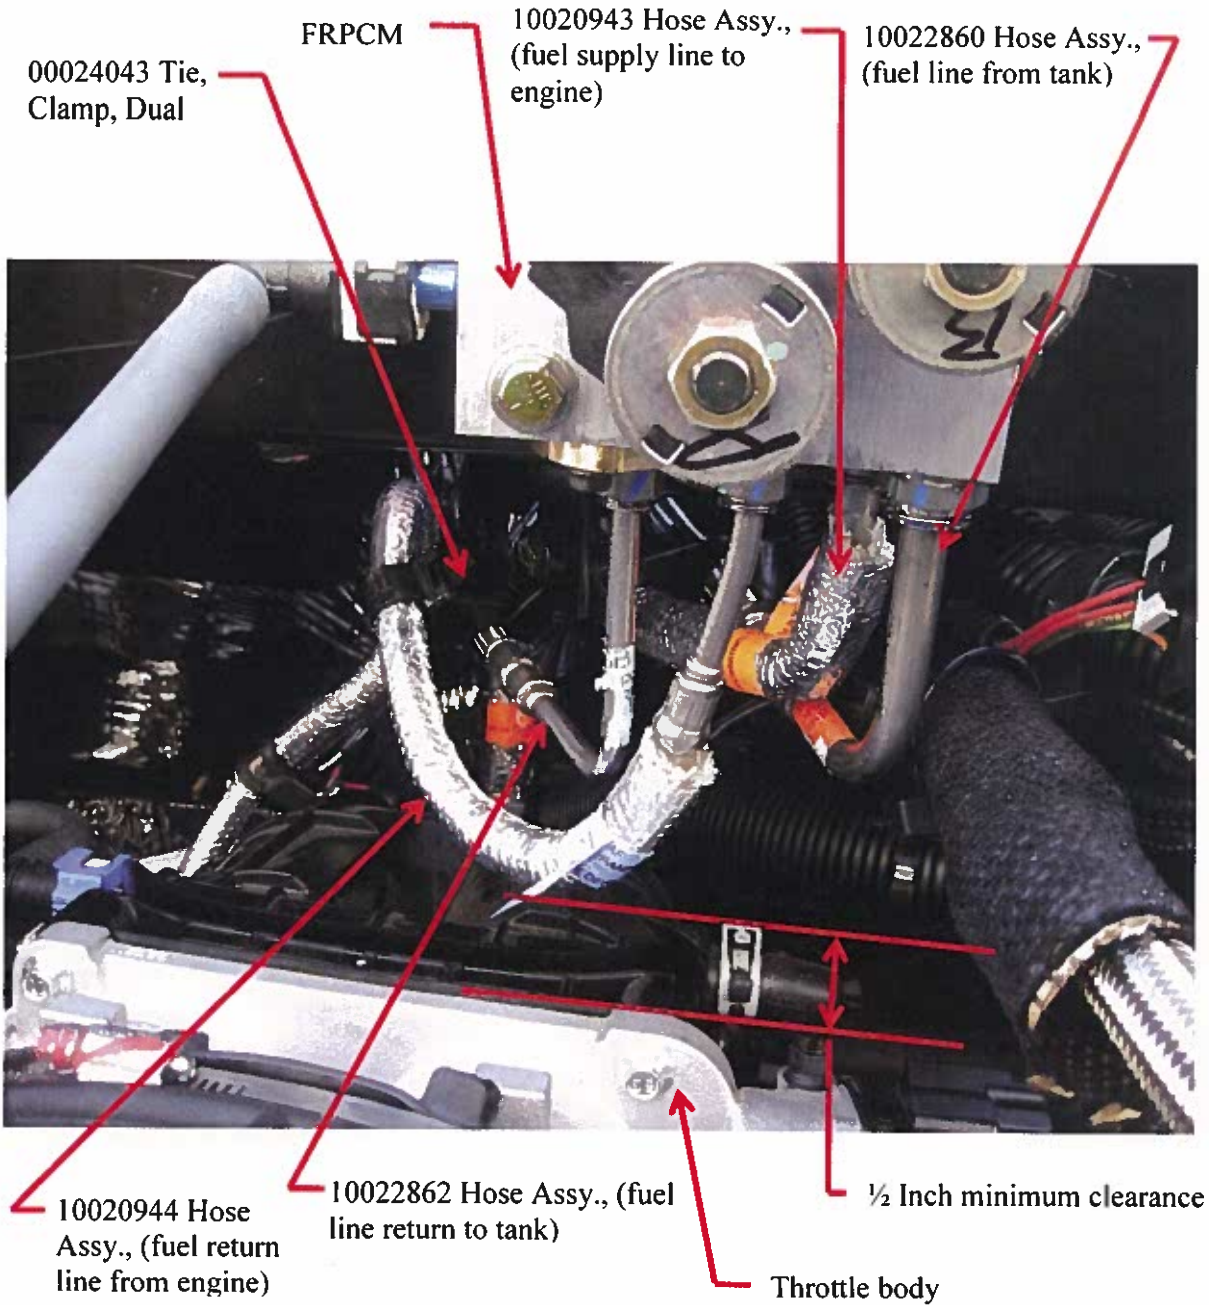
Photo 1
(Viewed from front of engine)

PROPER ROUTING AND CLAMPING

5. Using Photo's 1, 2, 3, and 4 in the **Proper Routing and Clamping Section** as your guide, reroute the four fuel lines to be parallel with each other. Install two or three dual clamp ties Part Number 00024043 to maintain separation.

- b. **Be sure to follow ALL of the Warnings and Cautions in the propane section of Blue Bird Service Manual.**
6. Maintain 1/2 inch minimum clearance between the throttle body/air intake tube and the bottom of the fuel lines (See Photo 1).

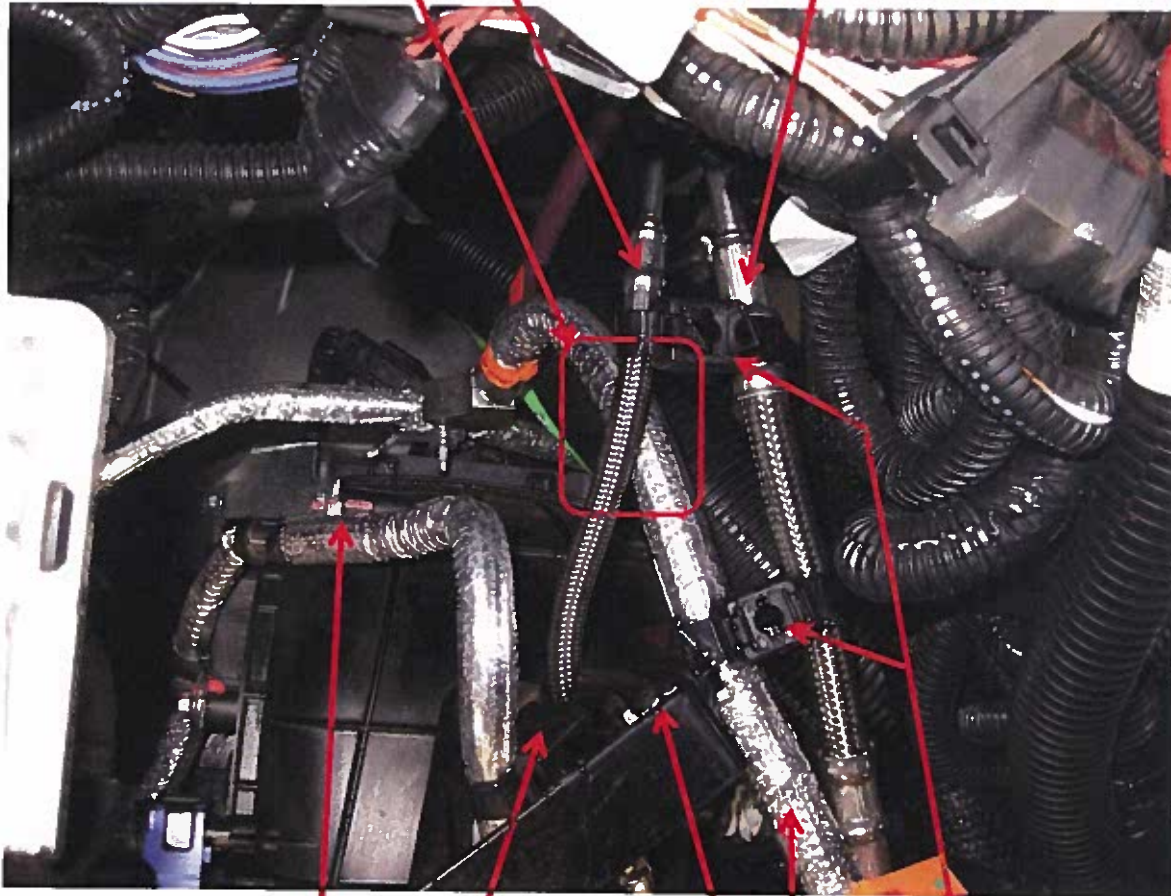
Photo 2
(Viewed looking down on top of engine with air brakes)

Note: Ensure there is a minimum of 1/2 inch clearance between hoses.

10022862 Hose Assy., (fuel line return to tank)

10022860 Hose Assy., (fuel line from tank)

10020944 Hose Assy., (fuel return line from engine)

Existing support bracket and two heavy duty cable mounts

00024043 Tie, Clamp, Dual

10020943 Hose Assy., (fuel supply line to engine)

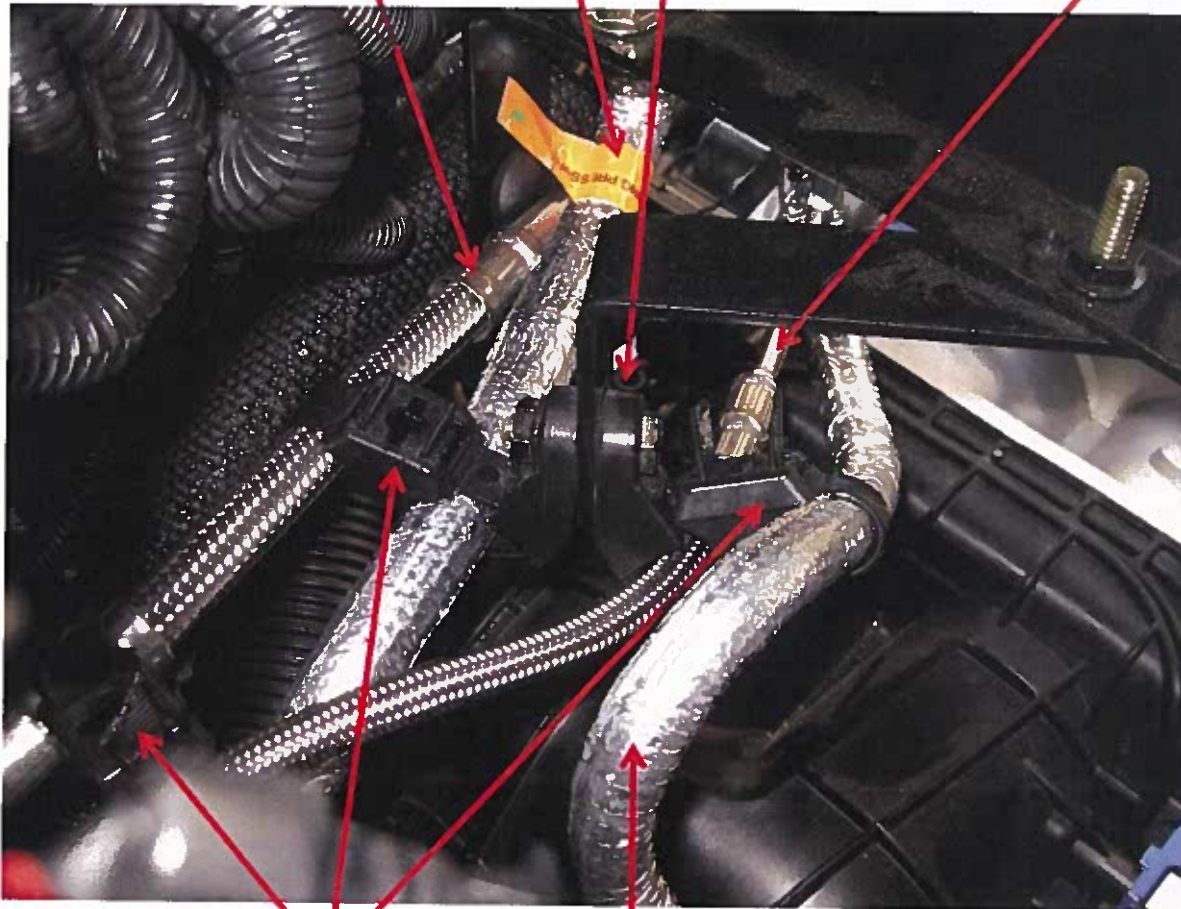
Photo 3
(Viewed from rear of engine looking forward with air brakes)

10020943 Hose Assy., (fuel supply line to engine)

10022860 Hose Assy., (fuel line from tank)

Existing support bracket and two heavy duty cable mounts

10022862 Hose Assy., (fuel line return to tank)

00024043 Tie, Clamp, Dual

10020944 Hose Assy., (fuel return line from engine)

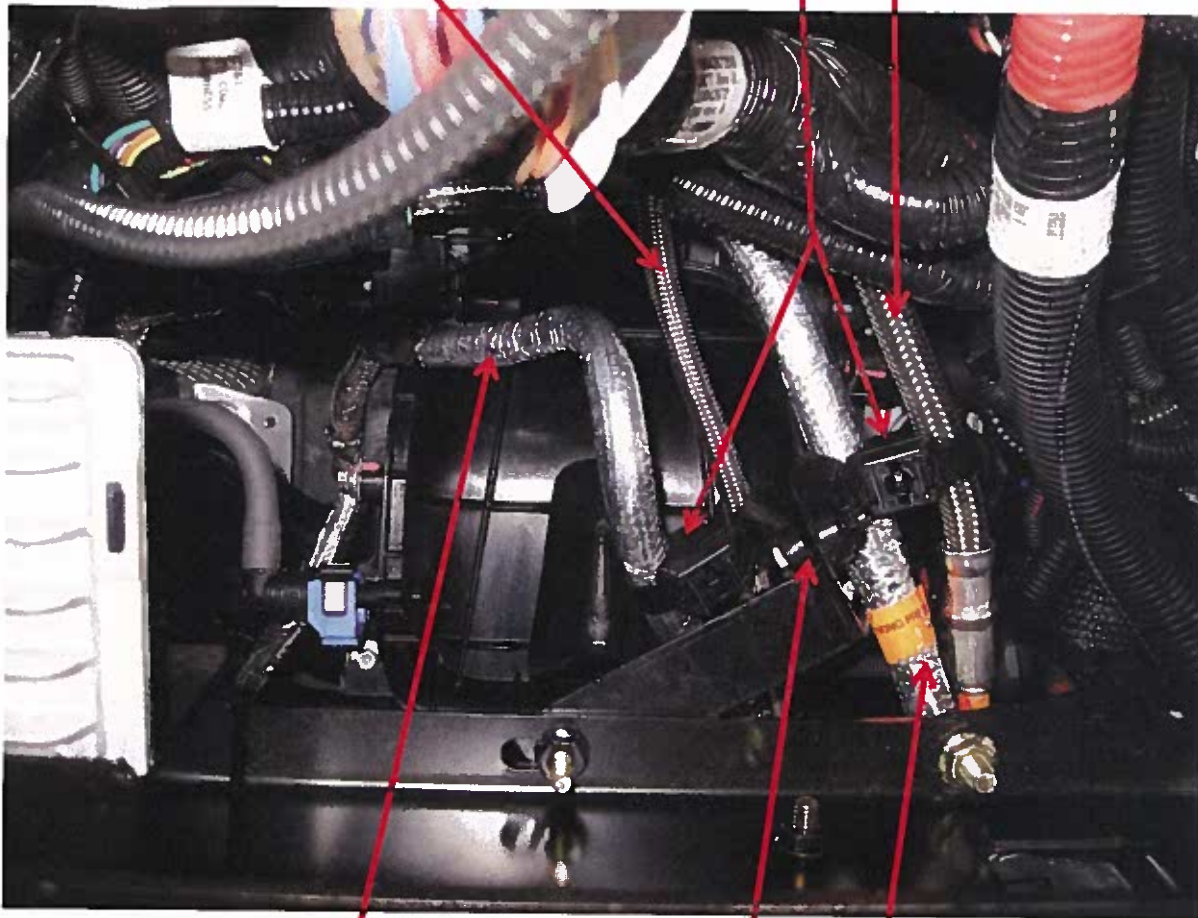
Photo 4
(Viewed looking down on top of engine with hydraulic brakes)

10022862 Hose Assy.,
(fuel line return to tank)

00024043 Tie, Clamp, Dual

10022860 Hose Assy.,
(fuel line from tank)

10020944 Hose Assy.,
(fuel return line from
engine)

Existing support bracket
and two heavy duty
cable mounts

10020943 Hose Assy.,
(fuel supply line to
engine)

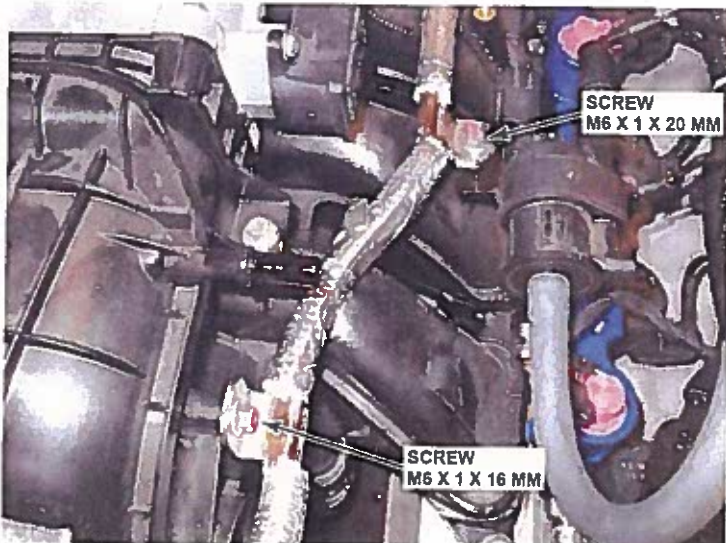
100397a

- a. Remove and discard (2) fuel return line bracket screws M6 x 1 x 20 and M6 x 1 x 16 as shown below.

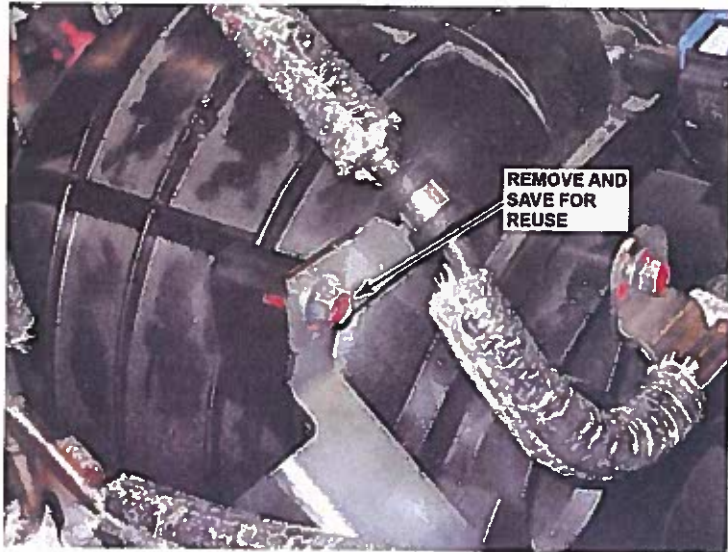
100380a

- b. Remove (1) M6 X 1 X 16 screw and save for reuse. Remove the fuel return line from the engine.

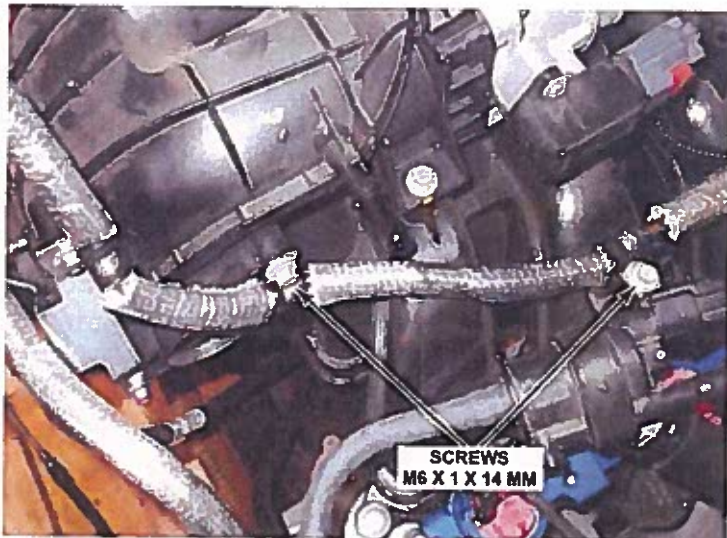
100409a

14. Remove (2) M6 x 1 x 14 screws and (1) M6 x 1 x 16. Save mounting screws for reuse. Remove the fuel return line from the engine.

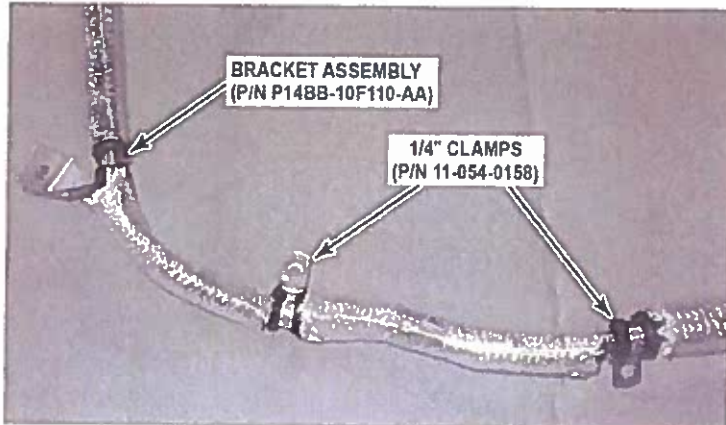
100407a

15. By hand, slightly spread open the fuel return line bracket assembly (P/N P14BB-10F110-AA) and 1/4" clamps (P/N 11-054-0158). While supporting the fuel return line, install the bracket assembly over the fuel return line. Make sure the rubber portion of the bracket assembly is seated around the fuel return line and is not rolled or pinched. Position the fuel return line bracket assembly against the crimp on the fuel return line.

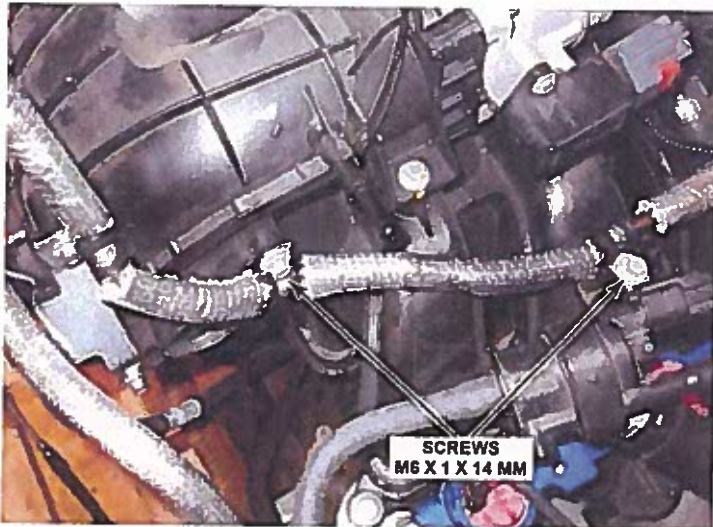
100409a

16. Position the replacement fuel return line onto the engine and connect the fuel return line to both the RH and LH fuel rails.

17. Loosely install two (2) M6 X 1 X 14 mm fuel return line bracket screws.

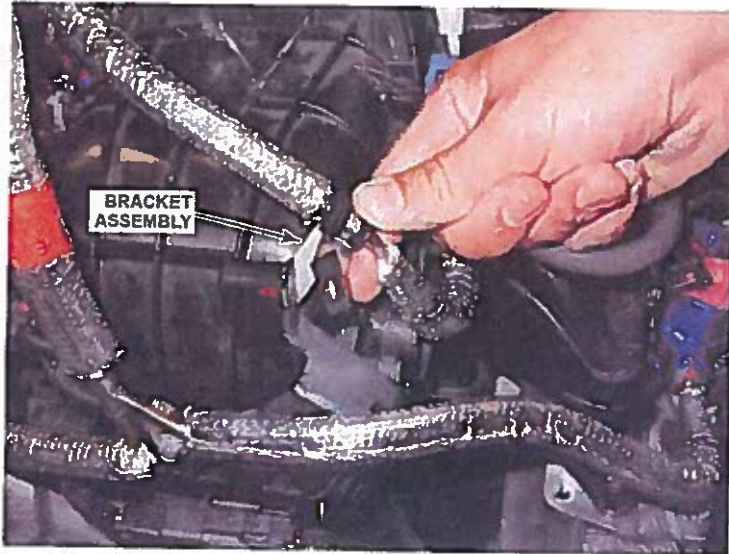
100346a

18. Compress the fuel return line bracket assembly around the fuel return line. Align the fuel return line bracket assembly to the fuel supply line support bracket. Ensure that the bracket assembly does not have to be forced into position.

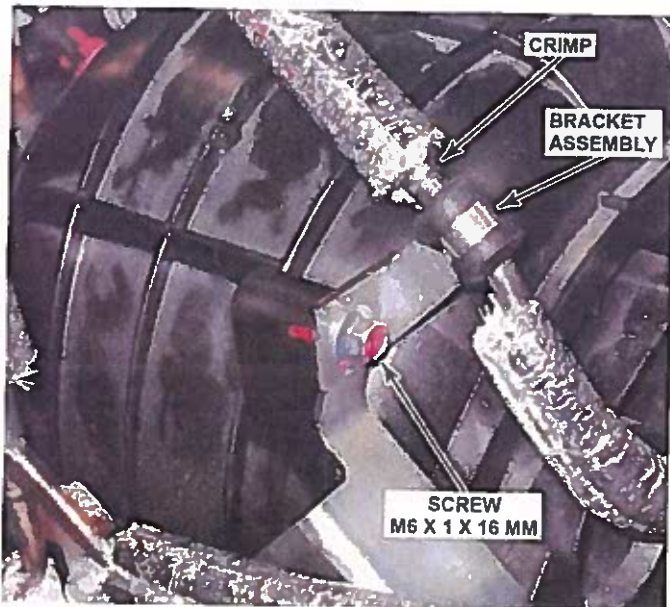
100347b

NOTE: Do NOT bend the fuel return line.

Install the bracket assembly with the previously removed M6 X 1 X 16 mm screw. While tightening, make sure to apply pressure to the back of the bracket assembly to keep it from contacting the intake manifold. Torque to 8-12 Nm and mark the head of the screw after applying specified torque.

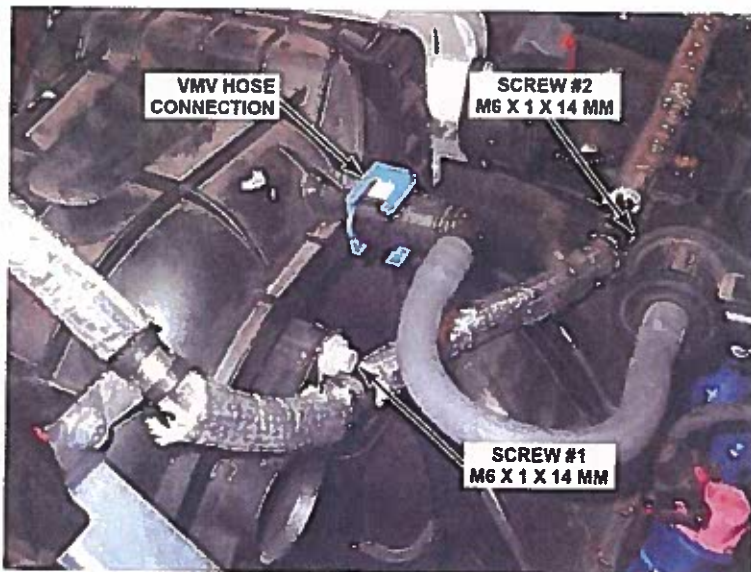
100408a

19. Tighten and torque the remaining fuel return line mounting bracket screws in sequence. Torque screw labeled #1 first followed by screw labeled #2. Torque to 8-12 Nm and mark the head of the screw after applying specified torque.
20. Reconnect the VMV hose to the intake manifold and position lock tab. Verify connection by gently pulling on VMV hose.
