# F/CMVSS Noncompliance Recall

## 50190 Up-Level Headlamp Incorrect Marking

**Reference Number:** N16205019  
**GWM Number:** 2050190

<b>Condition</b>	General Motors has decided that certain 2016 model year Cruze LT and Premier vehicles fail to conform to Federal/Canada Motor Vehicle Safety Standard No. 108, "Lamps, Reflective Devices, and Associated Equipment." The headlamp lenses in these vehicles are not marked with a three-digit identifier code that provides instructions for properly aiming the headlamps, as required by F/CMVSS No. 108. Although the headlamps in these vehicles were properly aimed by the GM assembly facility, if headlamp aim is affected by a crash or other incident, the missing code may be necessary to properly aim the headlamps in servicing. Improperly aimed headlamps may reduce nighttime forward visibility or increase glare for vehicles ahead, which could increase the risk of a crash.
<b>Correction</b>	GM will mail customers and dealers adhesive labels with the correct marking and instructions for applying the label to the headlamp lenses. Customers may bring the vehicles to a dealer for assistance in applying the labels.

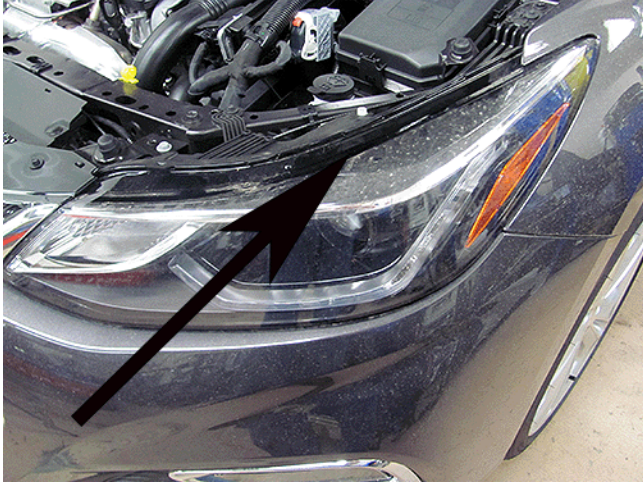
4549669

1. Open the vehicle hood.

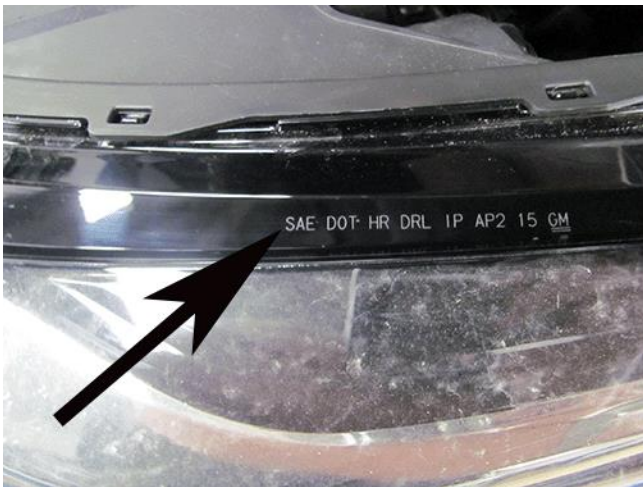
4549671

2. Locate the existing identification information etched into the top edge of both headlamp assemblies.
3. Using a soft dampened towel, clean the area inboard (center of vehicle) of the existing identification information. Use care to not scratch the surface.

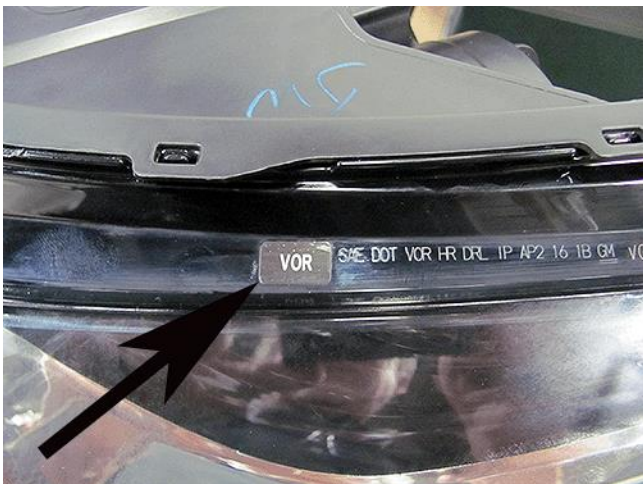
4549674

4. Peel the "VOR" label off of the backing paper and place it approximately 3mm inboard of the existing identification information. Repeat this process on both headlamps.
