# F/CMVSS Noncompliance Recall

## 53501 Tire and Loading Information Label Incorrect

**Reference Number:** N162053501  
**GWM Number:** 2053501  
**Revision Description:** This bulletin is being revised to change the Labor Code. Please discard all previous copies of bulletin 53501.

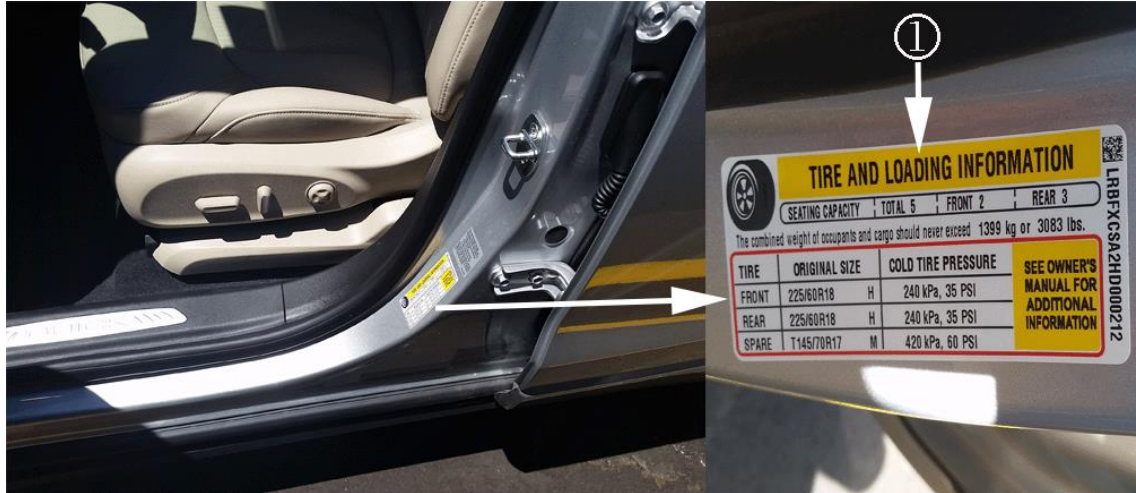
4555806

2. Locate the tire and loading information label (1).
3. Clean the tire and loading information label with isopropyl alcohol (rubbing alcohol) and a clean shop towel.

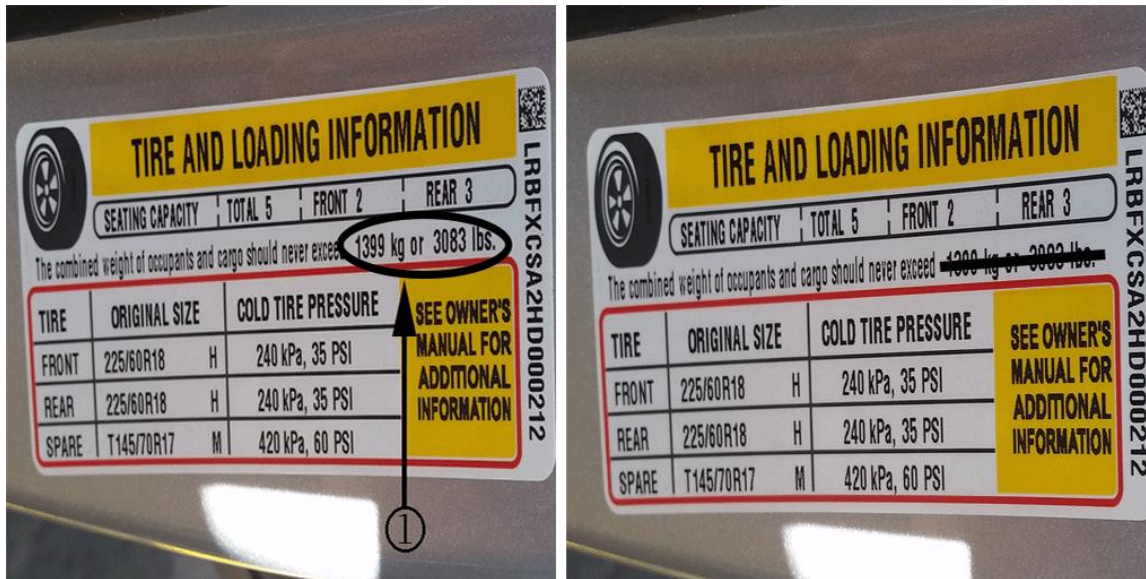
4555809

4. Perform a single strikethrough of the incorrect weight values (1) with a Sharpie Industrial Permanent Ink marker 13601.
