David J. Johnson  
Director  
Service Engineering Operations  
Ford Customer Service Division

September 24, 2018

**SUBJECT: Safety Recall 17S01 – *Supplement #7***  
Certain 2005-2006 Ford GT, 2005-2009 and 2012 Mustang, 2006-2009 Milan,  
2006-2009 and 2012 Fusion and MKZ/Zephyr, 2007-2009 Edge and MKX, and  
2007-2009 Ranger Vehicles  
Passenger Airbag Inflator Replacement

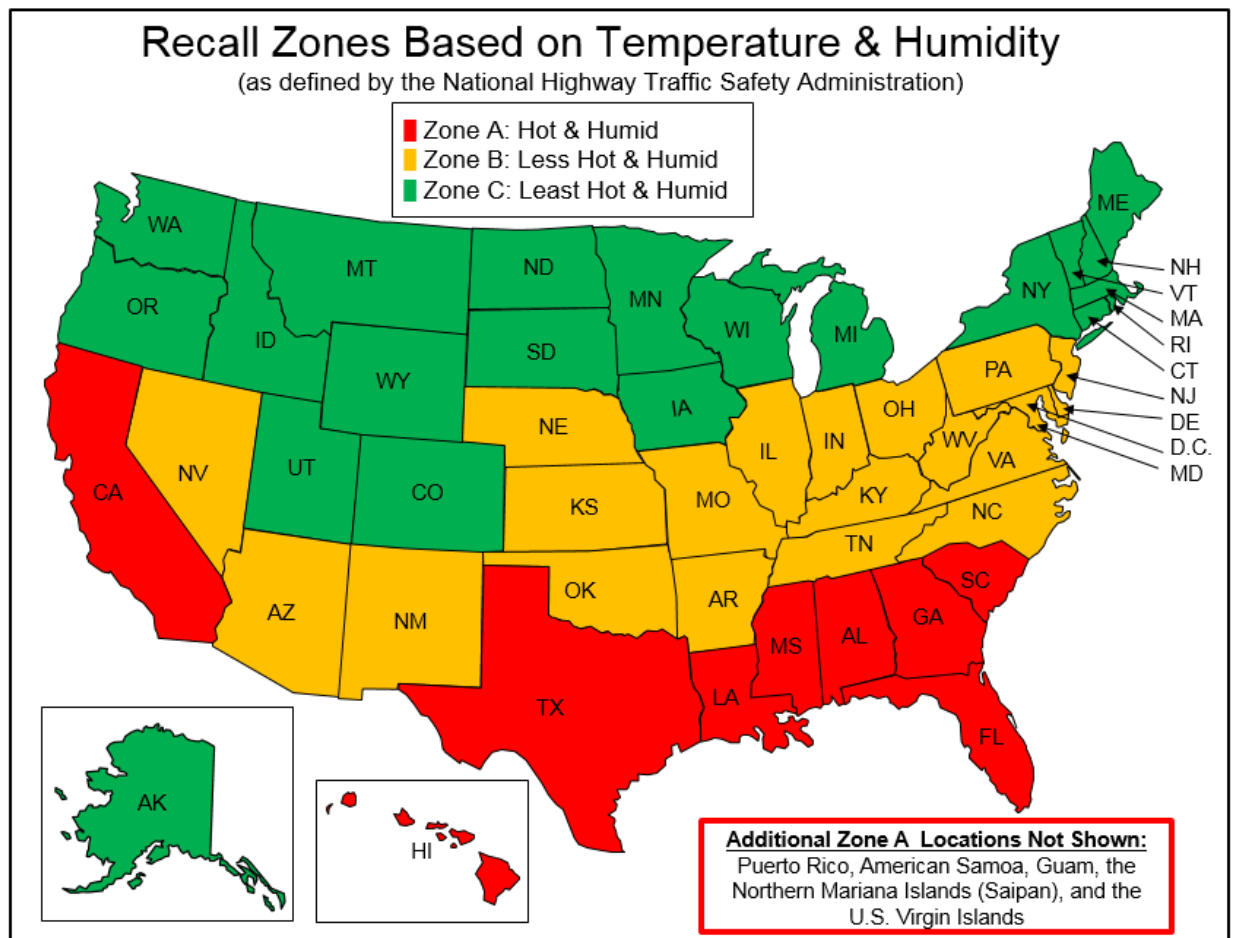
**FIGURE 1**

The Takata airbag recall zones have been defined by the NHTSA, based on temperature and humidity.

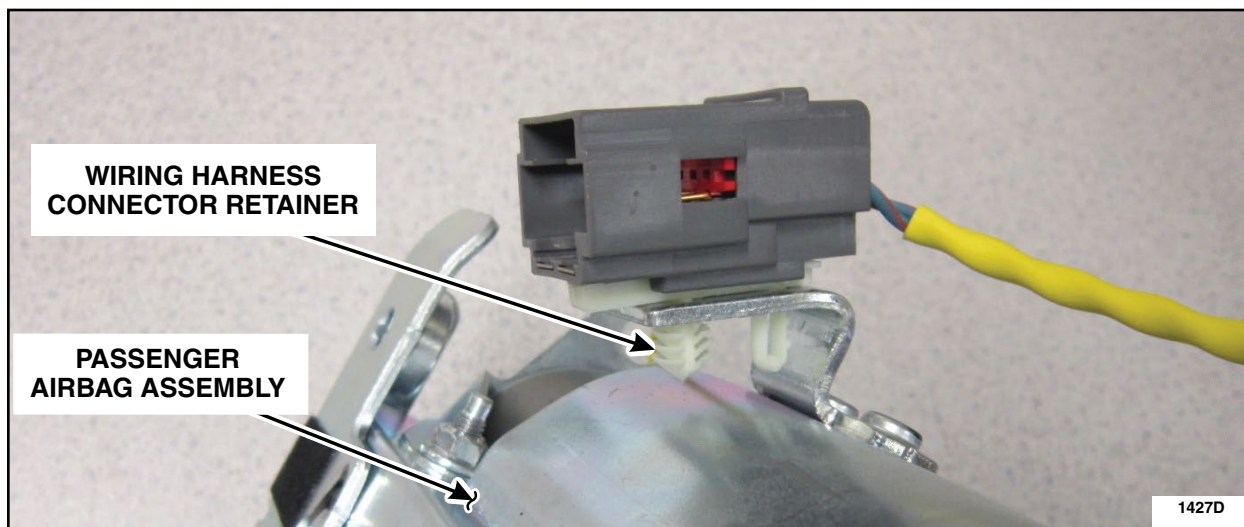
**FIGURE 1**

1. Remove the passenger airbag from the vehicle. Please follow the WSM procedures in Section 501-20B.
2. Set the airbag face down onto a surface that will not scratch or damage the airbag face.
3. Remove the wiring harness connector retainer from the passenger airbag assembly. See Figure 1.

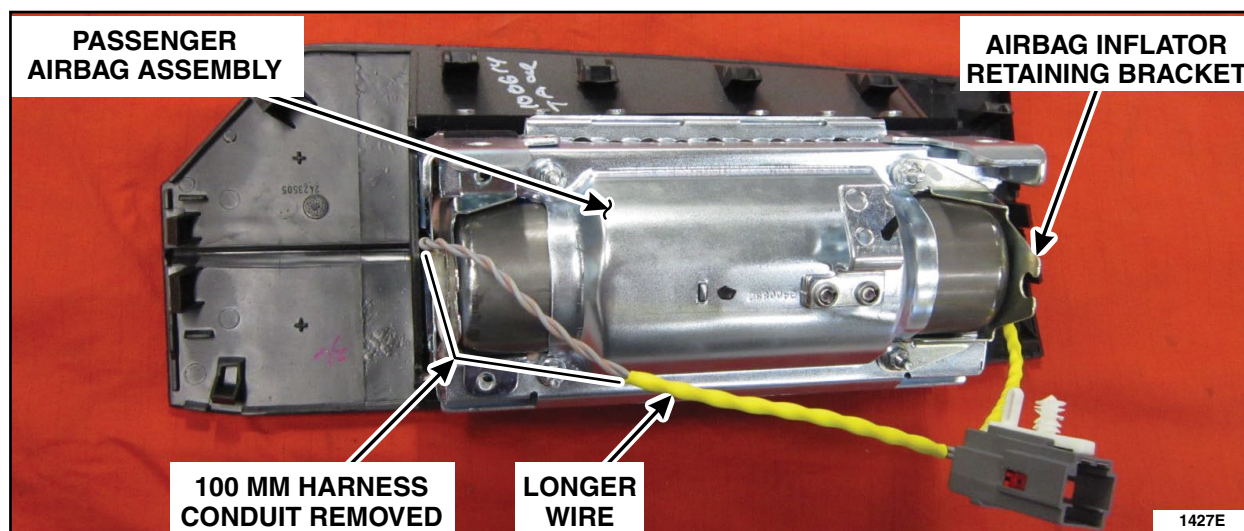
**FIGURE 2**

**NOTE:** Carry out this step on the longer wire on the end opposite of the airbag inflator retaining bracket. See Figure 2.

4. Remove approximately 100 mm (3.93 in) of the conduit from the passenger airbag assembly wire harness. See Figure 2.

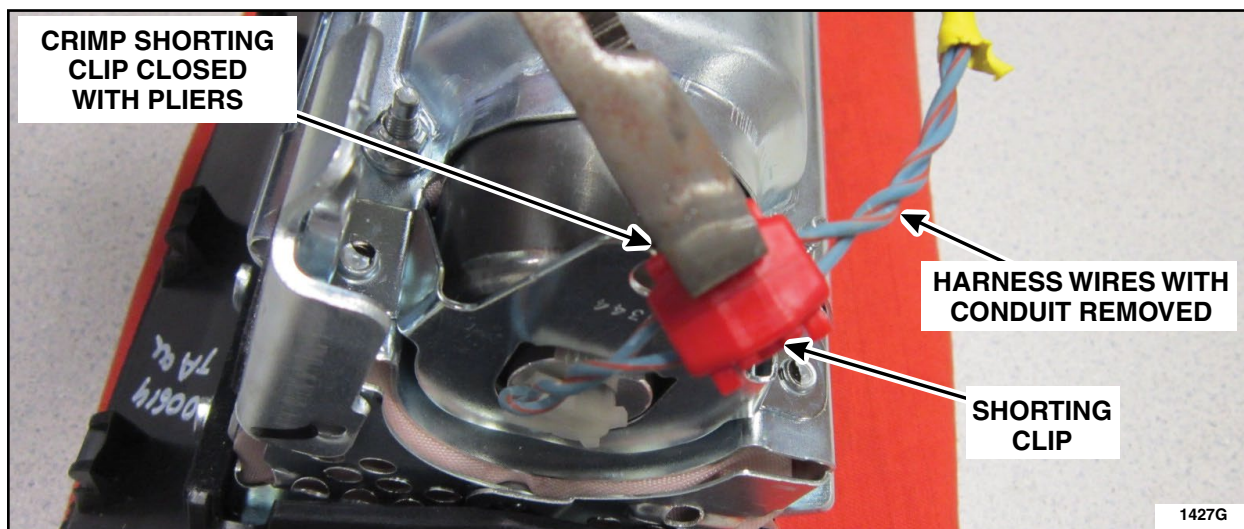
FIGURE 3

5. Position the shorting clip onto the harness wires, and crimp the shorting clip together one side at a time using pliers. See Figure 3.

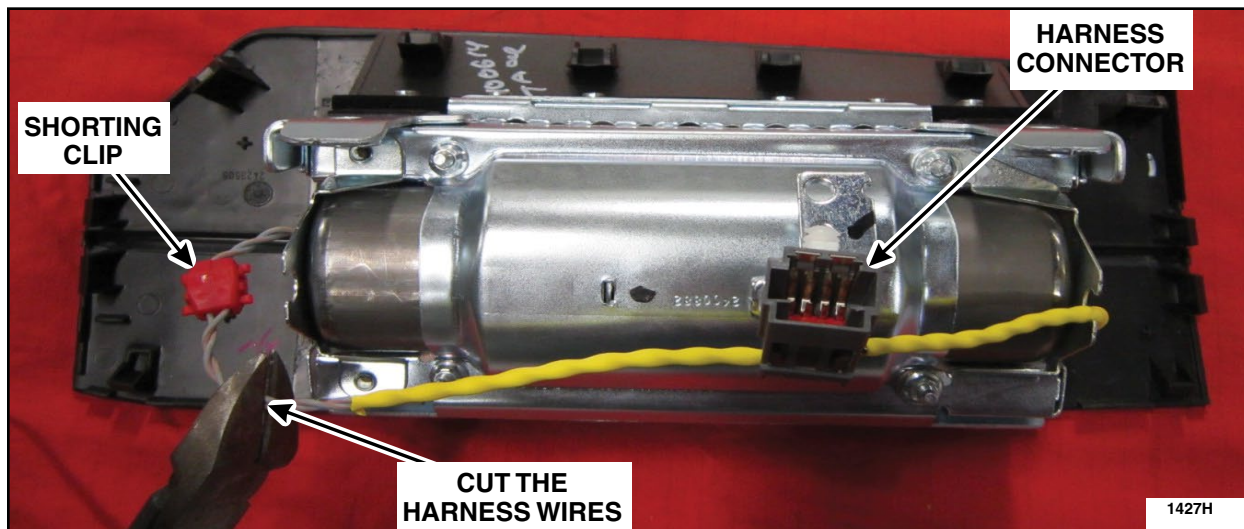
FIGURE 4

6. Cut the harness wires between the shorting clip and the harness connector. See Figure 4.

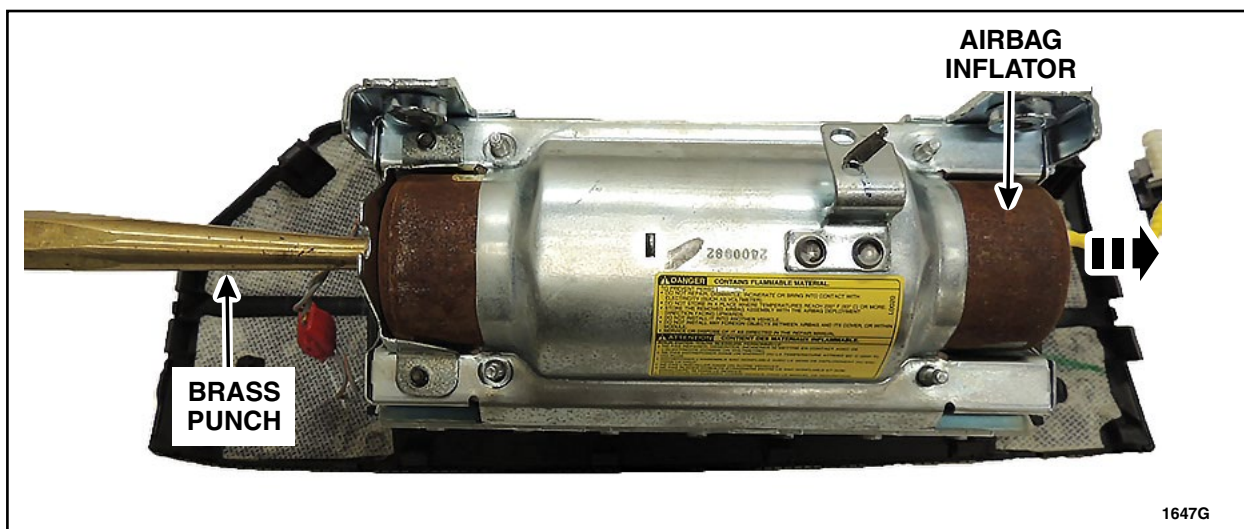
FIGURE 6

- If required, use of a brass punch is permitted (only at the location shown) to free the inflator from its mounted position.

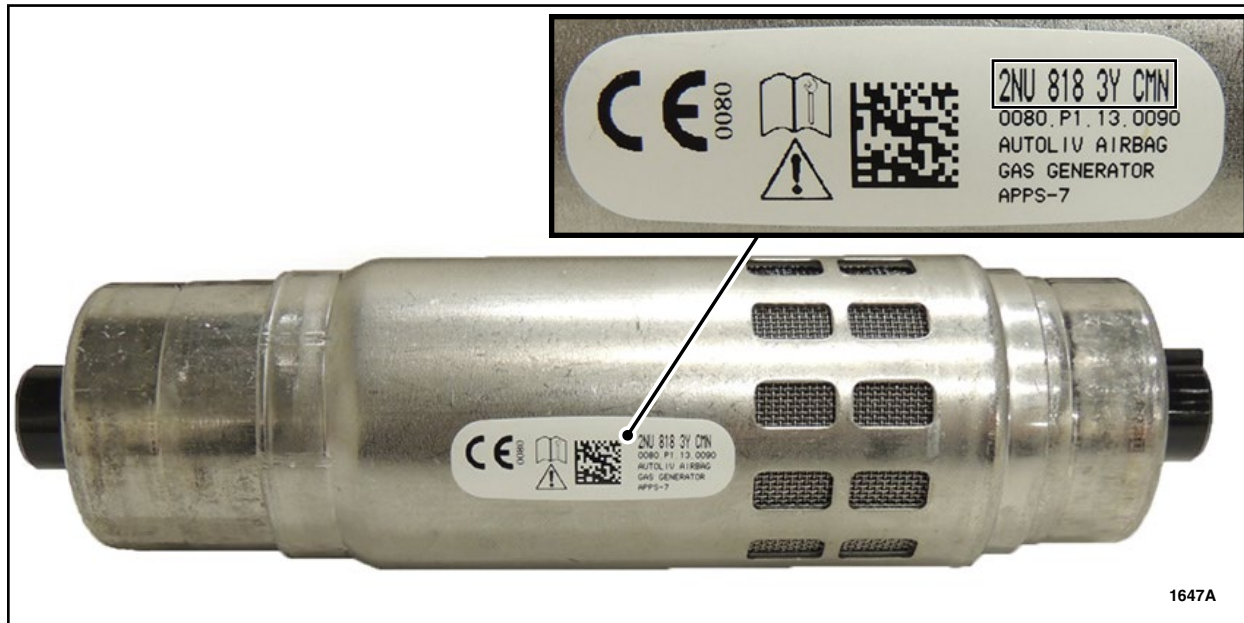
**FIGURE 7**

9. Record the 11 character serial number of the *new* airbag inflator on the repair order. See Figure 7.

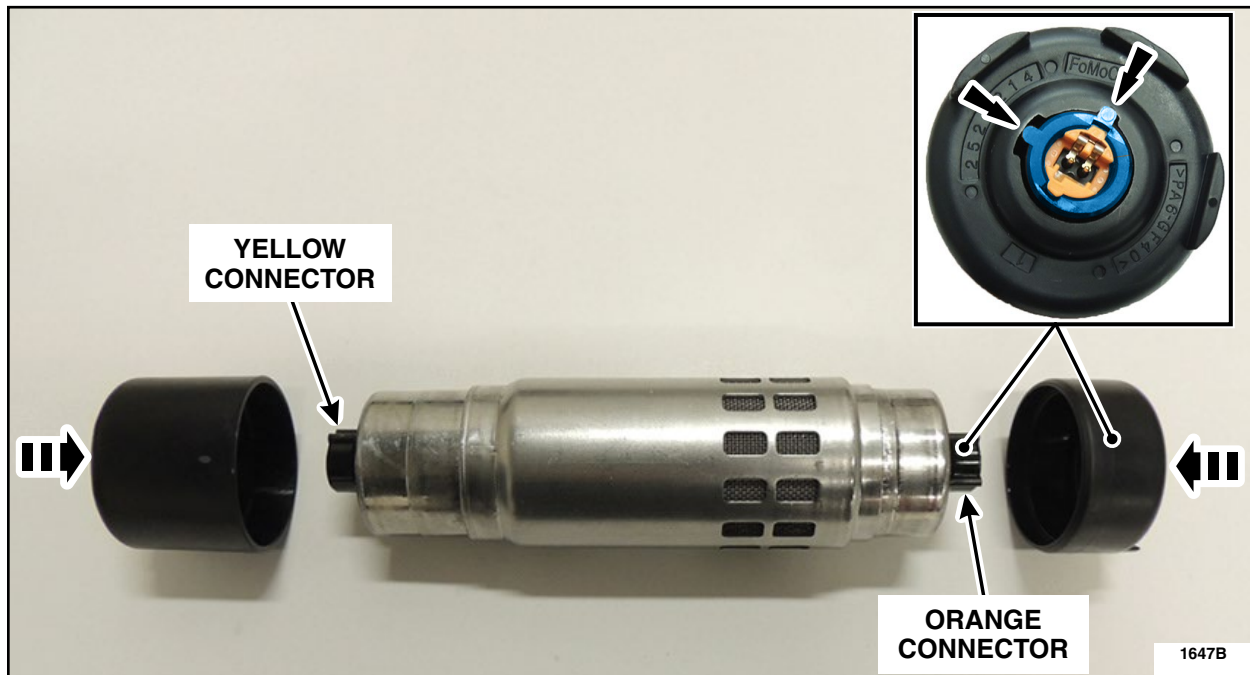
FIGURE 8

Install both *new* inflator end caps making sure the alignment feature on the cap nearest the inflator retaining bracket is properly oriented. See Figure 8.

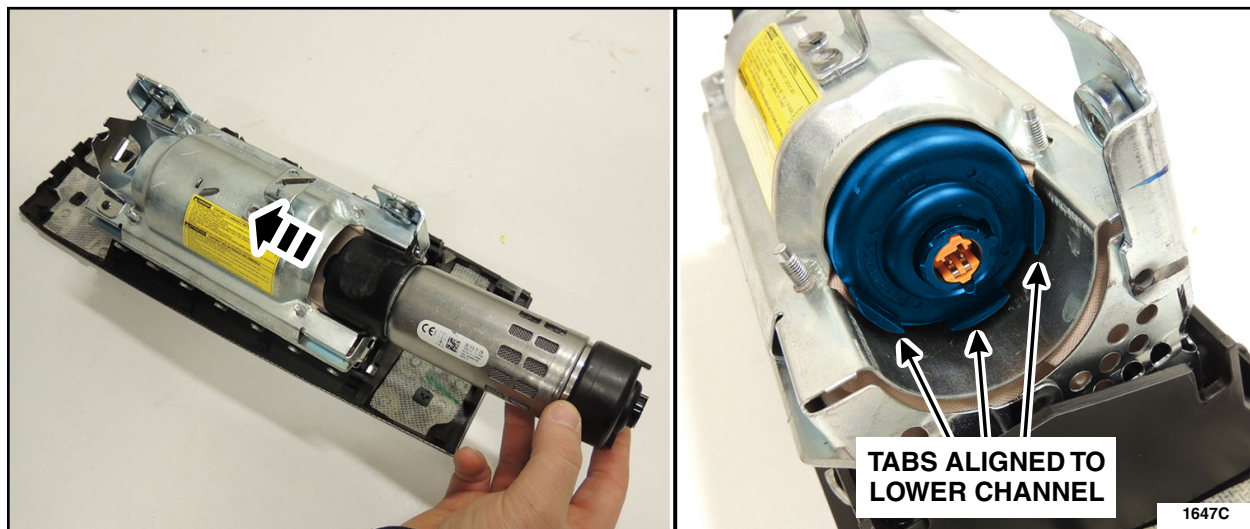
FIGURE 9

11. Install the inflator into the passenger airbag assembly with the orange connector end facing out. Align the three tabs on the cap nearest the inflator retaining bracket with the airbag module lower channel (facing down). See Figure 9.

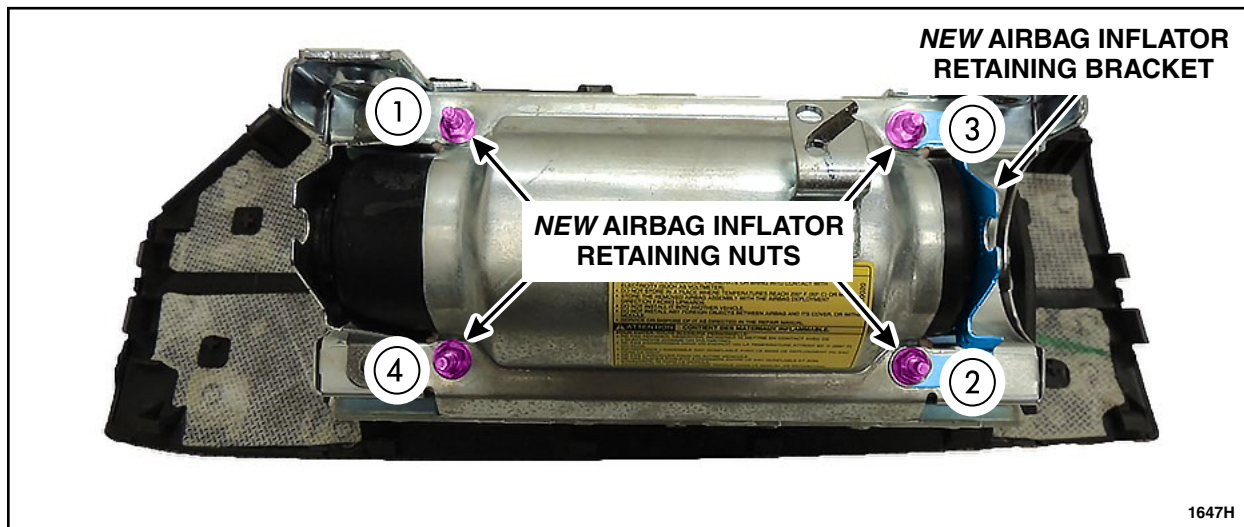
**FIGURE 10**

- Torque the new retaining nuts in the sequence shown below to 4 Nm (35 lb.in).

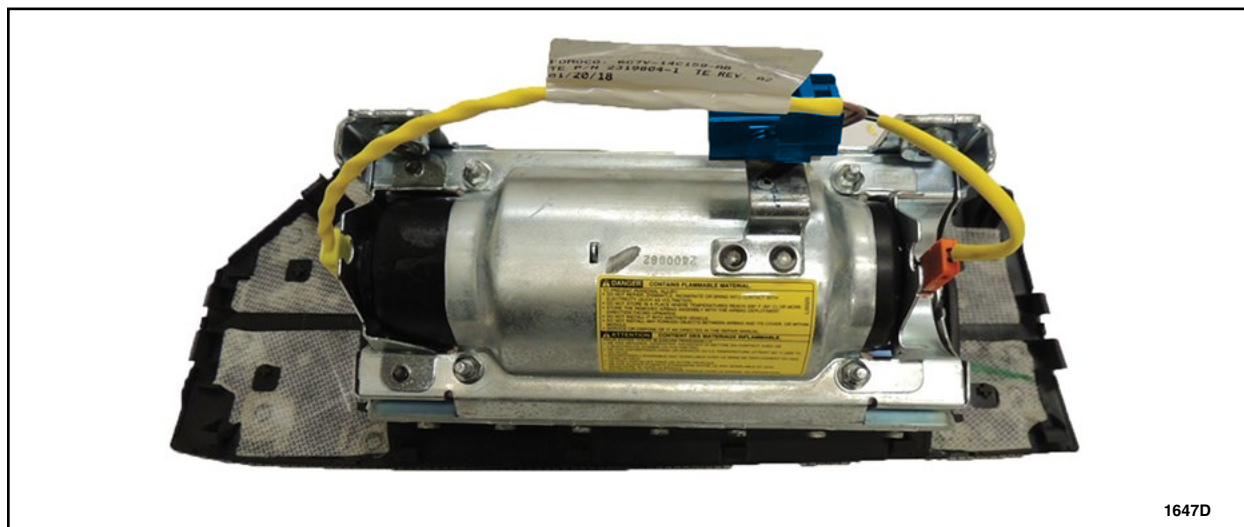
**FIGURE 11**

13. Align the T-shape index on both the wiring harness electrical connector and the airbag inflator. Install the new wiring harness onto the passenger airbag module and connect to both sides of the inflator. See Figure 11.

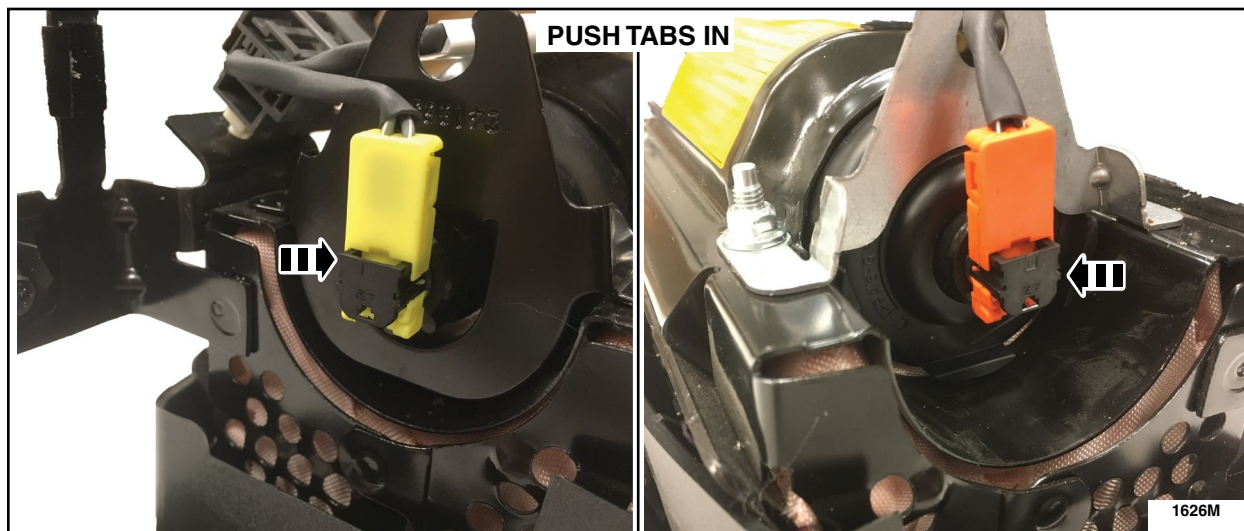
**FIGURE 12**

NOTE: Pull gently on the wiring harness to ensure it is properly seated.

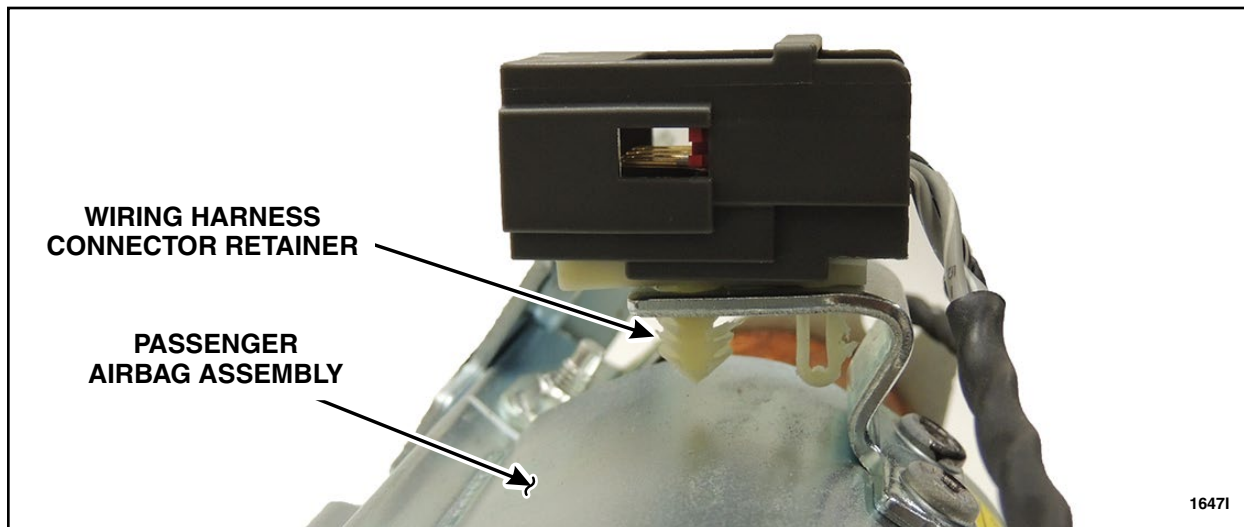
**FIGURE 1**

1. Remove the passenger airbag from the vehicle. Please follow the WSM procedures in Section 501-20B.
2. Set the airbag face down onto a surface that will not scratch or damage the airbag face.
3. Remove the wiring harness connector retainer from the passenger airbag assembly. See Figure 1.

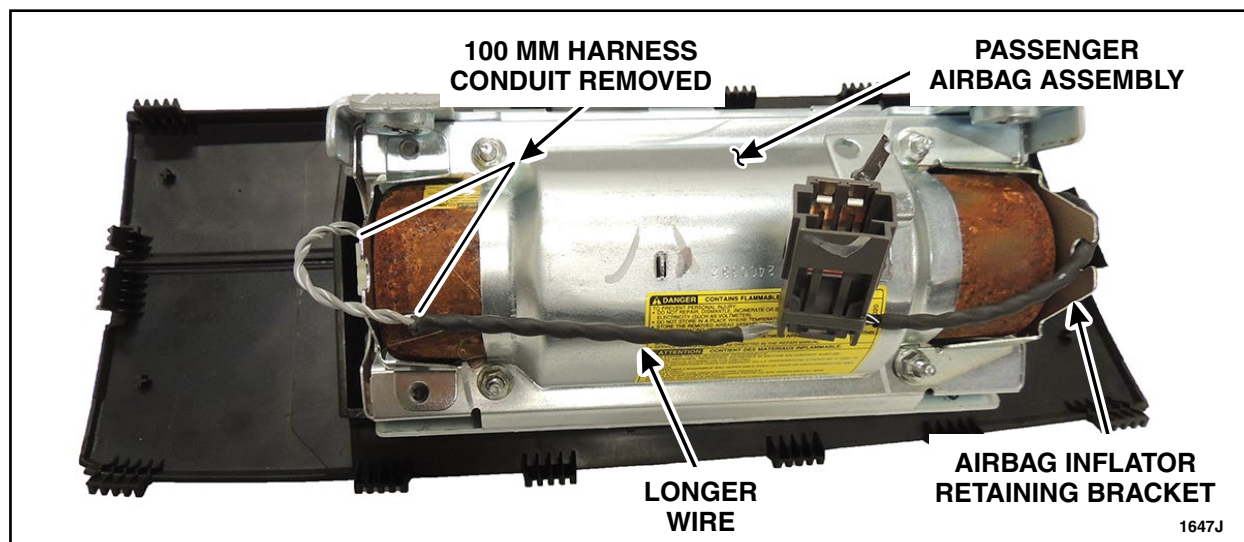
**FIGURE 2**

**NOTE:** Carry out this step on the longer wire on the end opposite of the airbag inflator retaining bracket. See Figure 2.

4. Remove approximately 100 mm (3.93 in) of the conduit from the passenger airbag assembly wire harness. See Figure 2.

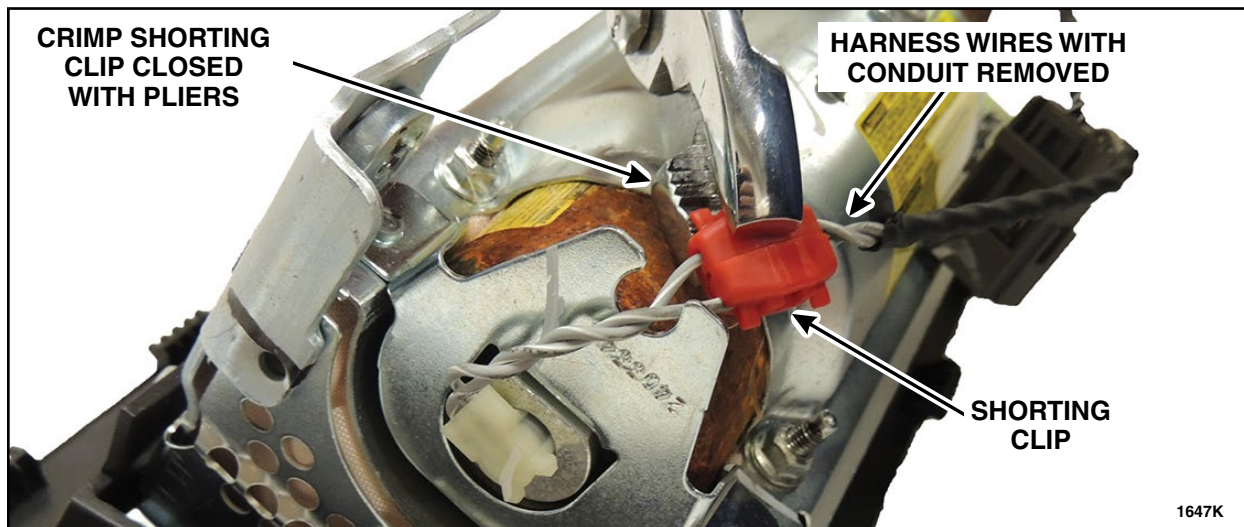
**FIGURE 3**

5. Position the shorting clip onto the harness wires, and crimp the shorting clip together one side at a time using pliers. See Figure 3.

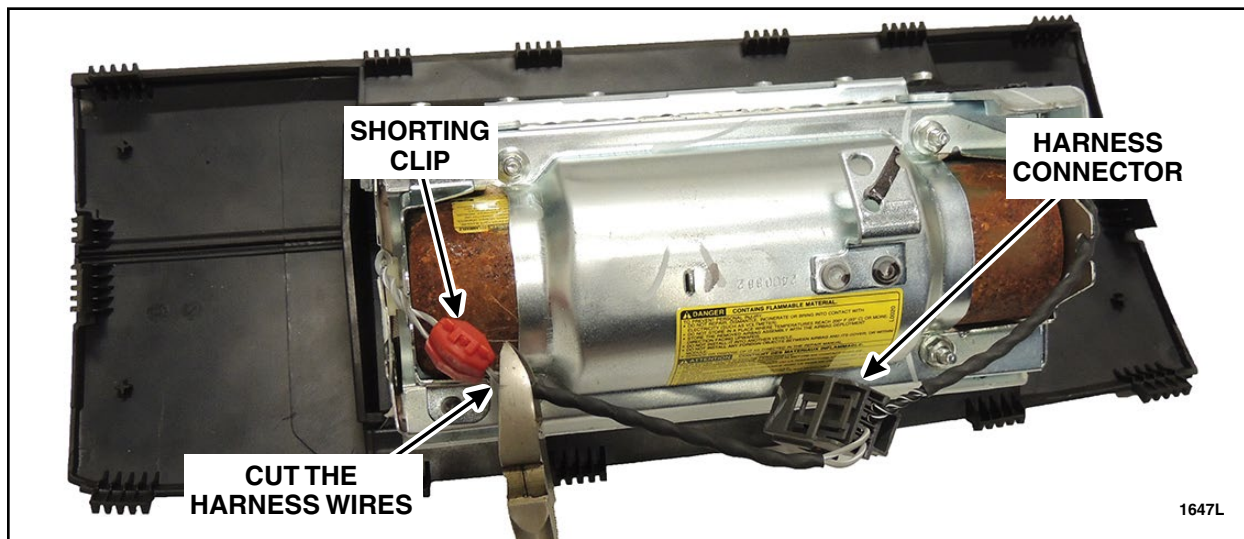
**FIGURE 4**

6. Cut the harness wires between the shorting clip and the harness connector. See Figure 4.

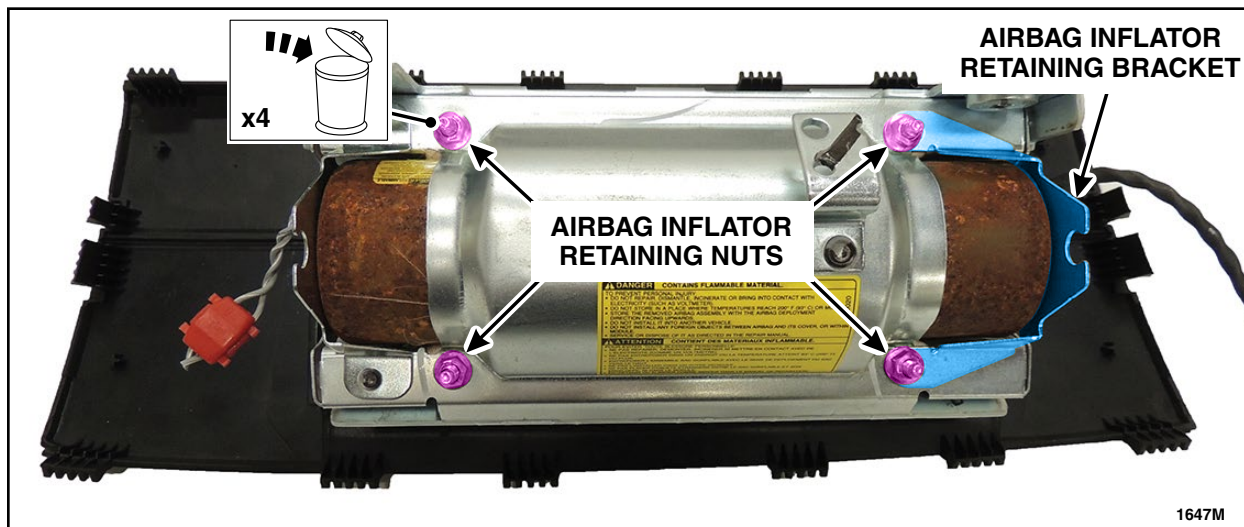
FIGURE 5

7. Remove and discard the four passenger airbag inflator retaining bracket nuts and the retaining bracket. See Figure 5.

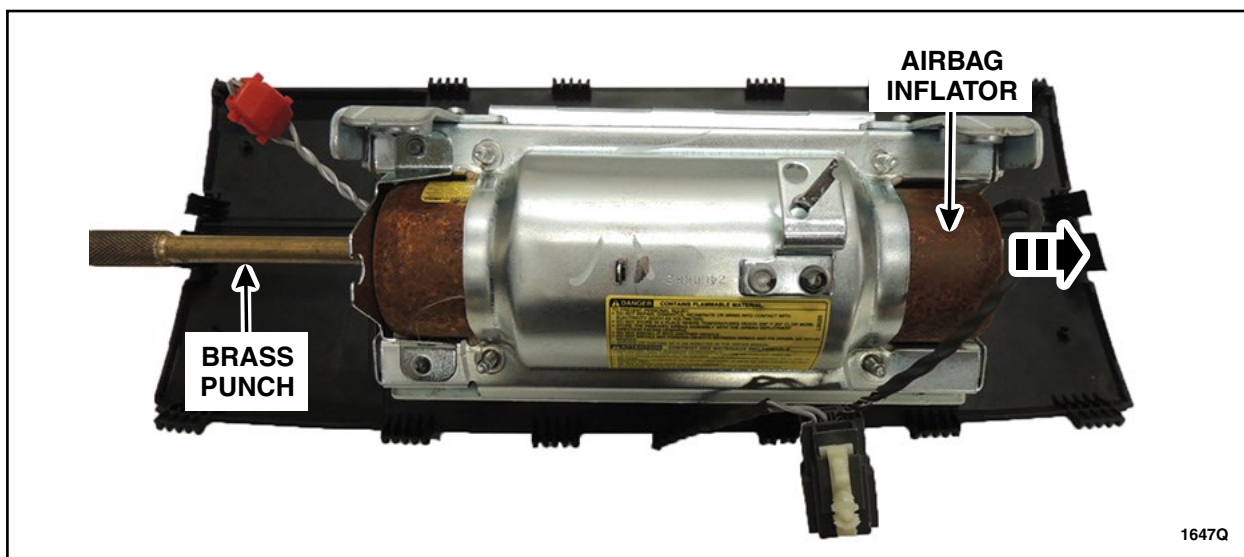
FIGURE 6

8. With an assistant holding the passenger airbag assembly, remove the inflator from the assembly by pushing outward on the inflator. Set the airbag inflator aside for return shipping. See Figure 6.
- If required, use of a brass punch is permitted (only at the location shown) to free the inflator from its mounted position.

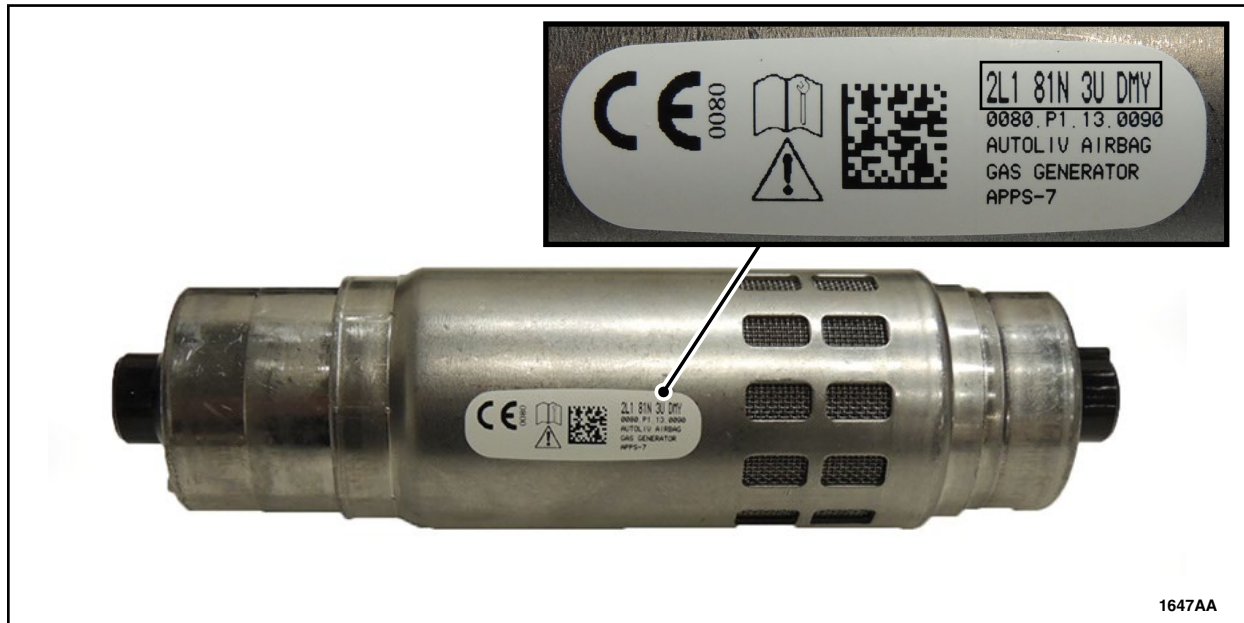
**FIGURE 7**

9. Record the 11 character serial number of the *new* airbag inflator on the repair order. See Figure 7.

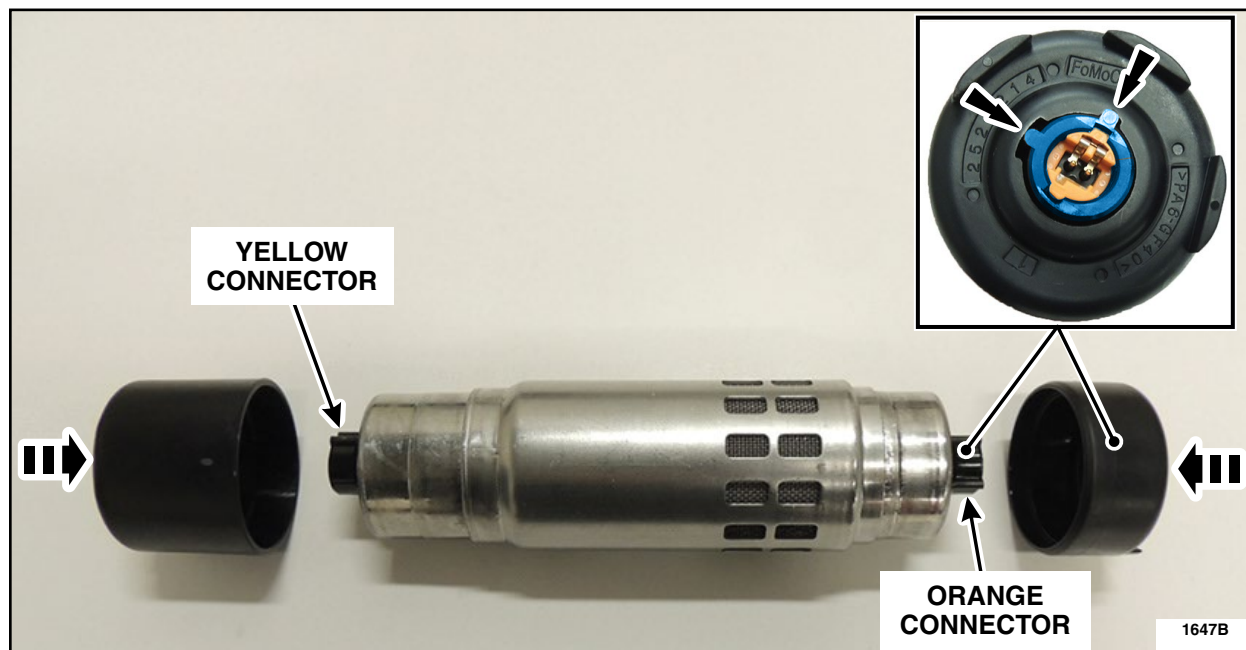
FIGURE 8

Install both *new* inflator end caps making sure the alignment feature on the cap nearest the inflator retaining bracket is properly oriented. See Figure 8.

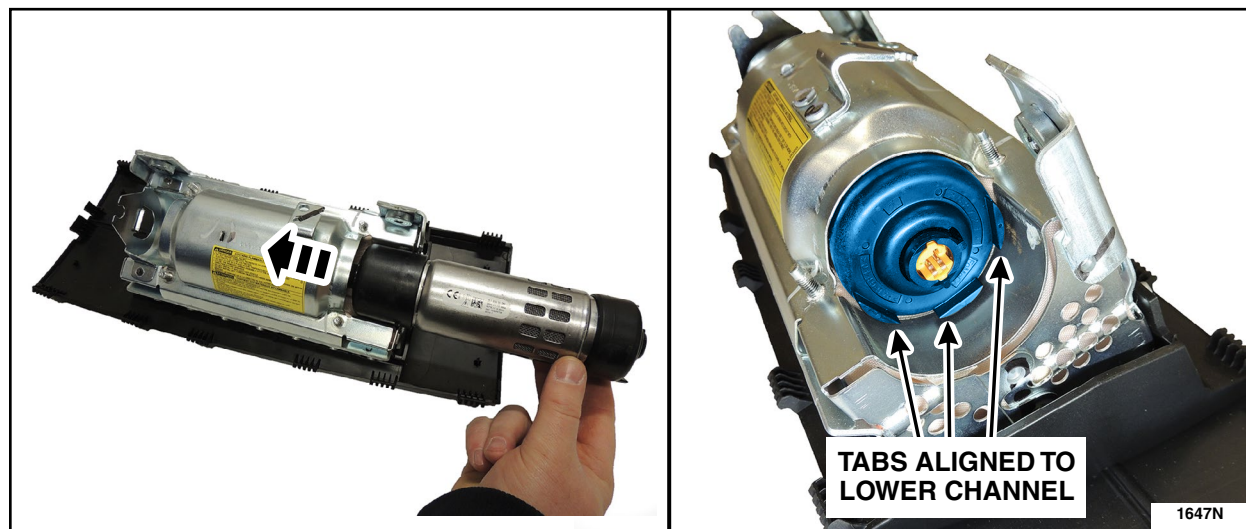
FIGURE 9

11. Install the inflator into the passenger airbag assembly with the orange connector end facing out. Align the three tabs on the cap nearest the inflator retaining bracket with the airbag module lower channel (facing down). See Figure 9.

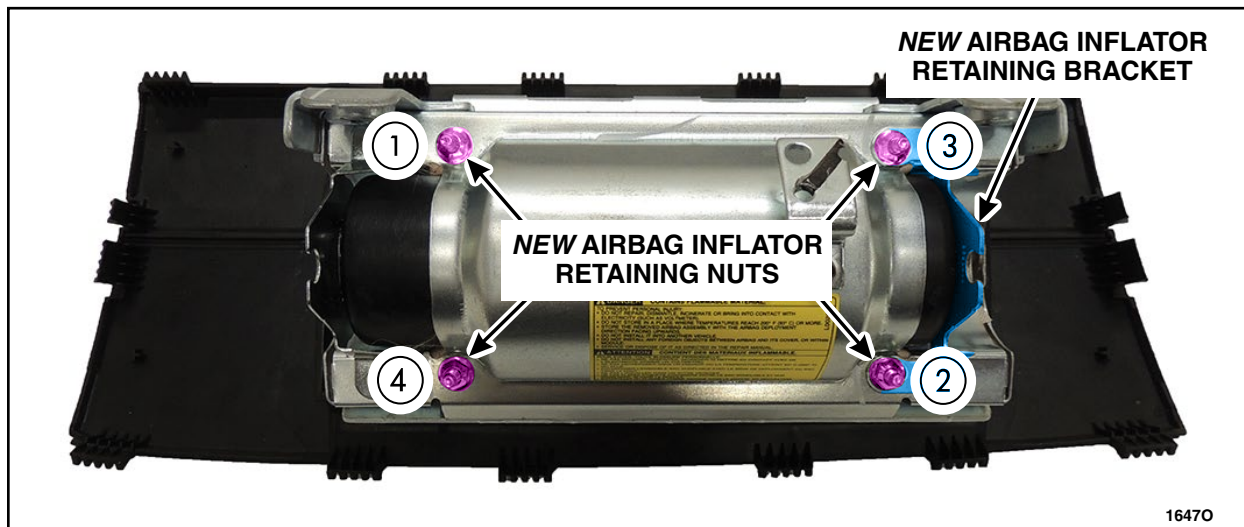
**FIGURE 10**

- Torque the new retaining nuts in the sequence shown below to 4 Nm (35 lb.in).

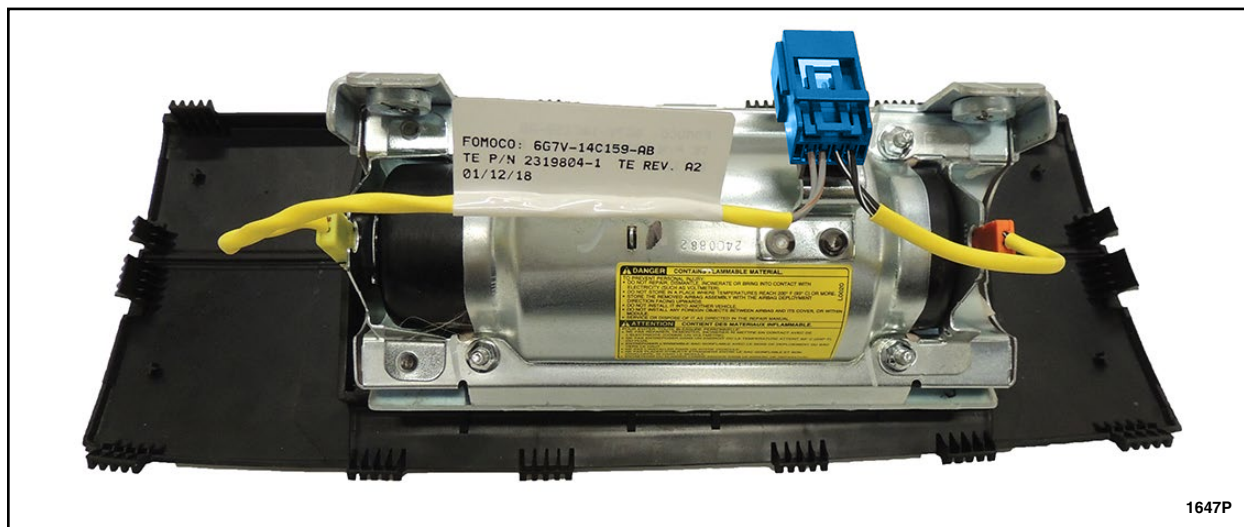
**FIGURE 11**

13. Align the T-shape index on both the wiring harness electrical connector and the airbag inflator. Install the new wiring harness onto the passenger airbag module and connect to both sides of the inflator. See Figure 11.

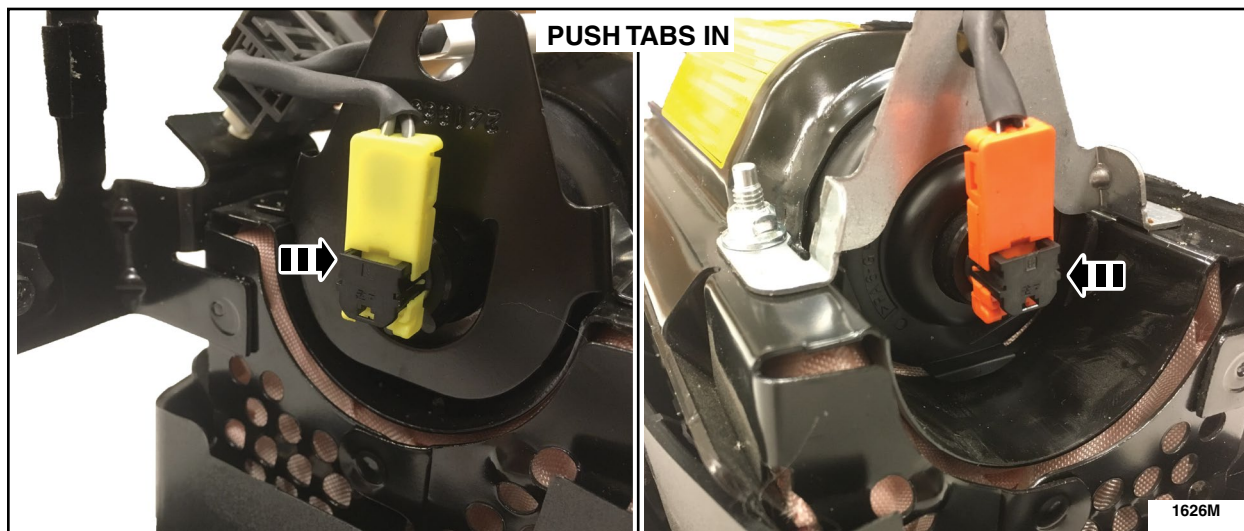
**FIGURE 12**

NOTE: Pull gently on the wiring harness to ensure it is properly seated.

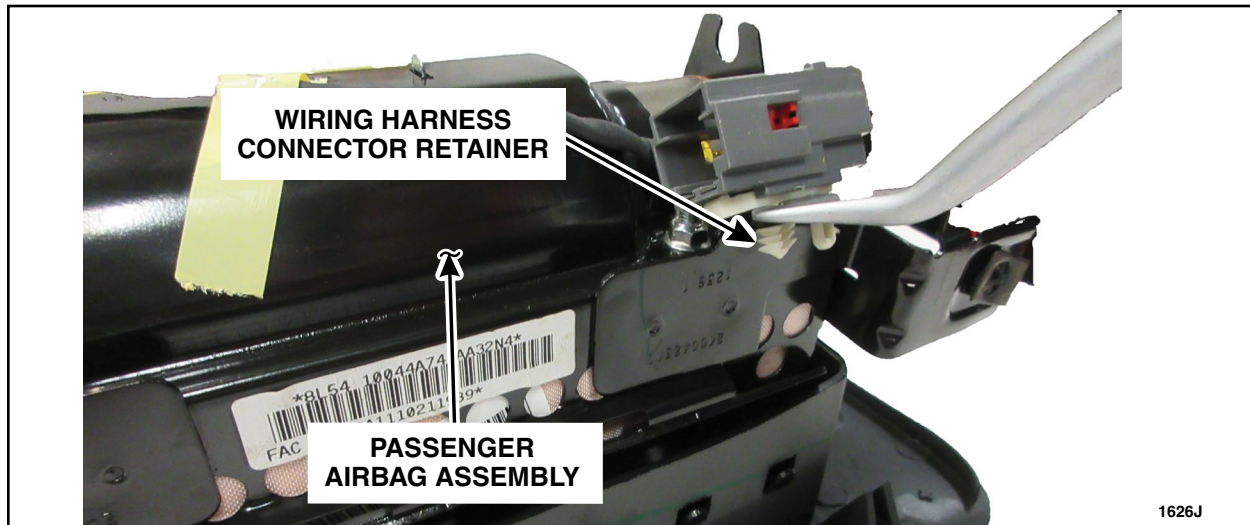
**FIGURE 1**

1. Remove the passenger airbag from the vehicle. Please follow the WSM procedures in Section 501-20B.
2. Set the airbag face down onto a surface that will not scratch or damage the airbag face.
3. Remove the wiring harness connector retainer from the passenger airbag assembly. See Figure 1.

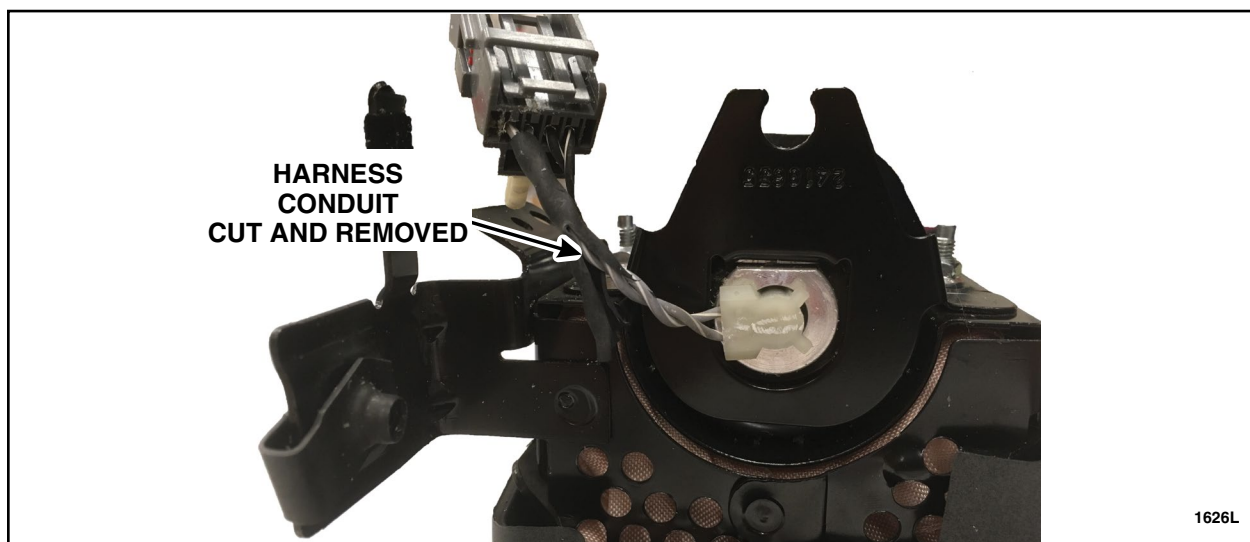
**FIGURE 2**

**NOTE:** Carry out this step on the shorter wire on the end opposite of the airbag inflator retaining bracket. See Figure 2.

4. Remove the conduit from the passenger airbag assembly wire harness in the area shown. See Figure 2.

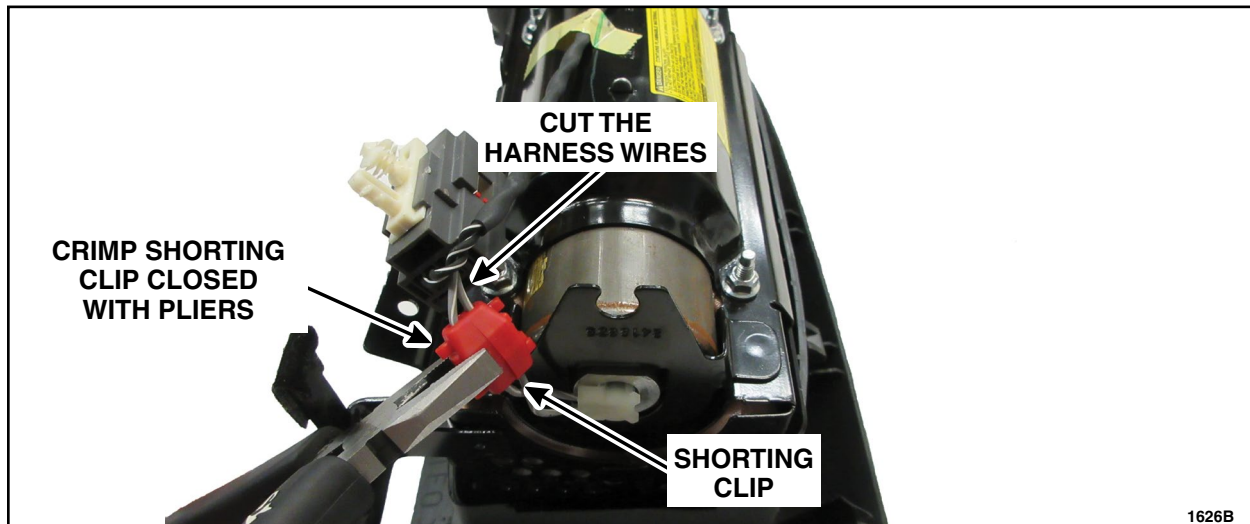
**FIGURE 3**

5. Position the shorting clip onto the harness wires, and crimp the shorting clip together one side at a time using pliers. See Figure 3.
6. Cut the harness wires between the shorting clip and the harness connector. See Figure 3.

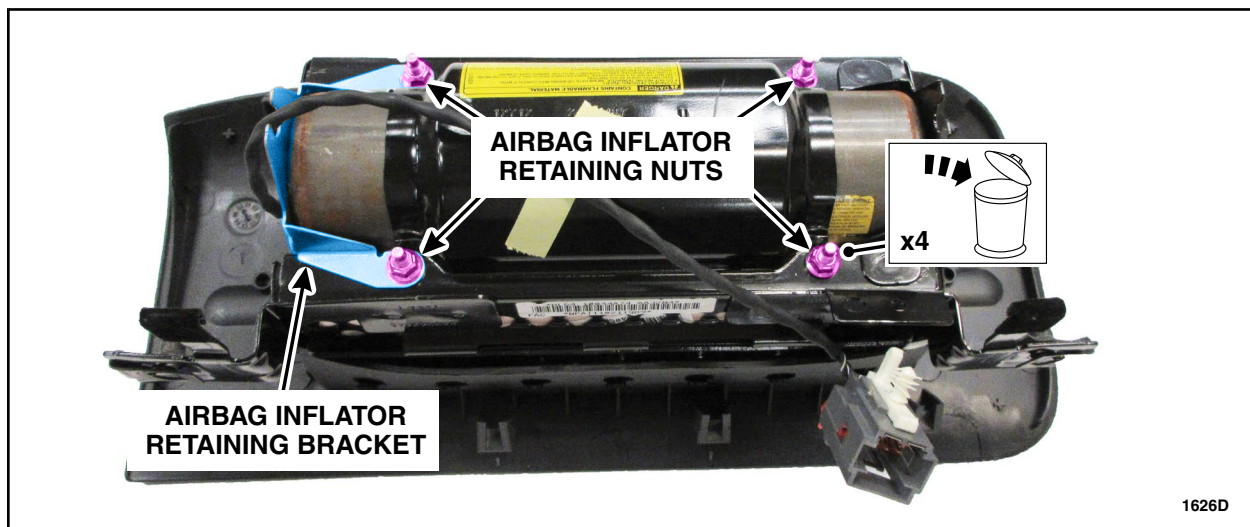
**FIGURE 4**

7. Remove and discard the four passenger airbag inflator retaining bracket nuts and the retaining bracket. See Figure 4.

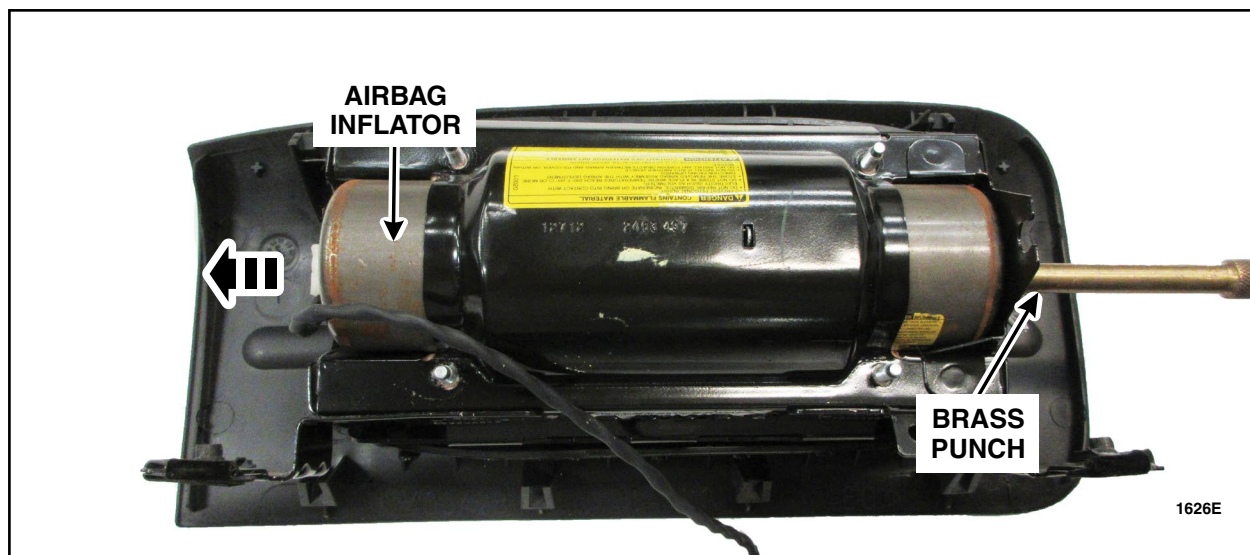
FIGURE 5

8. With an assistant holding the passenger airbag assembly, remove the inflator from the assembly by pushing outward on the inflator. Set the airbag inflator aside for return shipping. See Figure 5.
  - If required, use of a brass punch is permitted (only at the location shown) to free the inflator from its mounted position.

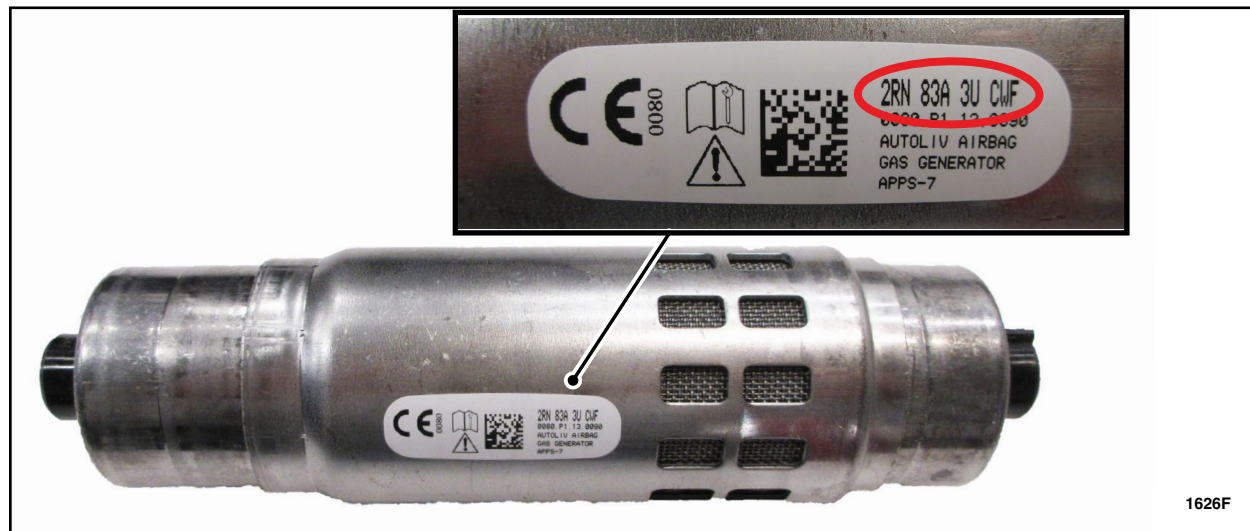
FIGURE 6

9. Record the 11 character serial number of the *new* airbag inflator on the repair order. See Figure 6.
