David J. Johnson  
Director  
Service Engineering Operations  
Ford Customer Service Division

September 24, 2018

**SUBJECT: Safety Recall 17S01 – *Supplement #7***  
Certain 2005-2006 Ford GT, 2005-2009 and 2012 Mustang, 2006-2009 Milan,  
2006-2009 and 2012 Fusion and MKZ/Zephyr, 2007-2009 Edge and MKX, and  
2007-2009 Ranger Vehicles  
Passenger Airbag Inflator Replacement

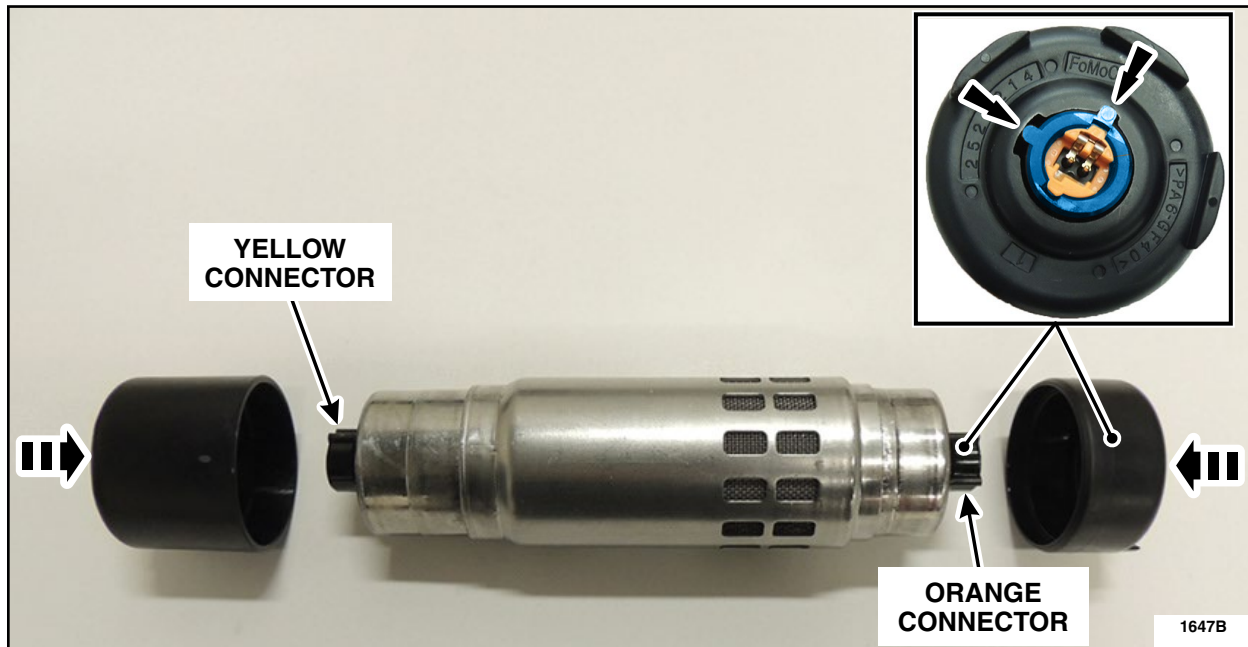
FIGURE 7

Install both *new* inflator end caps making sure the alignment feature on the cap nearest the inflator retaining bracket is properly oriented. See Figure 7.

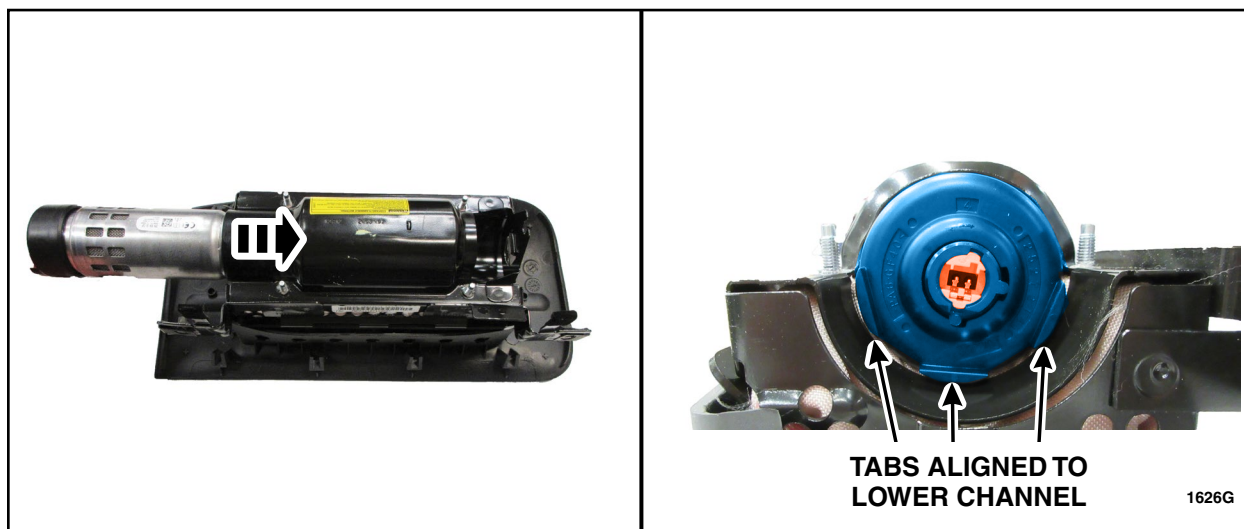
**FIGURE 8**

11. Install the inflator into the passenger airbag assembly with the orange connector end facing out. Align the three tabs on the cap nearest the inflator retaining bracket with the airbag module lower channel (facing down). See Figure 8.

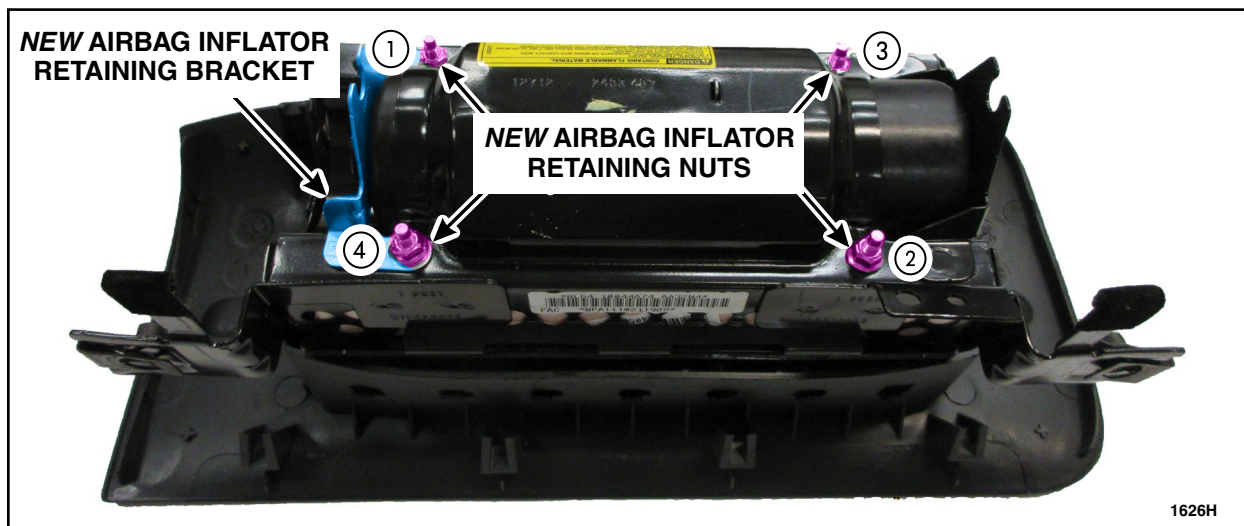
**FIGURE 9**

- Torque the new retaining nuts in the sequence shown below. Tighten to 4 Nm (35 lb in).

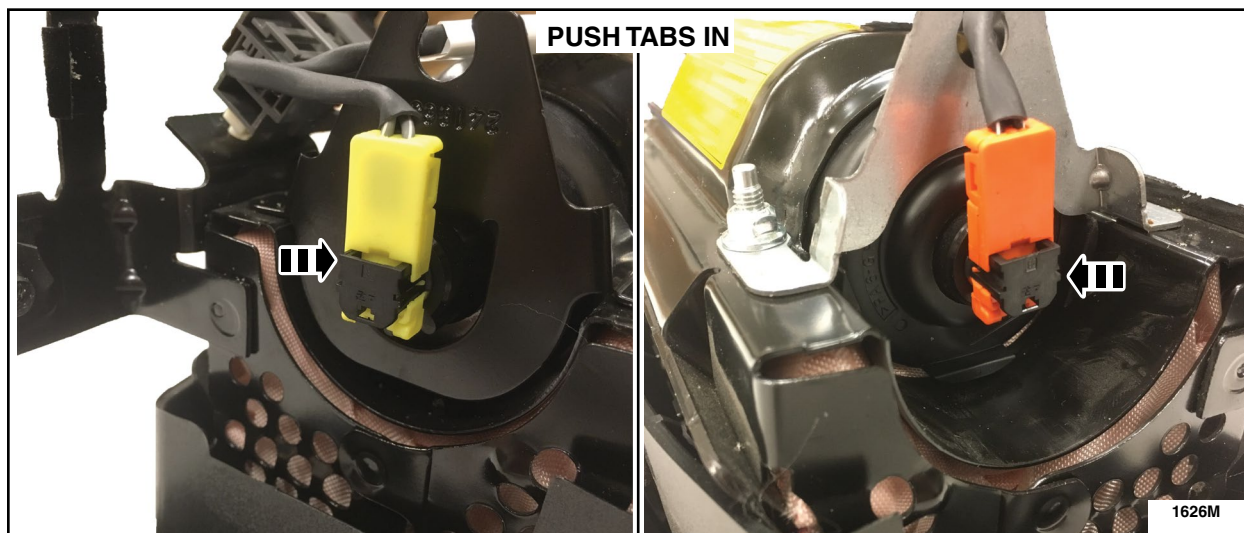
**FIGURE 10**

**NOTE:** Pull gently on the wiring harness to ensure it is properly seated.

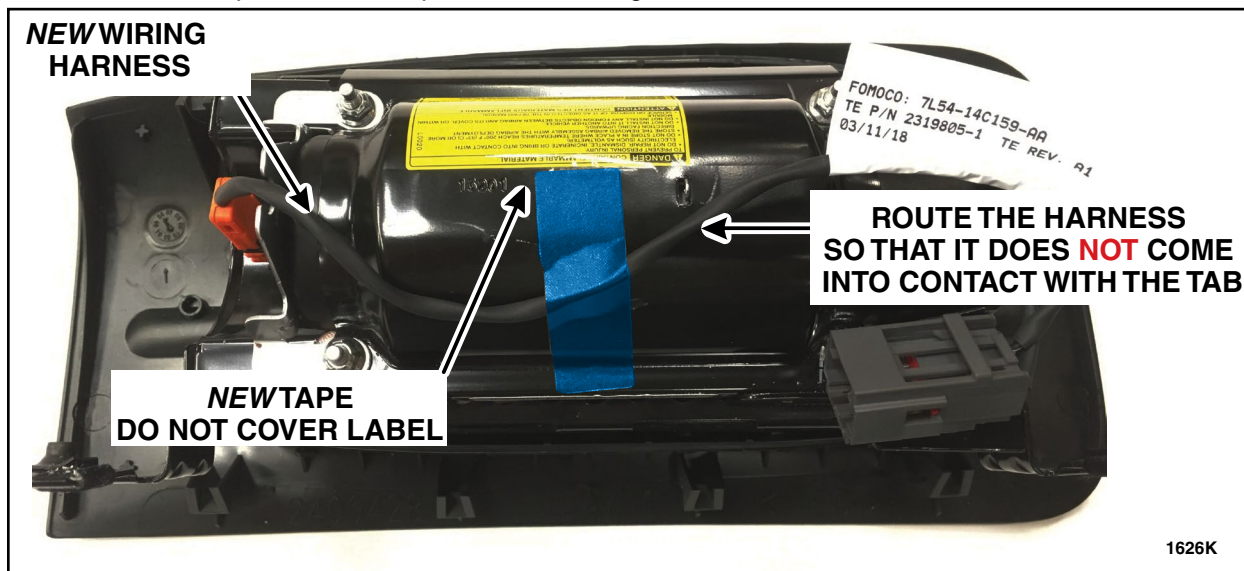
**FIGURE 11**

14. Install the *new* tape to the wiring harness and airbag assembly, do not cover the airbag warning label with the new tape. For correct placement See Figure 11.

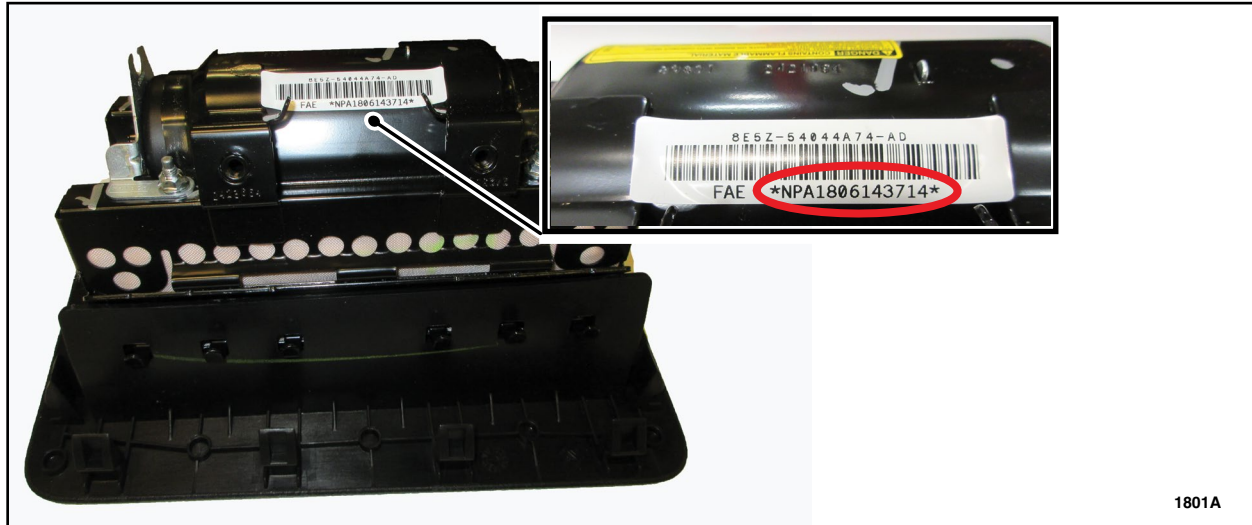
FIGURE 1

1. Record the 13 character serial number of the new airbag module on the repair order. See Figure 1.
2. Replace the passenger airbag module. Refer to section 501-20B of the workshop manual.
3. Package the replaced airbag module in the new part box and provide to the appropriate dealership personnel for part returns.

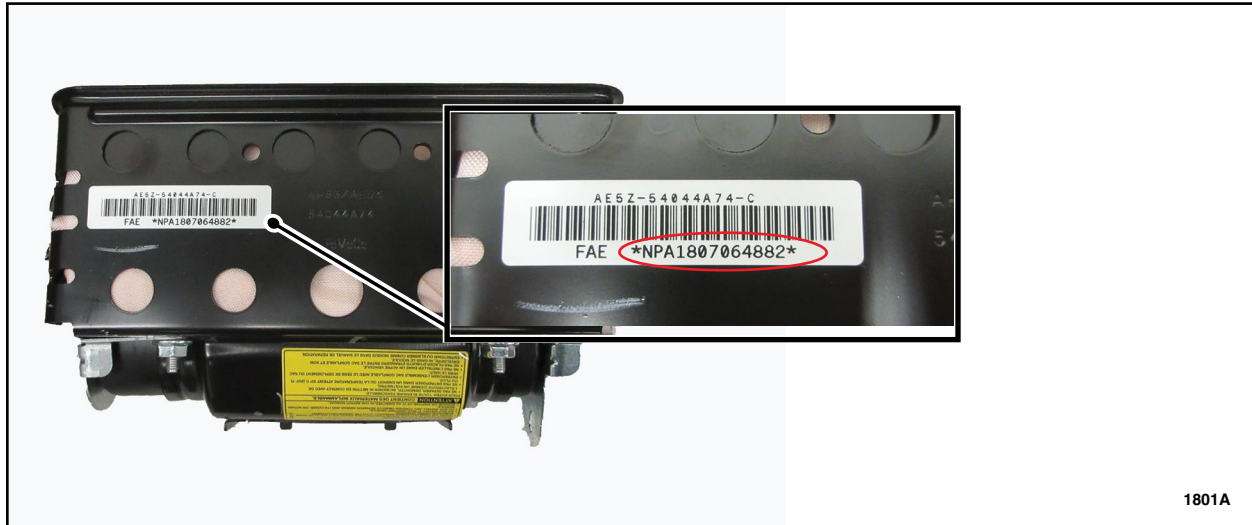
FIGURE 1

1. Record the 13 character serial number of the new airbag module on the repair order. See Figure 1.

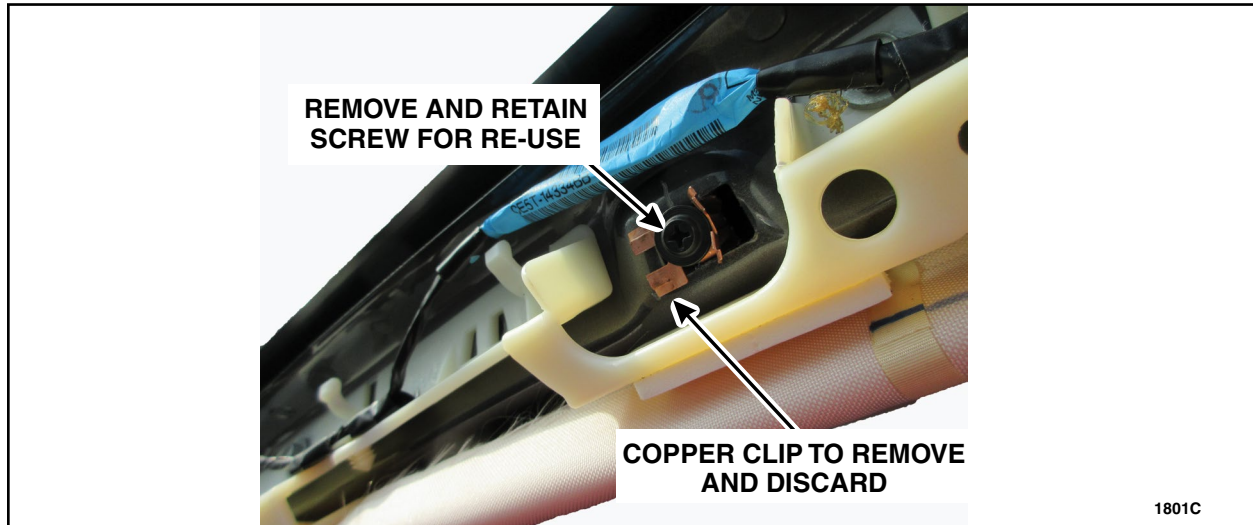
**FIGURE 3**

3. Remove and discard the top A-Pillar clip from the body. See Figure 3.

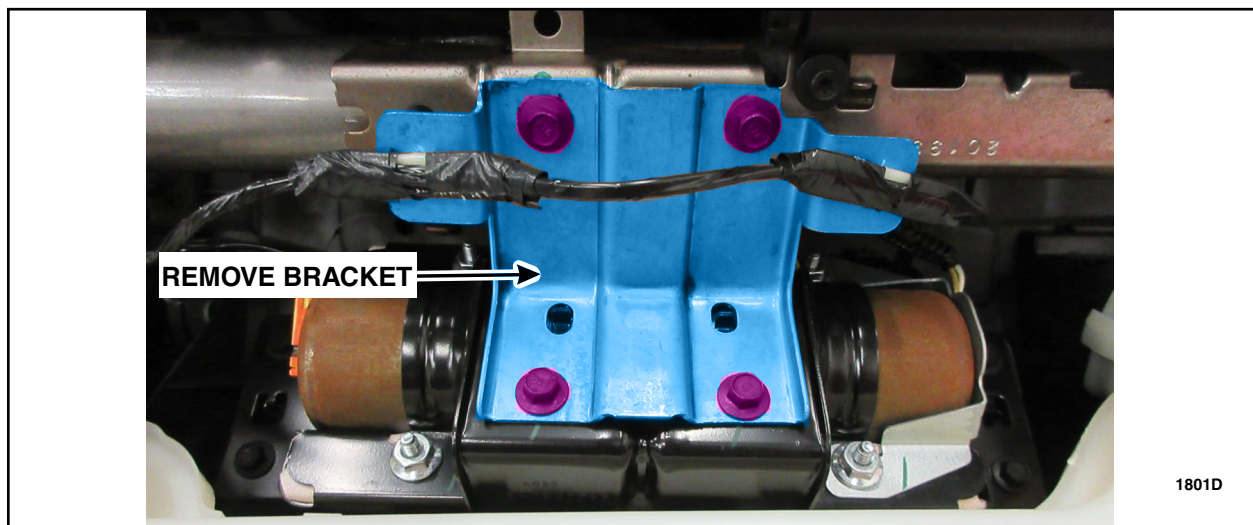
**FIGURE 4**

- Remove the instrument panel crossmember-to-airbag module bracket. See Figure 4.

8. Reinstall the airbag module bracket onto the instrument panel. See Figure 5.
9. Install the new airbag module and instrument panel. Please follow WSM procedures in section 501-20B.
- Install the instrument panel crossmember-to-airbag module bracket. See Figure 4.

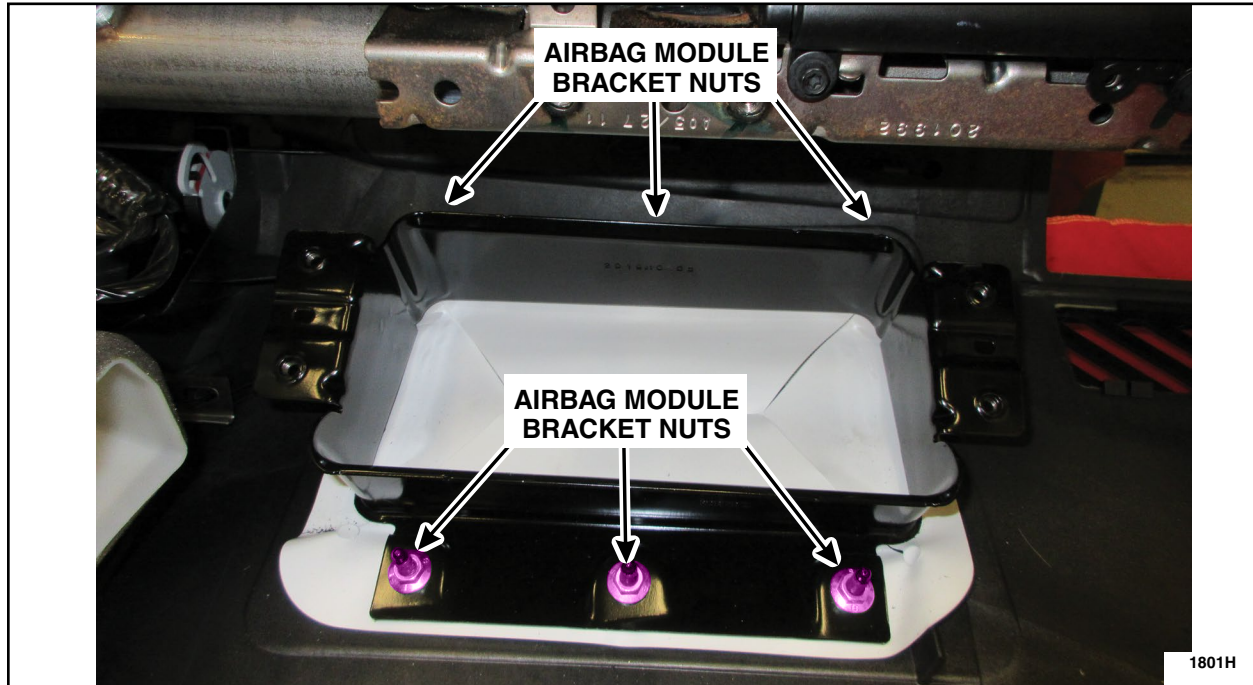
FIGURE 5

- Torque to 80 lb.in.

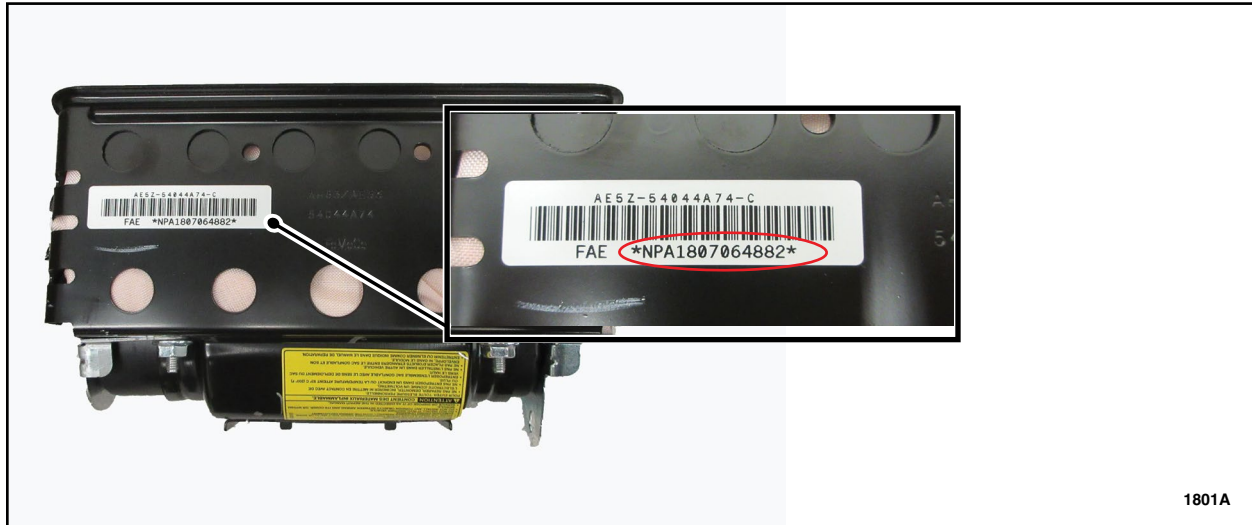
FIGURE 1

1. Record the 13 character serial number of the new airbag module on the repair order. See Figure 1.

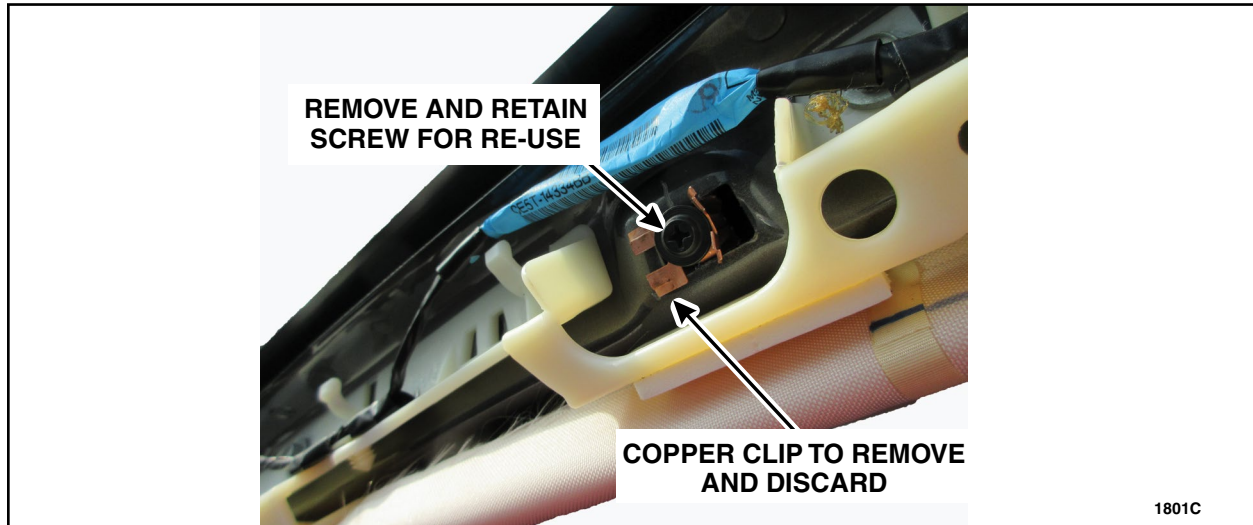
**FIGURE 3**

3. Remove and discard the top A-Pillar clip from the body. See Figure 3.

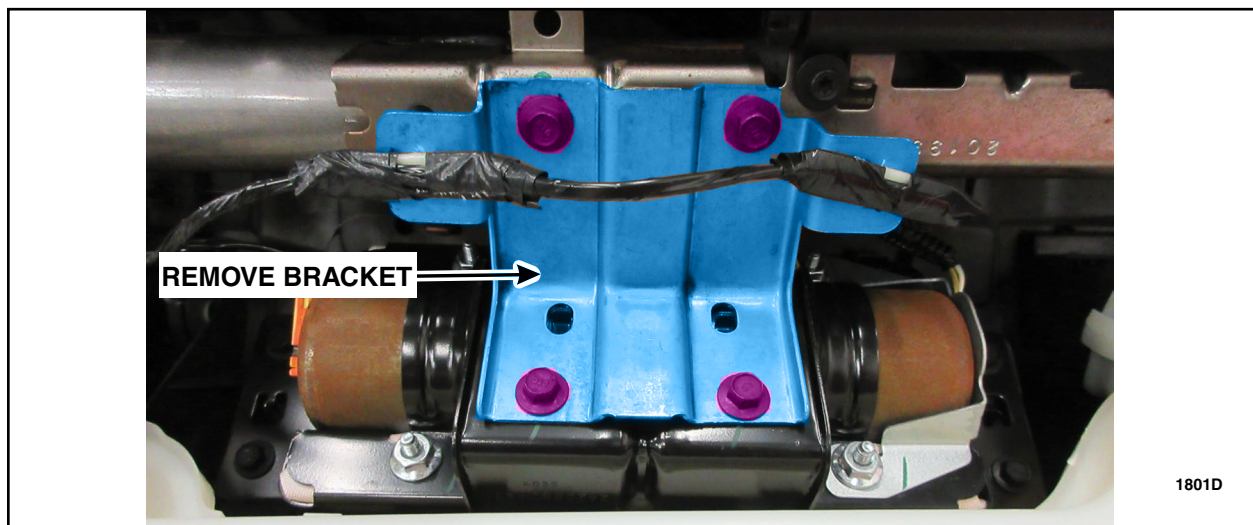
**FIGURE 4**

- Remove the instrument panel crossmember-to-airbag module bracket. See Figure 4.

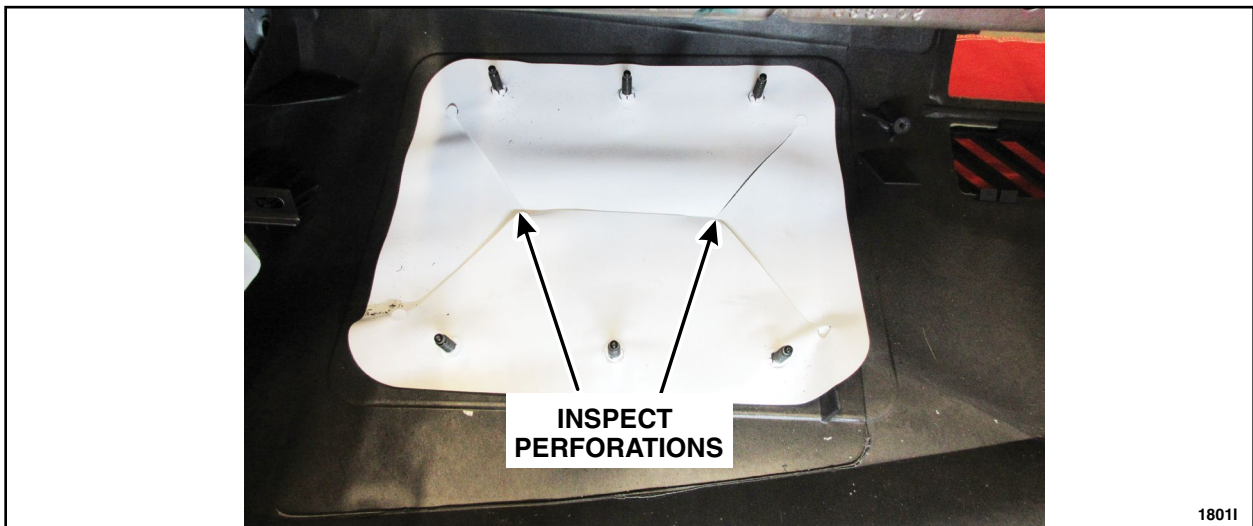
**FIGURE 6**

6. Inspect the white airbag cushion sheet installed on the instrument panel. See Figure 6.

**NOTE:** Sheet can be installed in any direction or orientation.

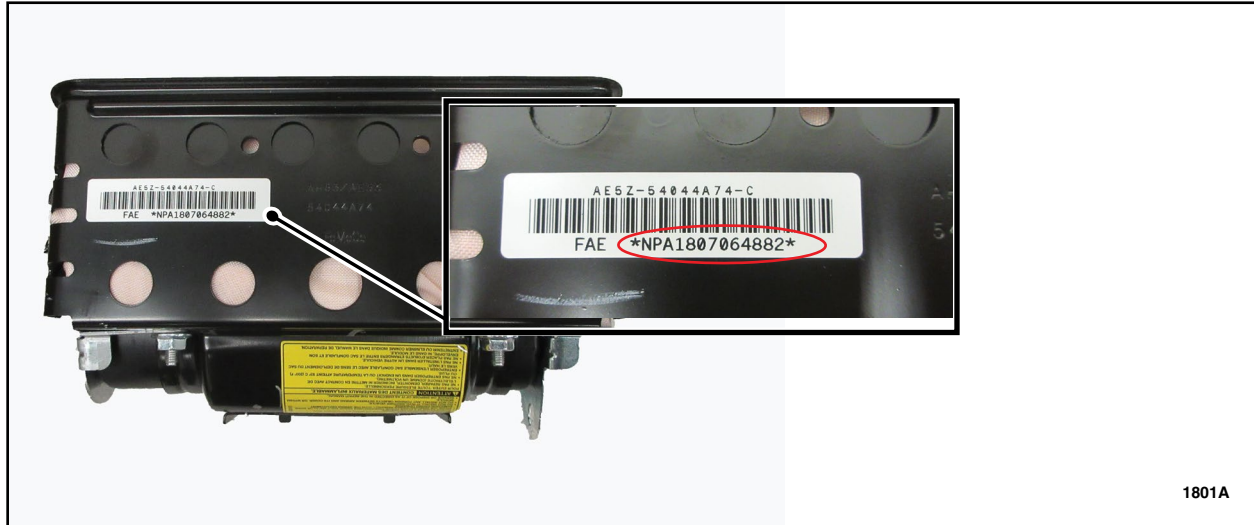
FIGURE 1

1. Record the 13 character serial number of the new airbag module on the repair order. See Figure 1.
2. Replace the passenger airbag module. Refer to section 501-20B of the Workshop Manual.
3. Package the replaced airbag module in the new part box and provide to the appropriate dealership personnel for part returns.
