November 5, 2018

**TO:** All U.S. Ford and Lincoln Dealers

**SUBJECT: Safety Recall 17S01 – *Supplement #8***  
Certain 2005-2006 Ford GT, 2005-2009 and 2012 Mustang, 2006-2009 Milan,  
2006-2009 and 2012 Fusion and MKZ/Zephyr, 2007-2009 Edge and MKX, and  
2007-2009 Ranger Vehicles  
Passenger Airbag Inflator Replacement

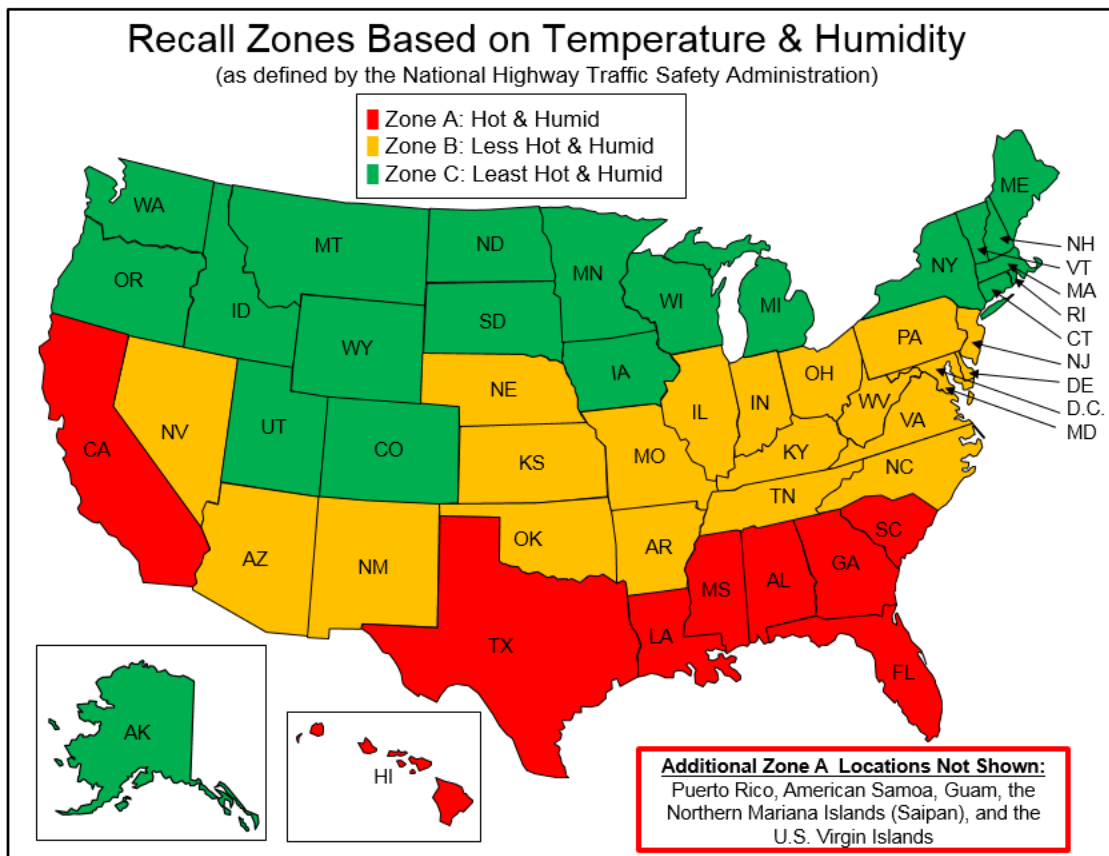
**FIGURE 1**

The Takata airbag recall zones have been defined by the NHTSA, based on temperature and humidity.
