L73X-  
R.02.17

To: Official After Sales Network  
Subject: Evap system update  
Date: February 24, 2017  
Pages: 42

Evap system upgrade .

Aventador Coupe and Roadster.

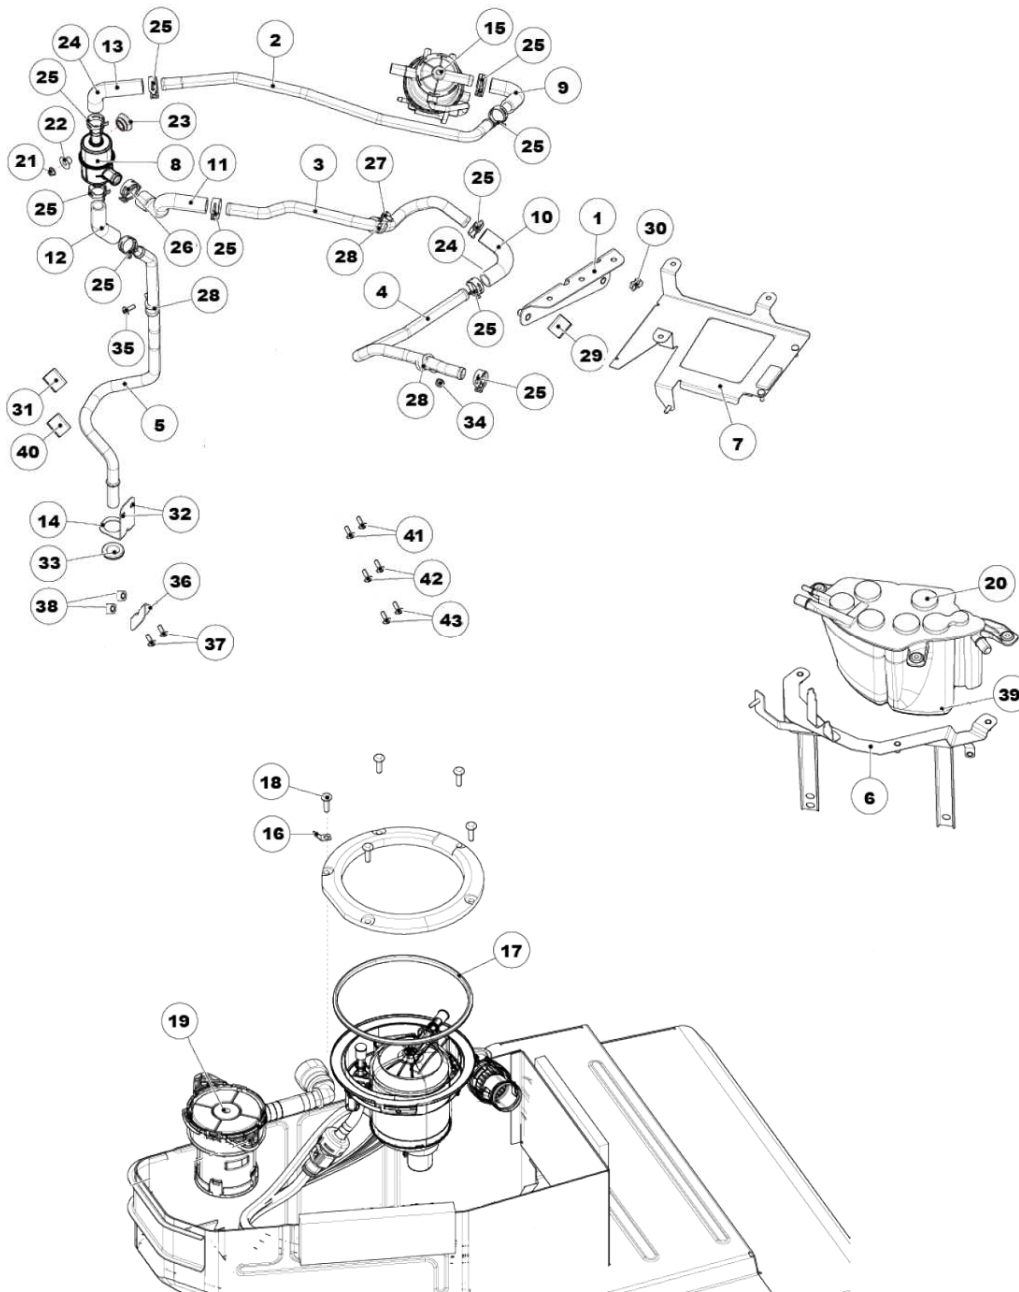
The Lamborghini Aventador fuel vapor collection circuit has been subjected to a few technical updates. A diagram of the updated components of the fuel system to be installed on the vehicle is provided below.

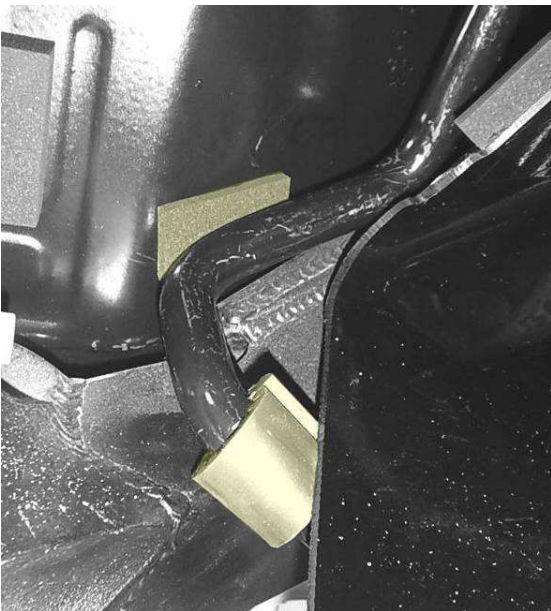
Clean the tank and glue the protection (p.n. 410863939) on as shown in the figure. Install the splined sleeve (p.n. 03L121722 ) on the hose at the conveyor.

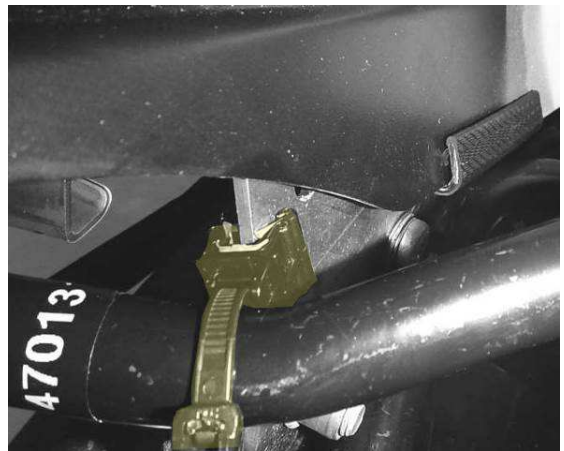
Fix the hose installed under point 56 of this procedure to the upper radiator bracket using the retaining clamp (p.n. 3D0971838M) as shown in the figure.

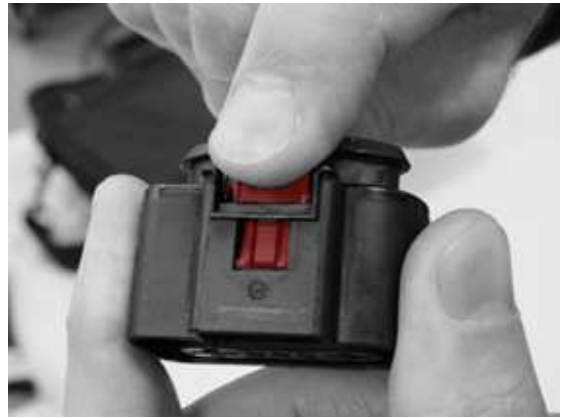
To remove the power connector, lift the break-in prevention feature and then press it as shown in the figure.

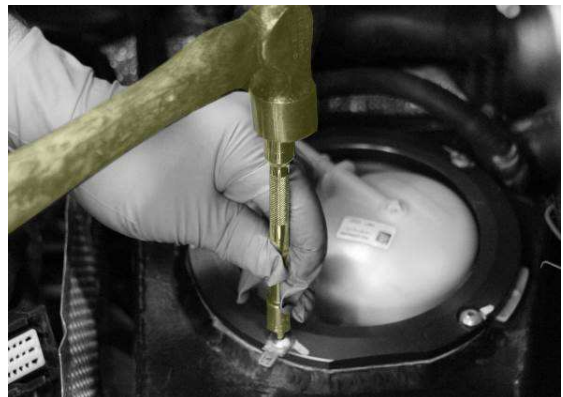
After removing the hoses and electric wiring, unscrew the 5 screws securing the fastening ring.

The screws have been fastened using threadlocker. Before removing them dislodge them with a hammer of suitable proportions. Use a hammer with a 200gr. maximum impact mass. Be careful not to damage the screw heads.

If the tank threads are damaged the entire component must be replaced.

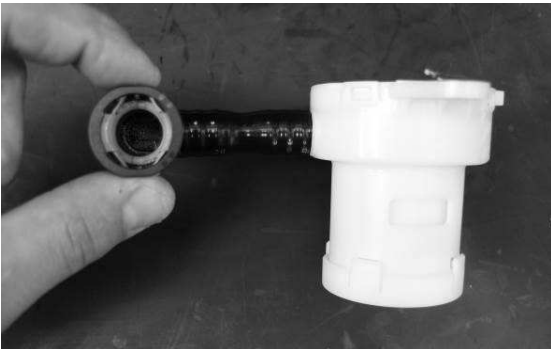
Open the quick coupling as shown in the figure and remove the FLVV valve from the tank.

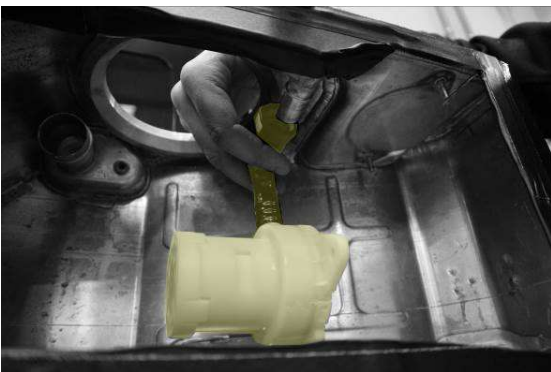
The picture below shows how to extract the old FLVV valve to be replaced.

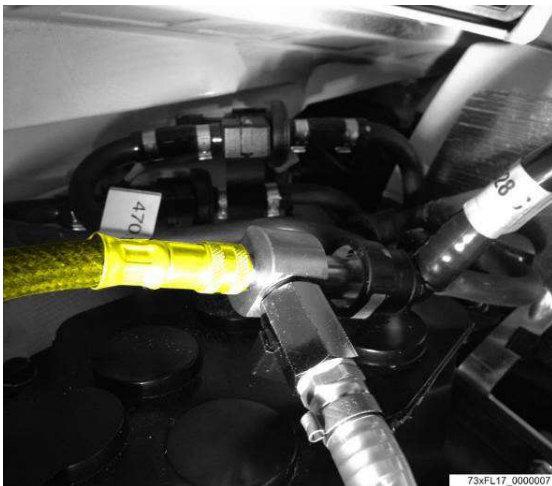
e) Connect the fuel tank seal test device 61353000375 to instrument 61353000397.

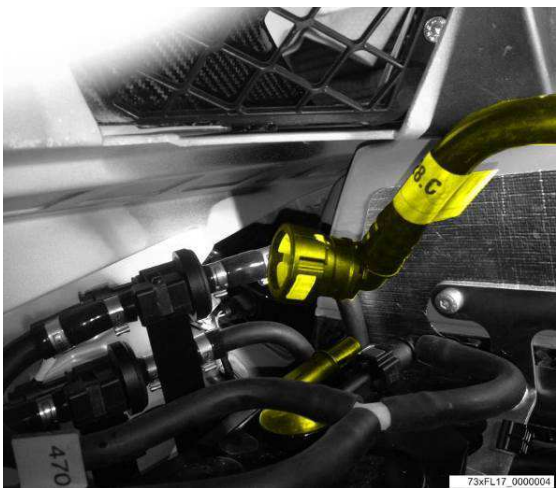
73xFL17\_0000004

f) Open the shut-off valve (position 1) and wait for the system to charge up. The pressure must stabilize at a value of around 0.02 bar (0.3 psi).

If the pressure goes below the set value, the tank system has one or more leaks: it will therefore be necessary to look for leaks in the system with a leak detector spray. If, on the other hand, the pressure remains stable at the set value, this means that the system has no leaks.

- i) Remove the instrument 61353000397 and the tank seal test device 61353000375.  
j) Reconnect the hose removed at point 68/b of this procedure.
